Report on
Preliminary Site Investigation for Contamination

Proposed Residential Development
45 Mulloway Road, Chain Valley Bay

Project 83515.01
November 2018

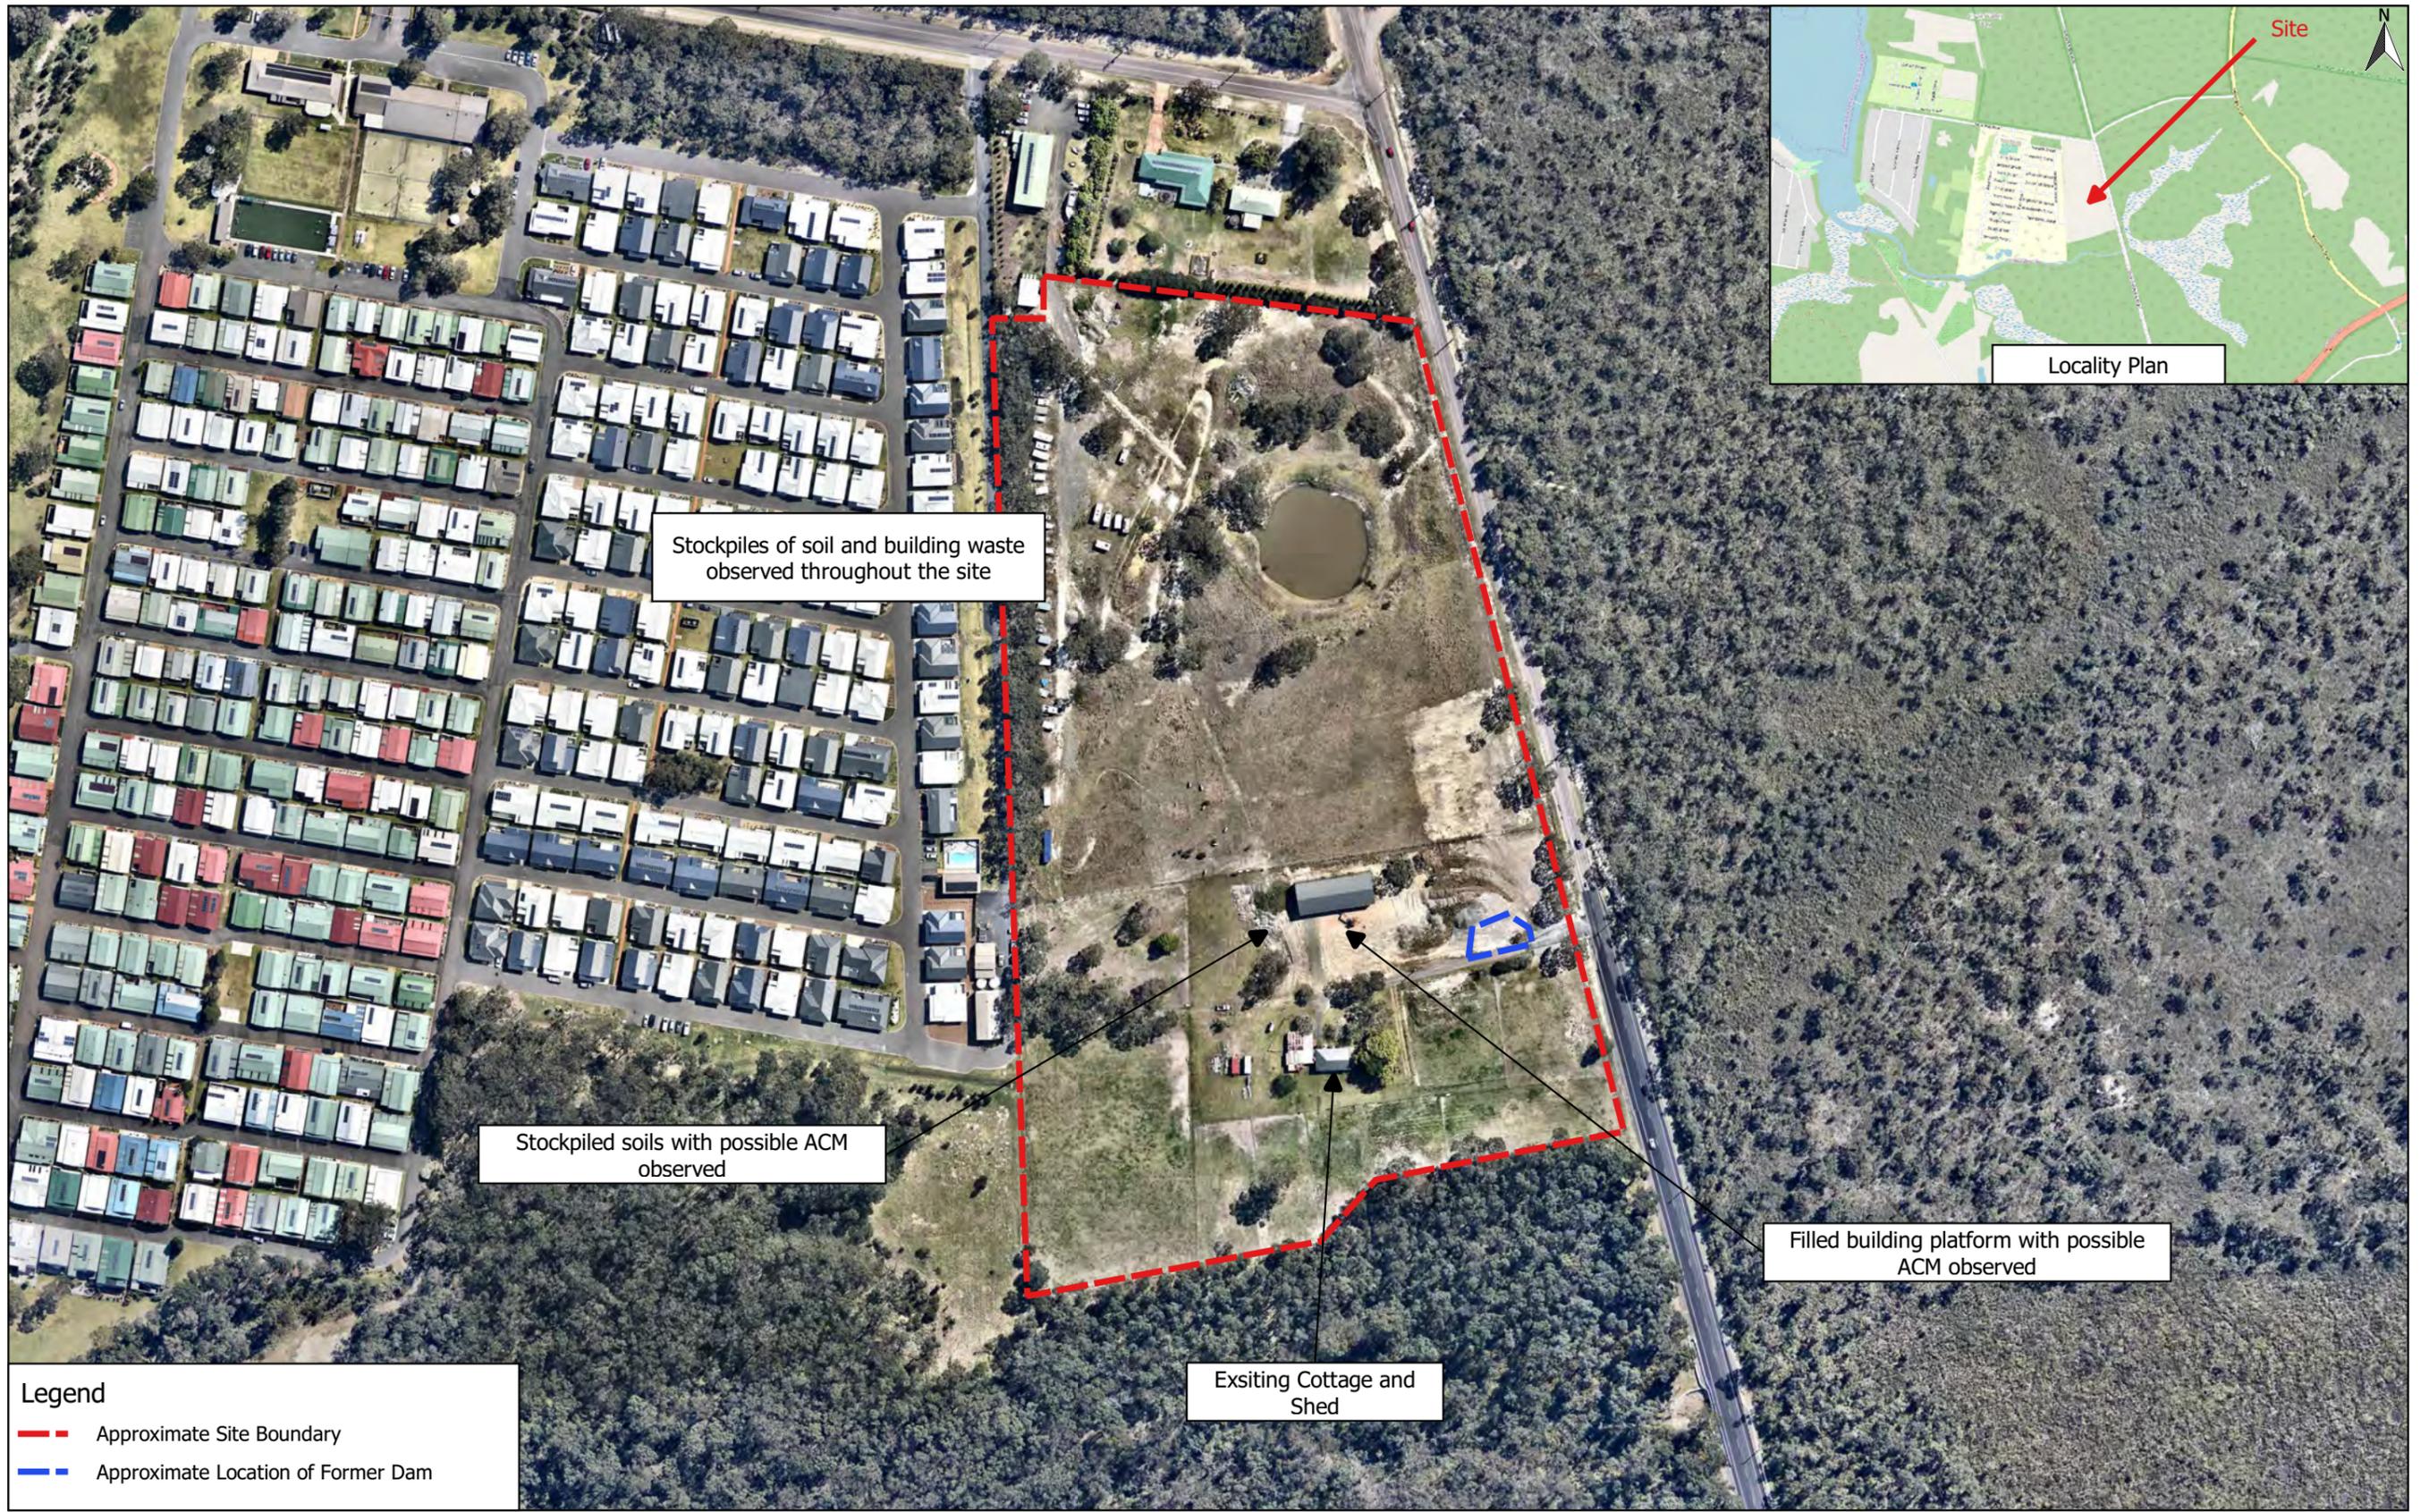
Stockpiles of soil and building waste observed throughout the site

Stockpiled soils with possible ACM observed

Filled building platform with possible ACM observed

Prior to completion of the further intrusive contamination investigations it is recommended that a licensed contractor is engaged to remove all debris and waste materials and suspected ACM fragments observed at the ground surface.

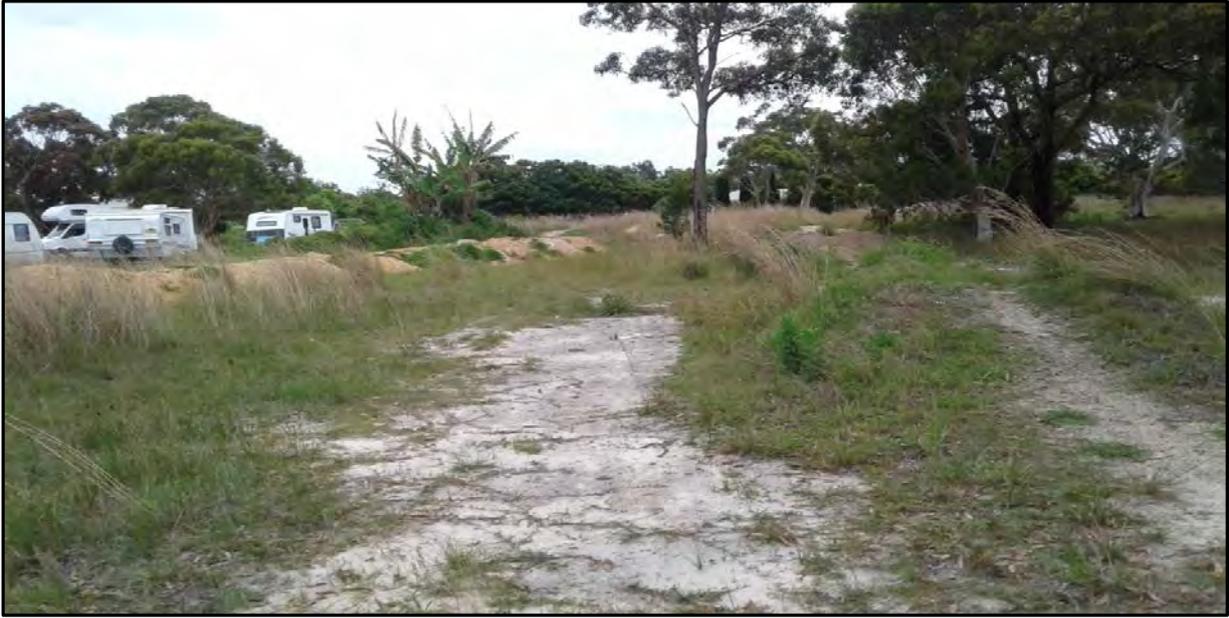
Photo 5: Stockpiles of soil in northern area of the site

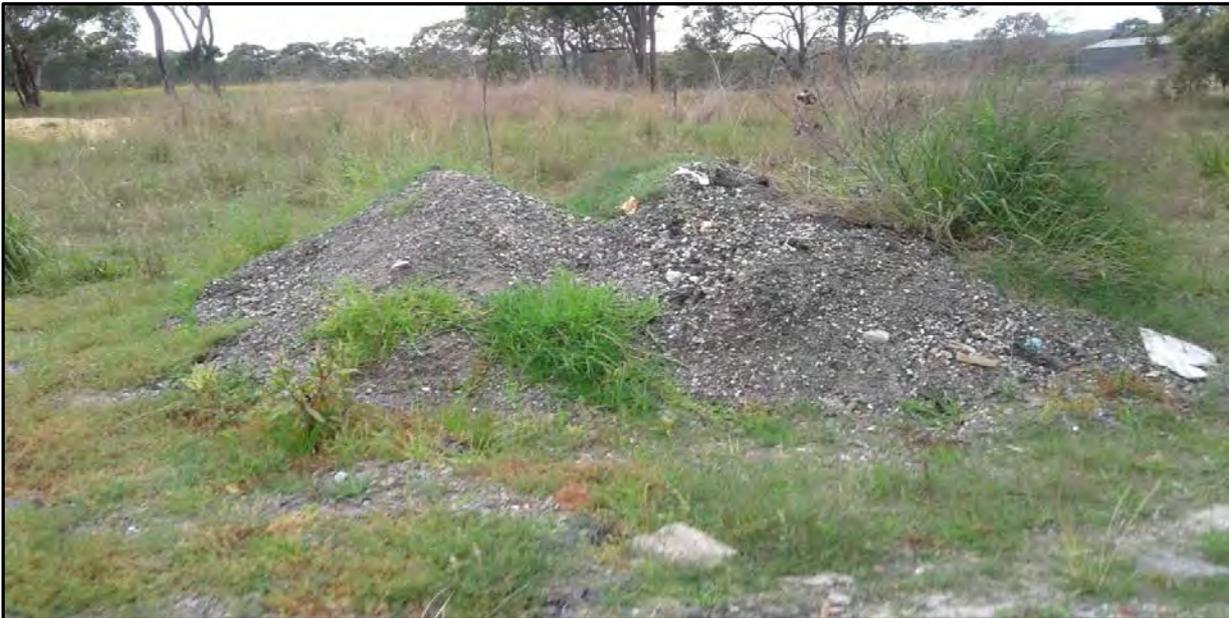
Photo 6: Stockpiles of building waste in northern area of the site

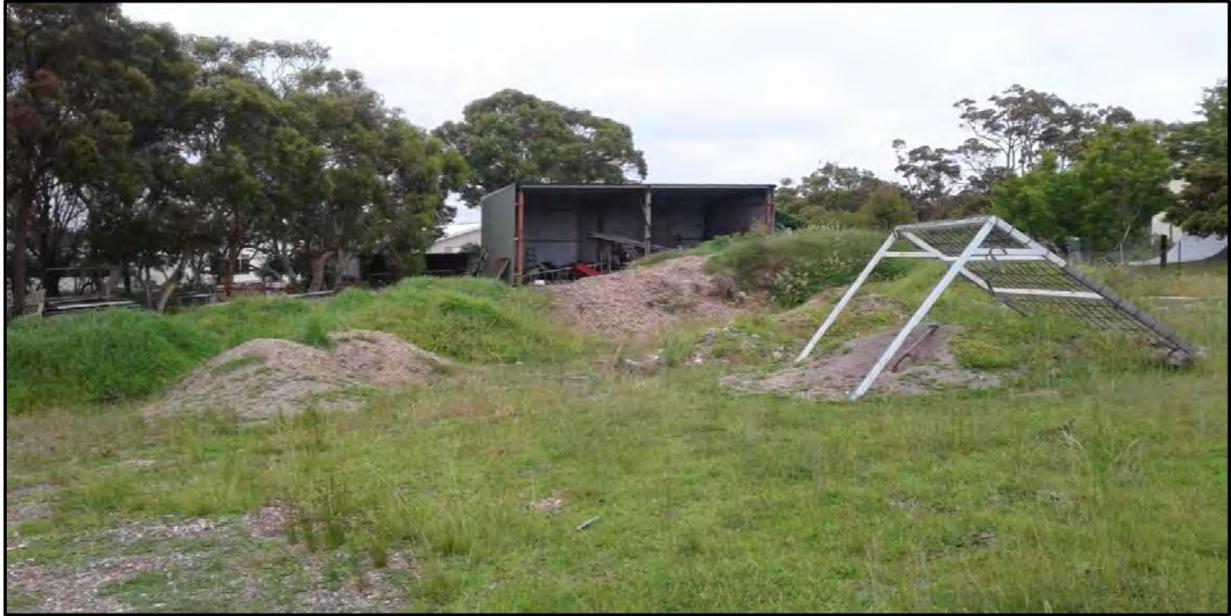
Photo 7: Stockpiles of soil in northern area of the site

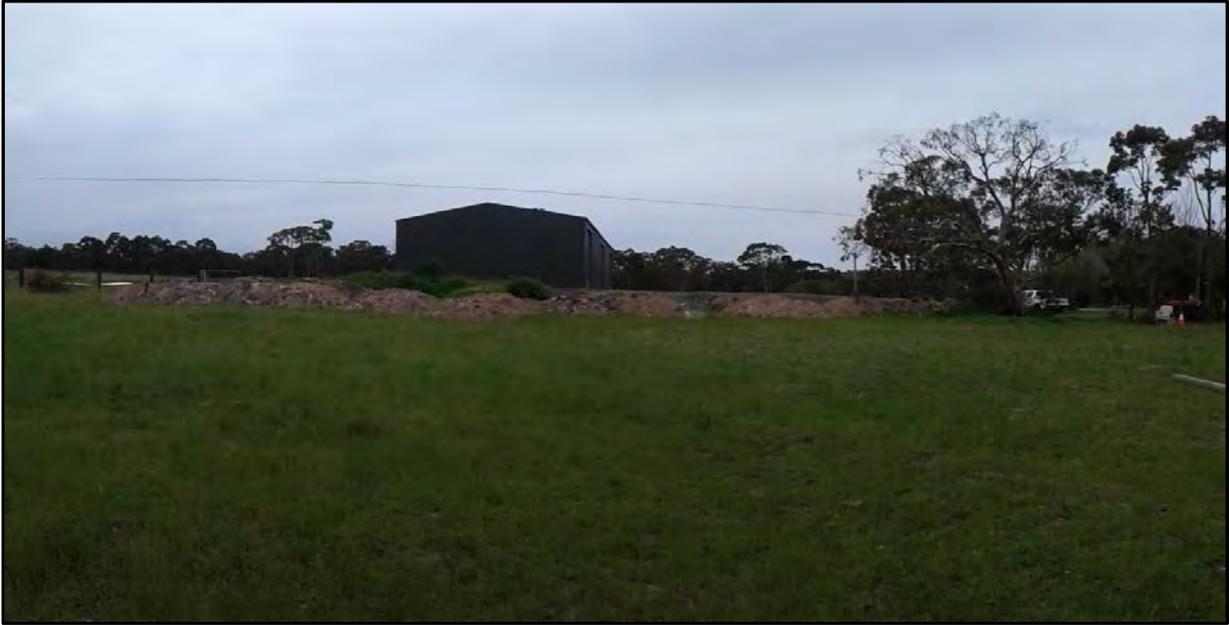
Photo 9: View of colorbond shed and stockpiles fill material in southern area of the site

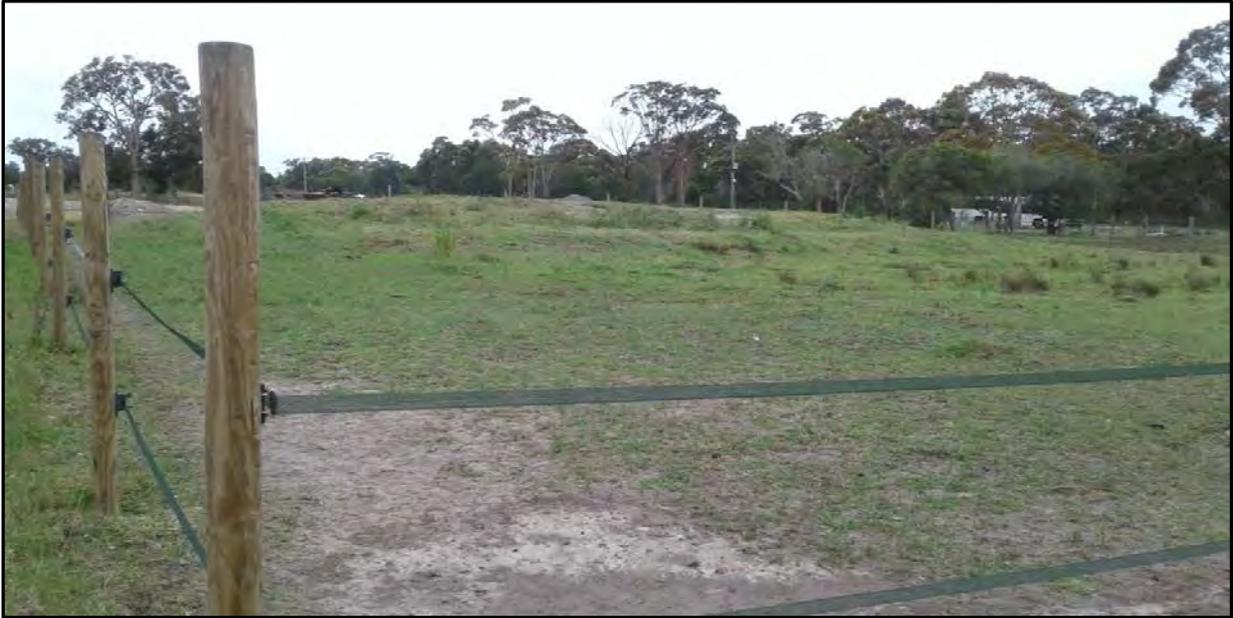
Photo 13: Fill material in southern area of site, looking north

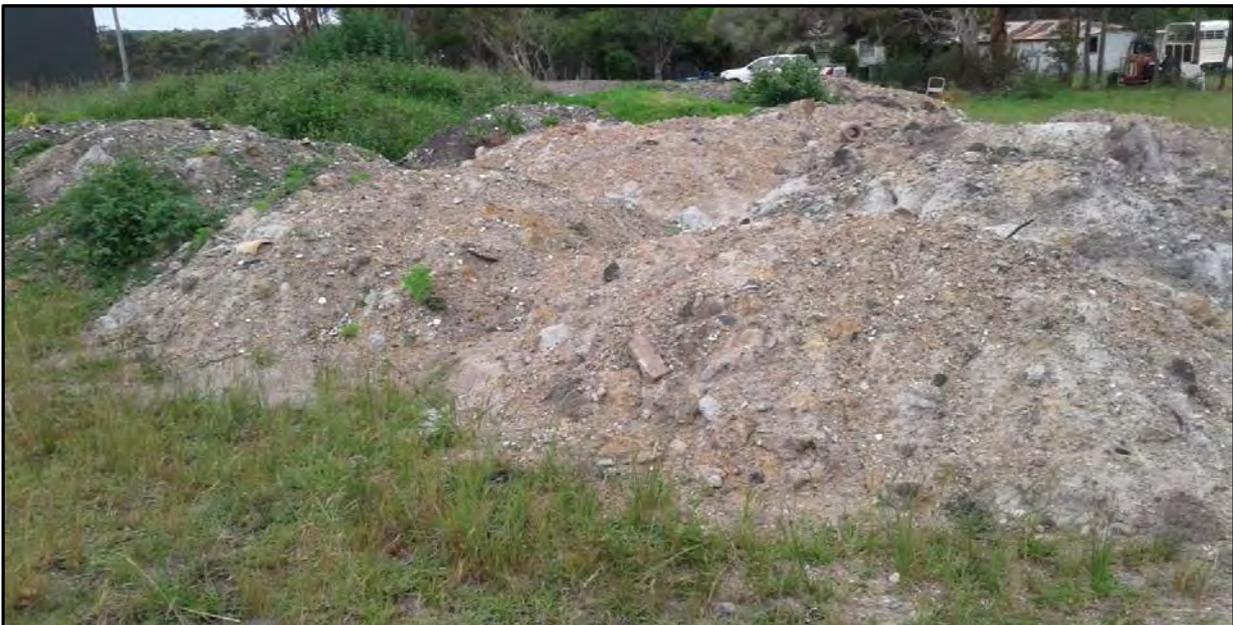
Photo 14: Stockpiles of soil and building waste in southern area of the site

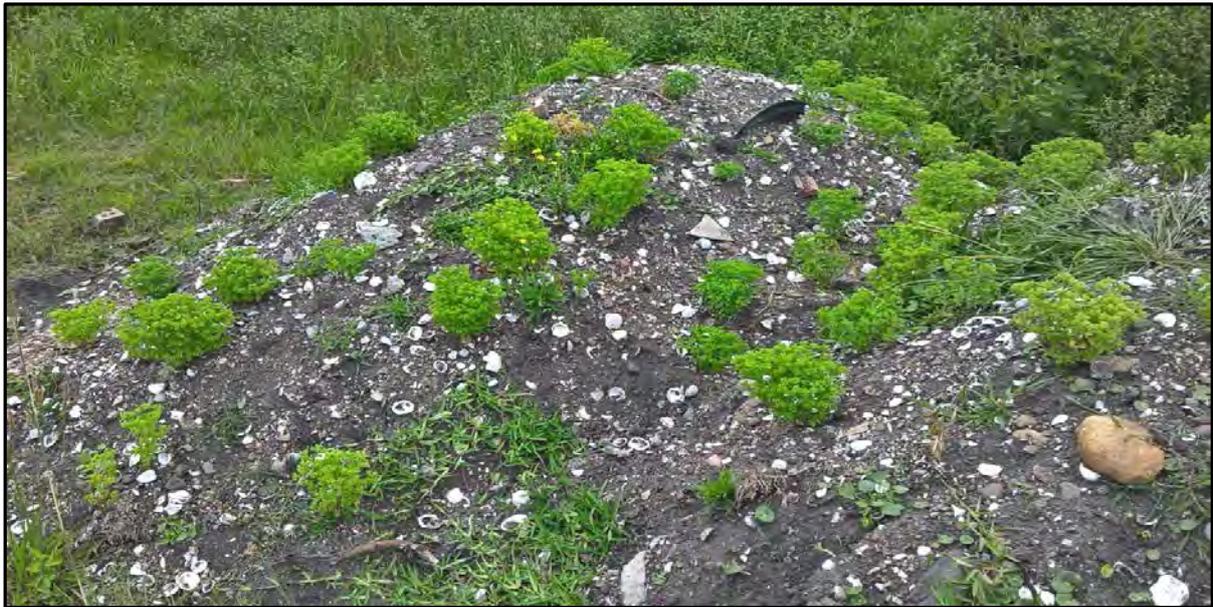
Photo 15: Stockpiles of soil and building waste in southern area of the site

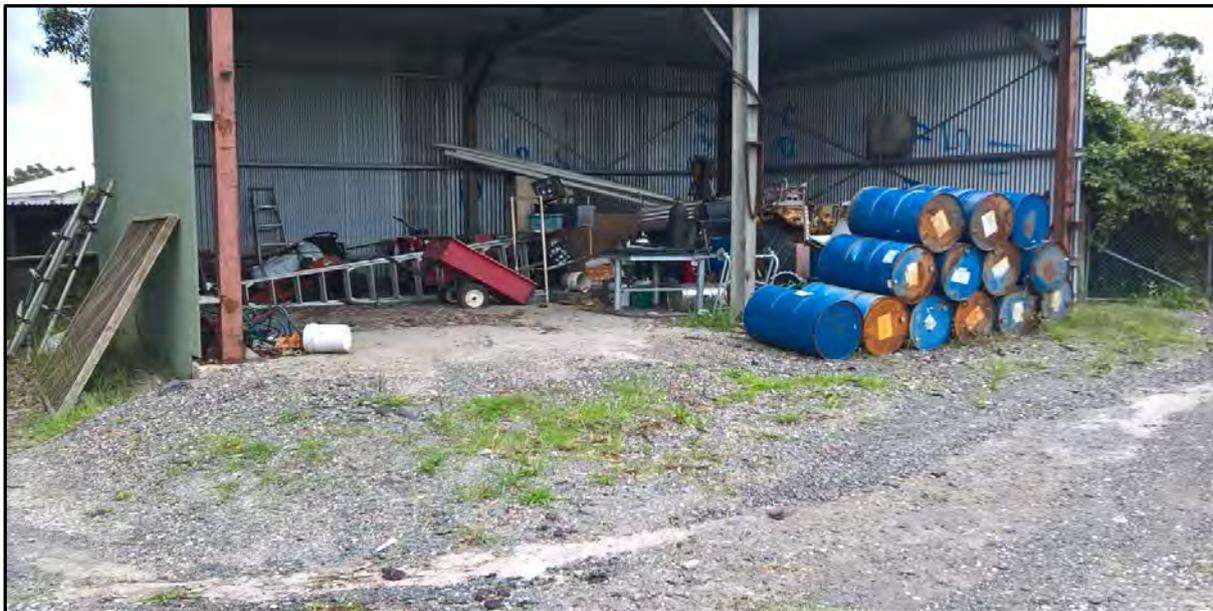
Photo 16: Shed with oil containers in property adjacent to northern boundary

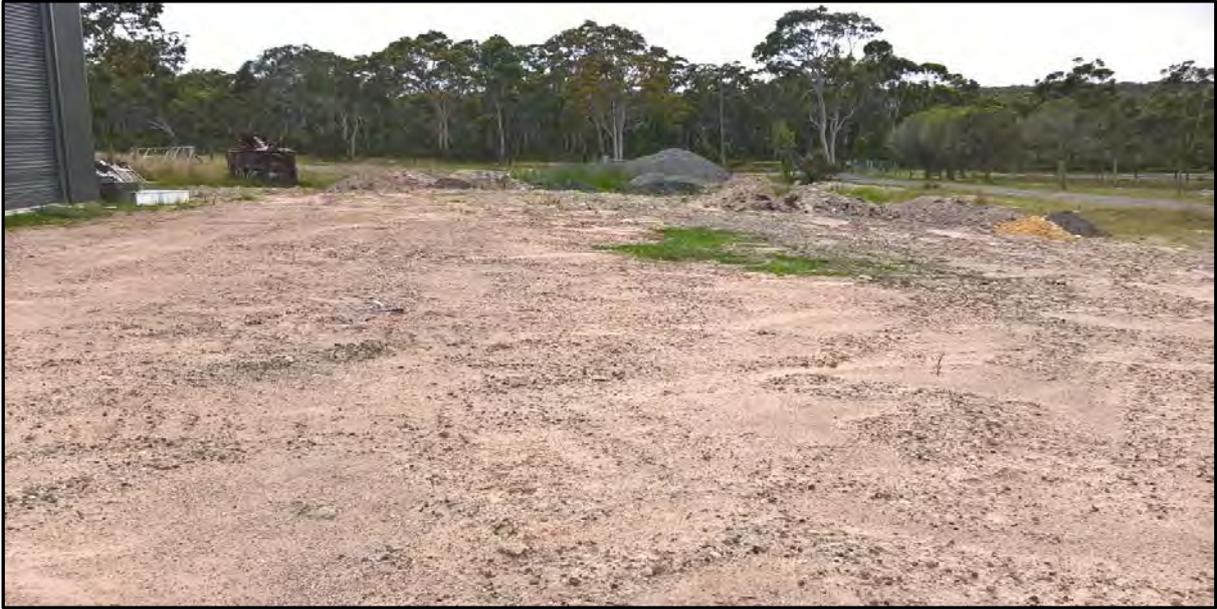
Photo 17: Fill pad in southern area of site

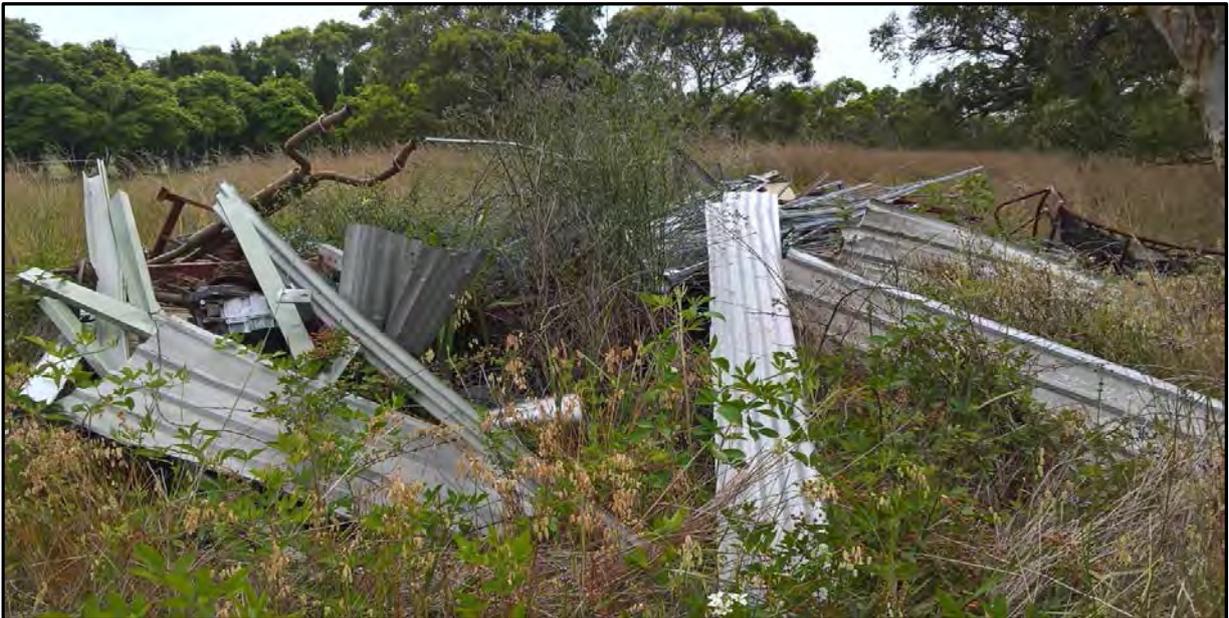
Photo 18: Scrap metal in northern area of site

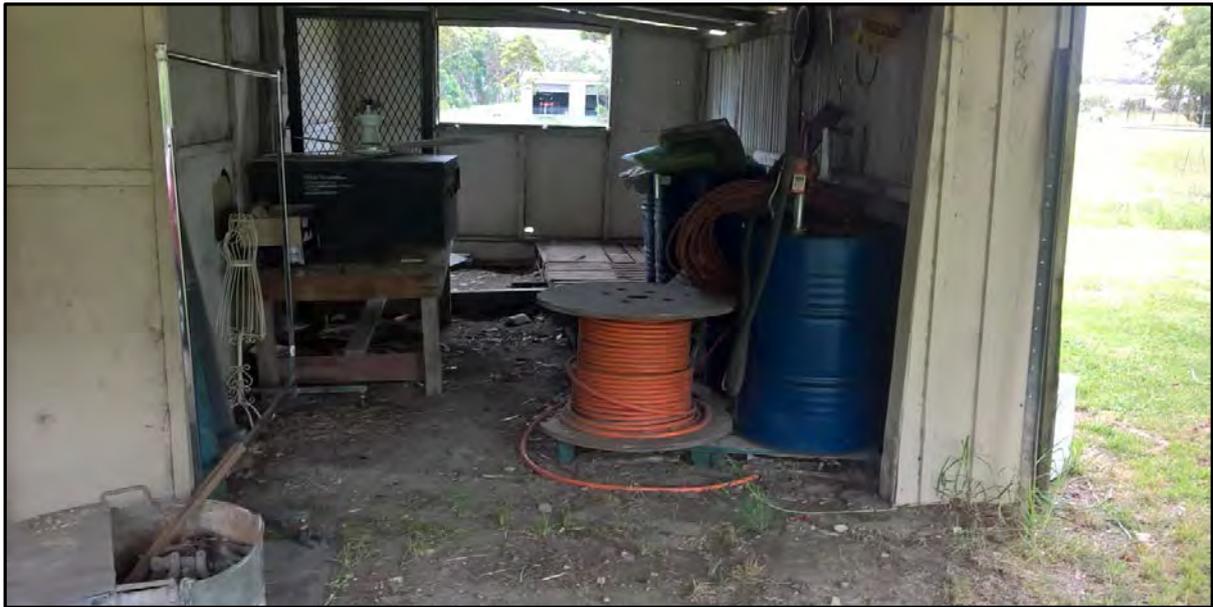
Photo 19: Contents of shed in southern area of the site

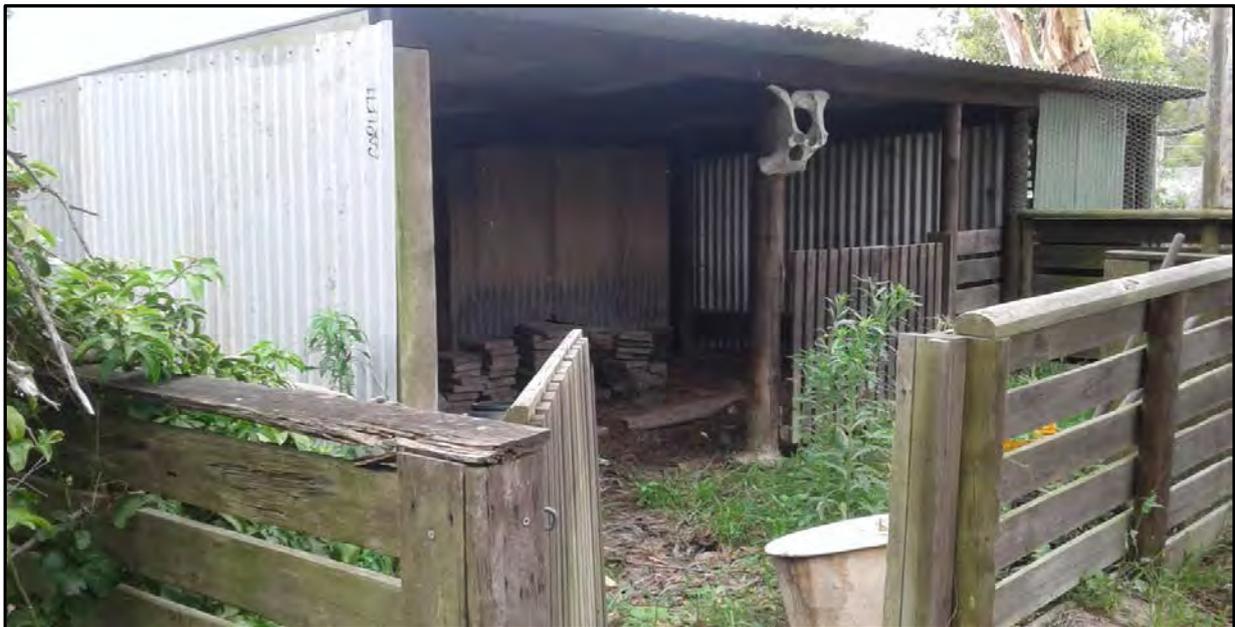
Photo 20: Possibkle former poultry shed
