Project 75853.02
11 December 2019
R.001.Rev0
TDM

Slope Stability Assessment
Proposed Rezoning
39 Dell Road, West Gosford

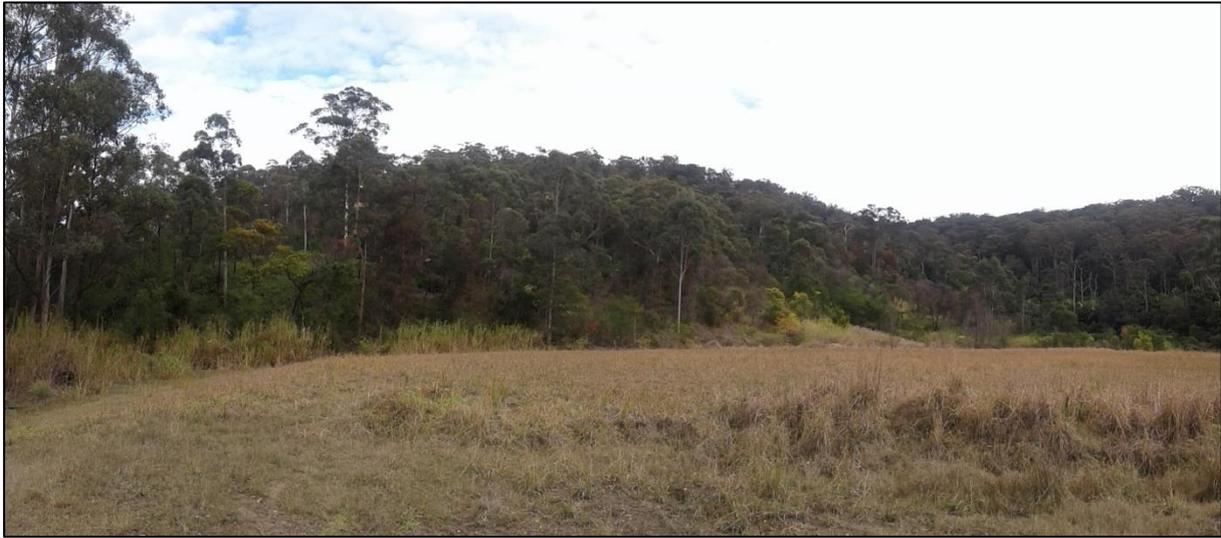
At the time of the inspection, the northern area of the site to be rezoned ‘IN1’ had been filled, to create a level building platform (refer Figure 2). Surface levels in this area are in the order of about RL 10 m to 14 m AHD.

Figure 2 – Photograph of filled area to be zoned ‘IN1’, looking west

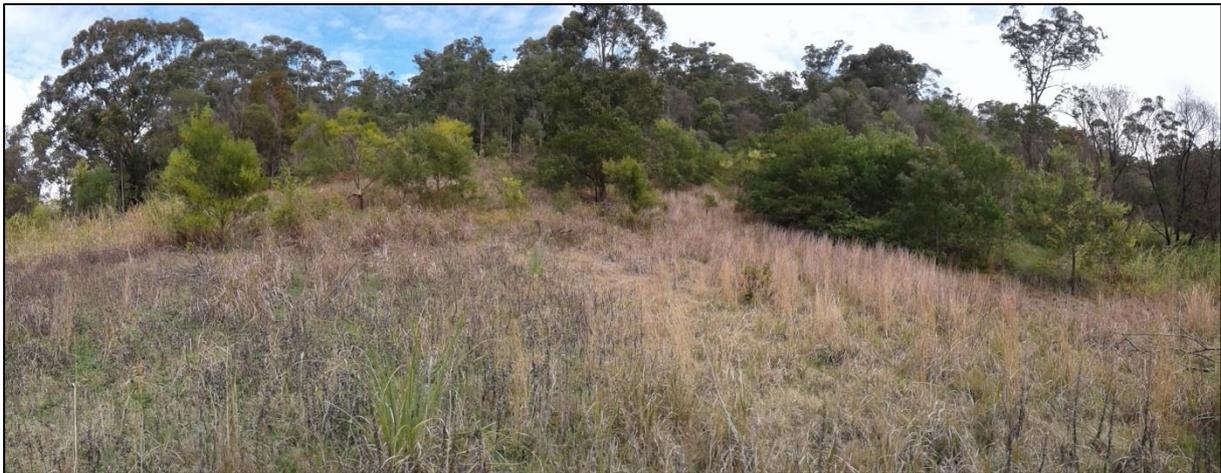
Figure 3 – View of cleared area at toe of slope and vegetated area beyond, looking west

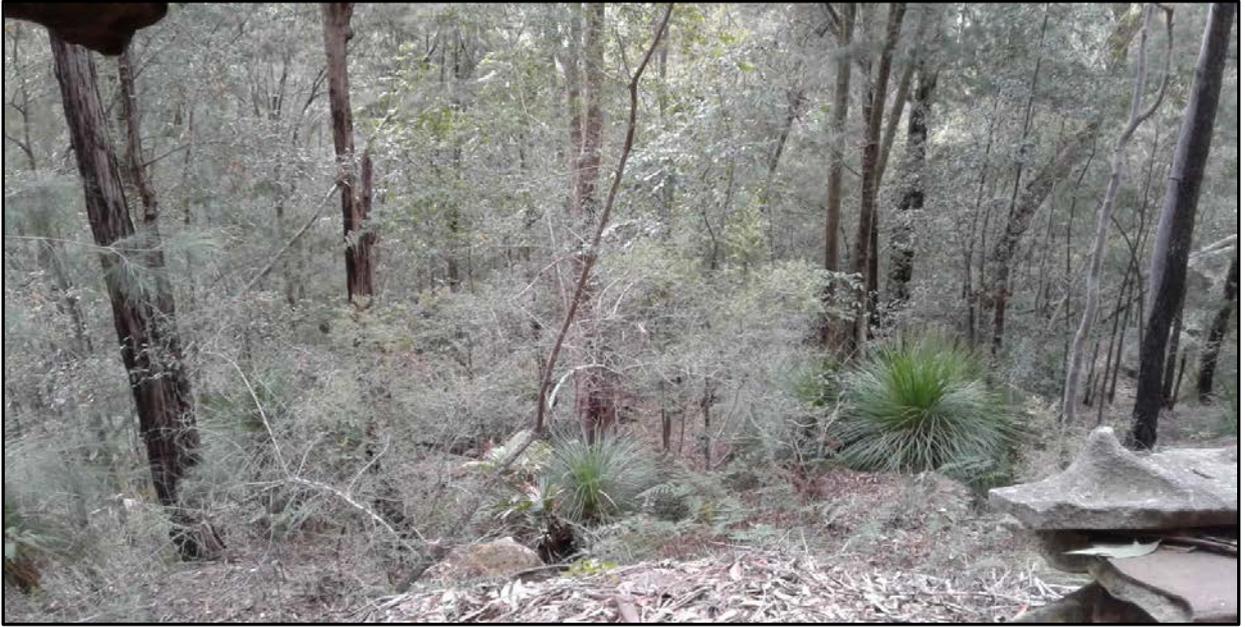
Photo 1: Path from toe of escarpment, toward development area

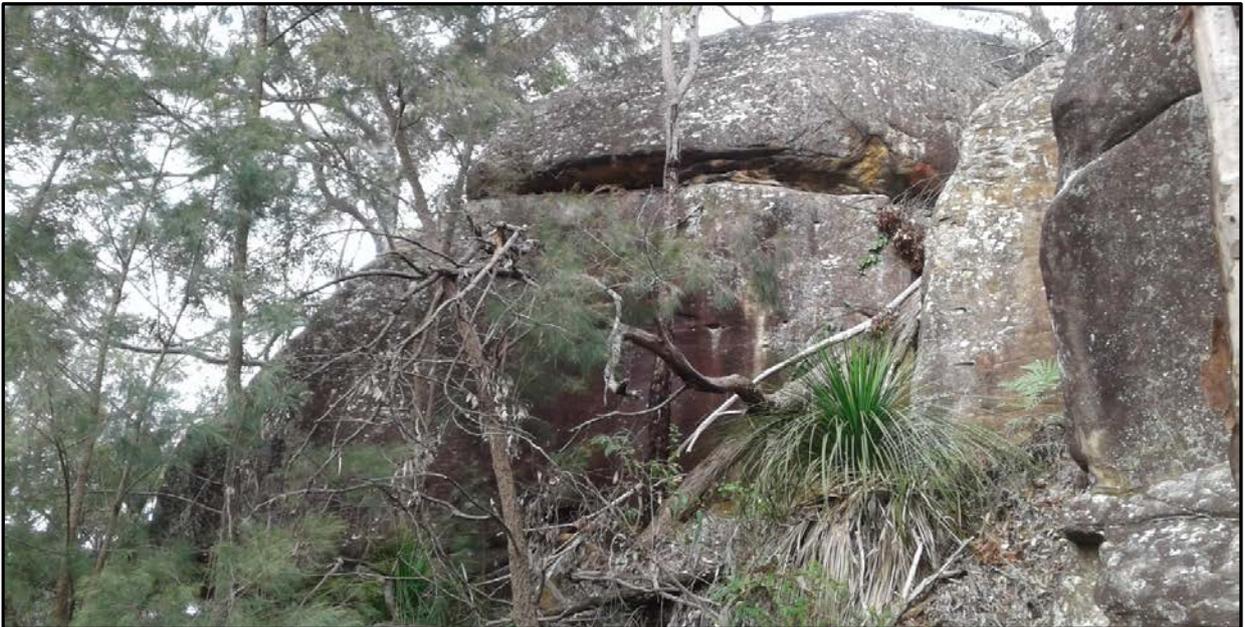
- No boulders were observed in or adjacent to the area to be rezoned 'IN1';
- The rock escarpment is approximately 8 m high. Some undercutting was observed near the base of the escarpment, however, no signs were observed to suggest that large boulders were becoming detached from the escarpment. Some smaller boulders (<2 m across), however, appeared to have detached and caught up within the escarpment;

Photo 2: Rock escarpment

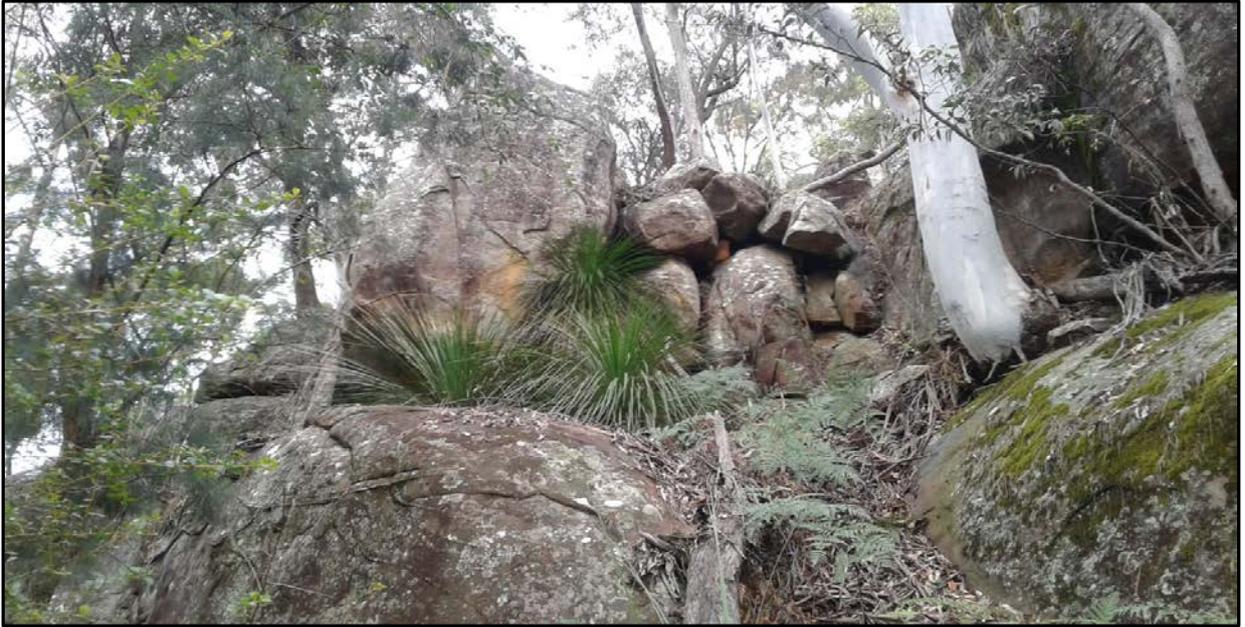
Photo 3: Small boulders caught up in escarpment

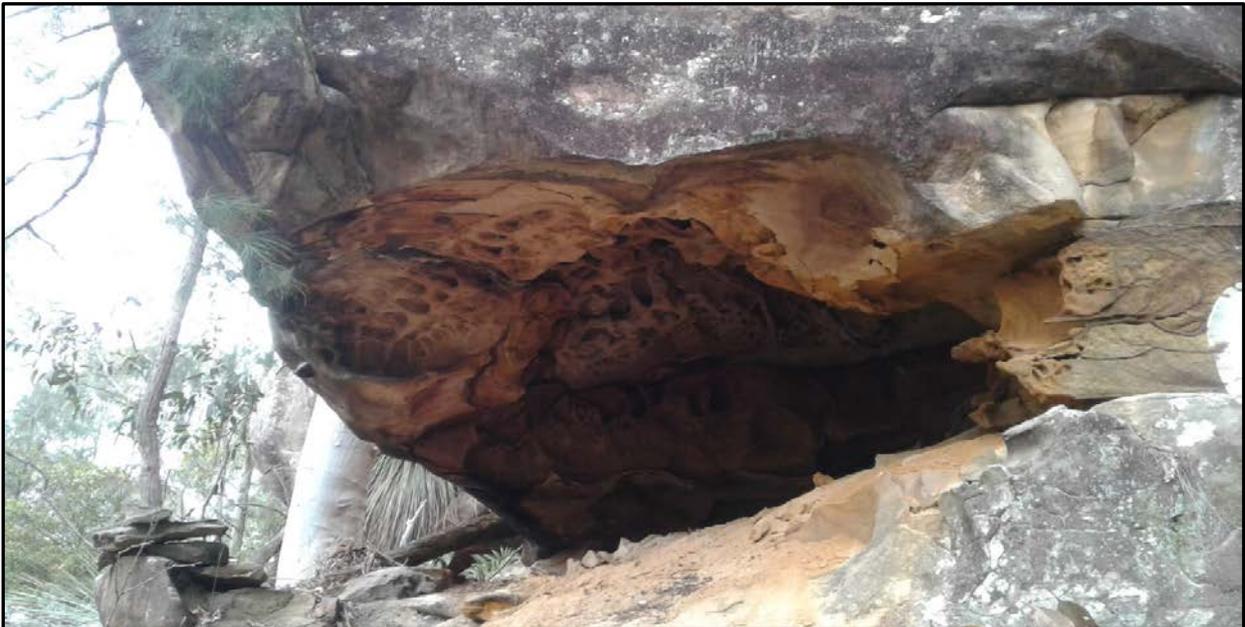
Photo 4: Undercutting near base of escarpment

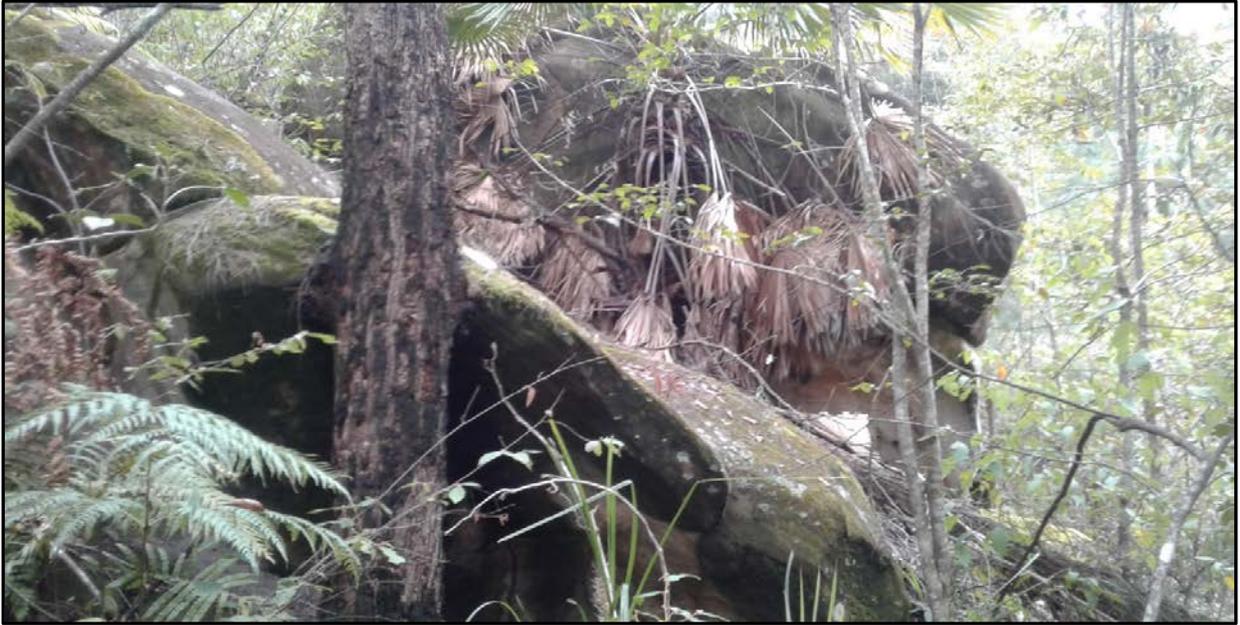
- Boulders are present upslope of the area to be rezoned 'IN1' and appear to have detached from the rock escarpment above. The closest boulders are relatively small (i.e. <3 m across) and approximately 80 m upslope of the proposed zone boundary. Larger boulders, up to about 8 m to 10 m across, were also observed approximately 50 m from the escarpment (i.e. about 150 m from the proposed zone boundary);

Photo 5: Large boulders detached from escarpment

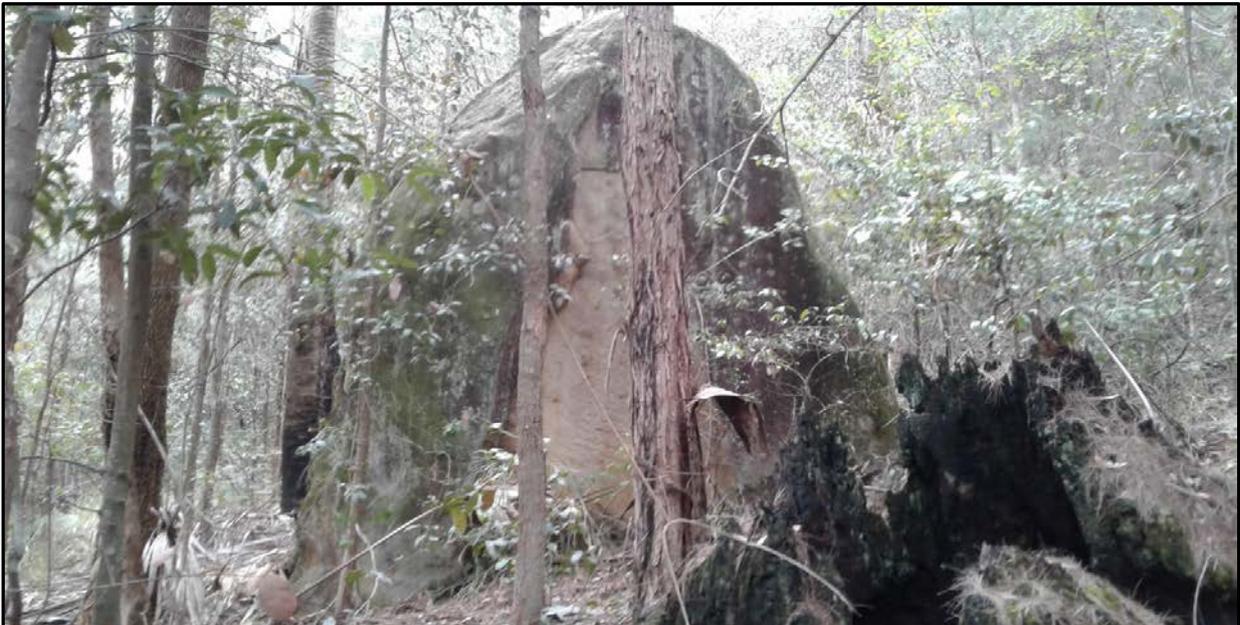
Photo 6: Large boulders detached from escarpment

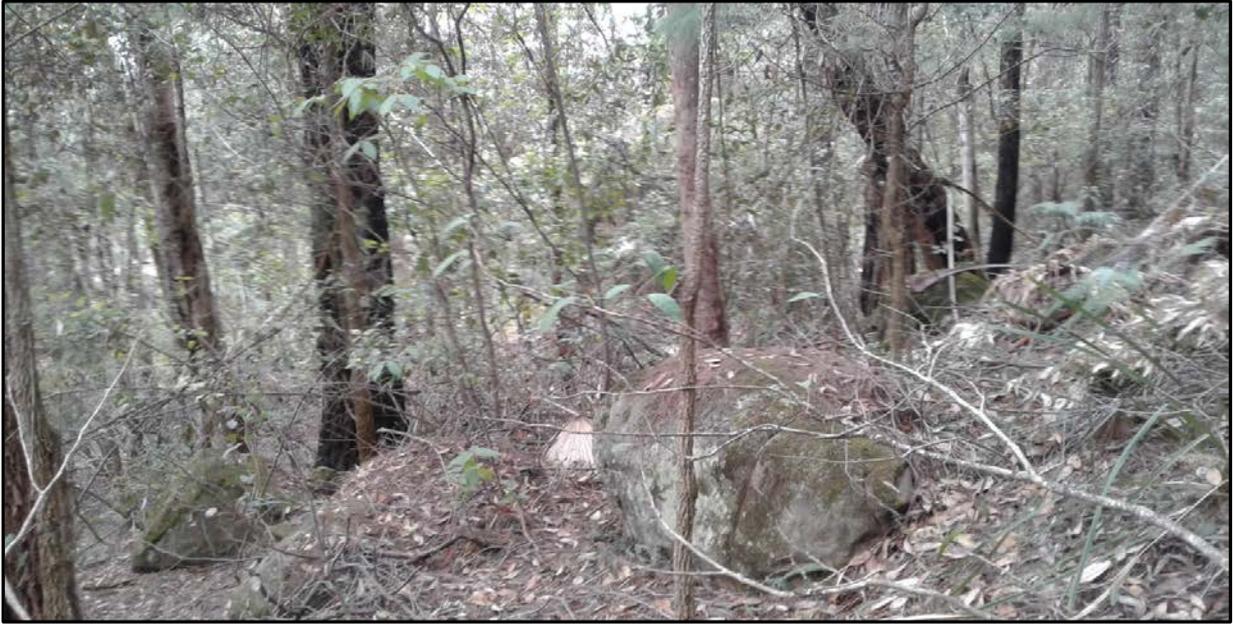
Photo 7: Small boulders, further downslope

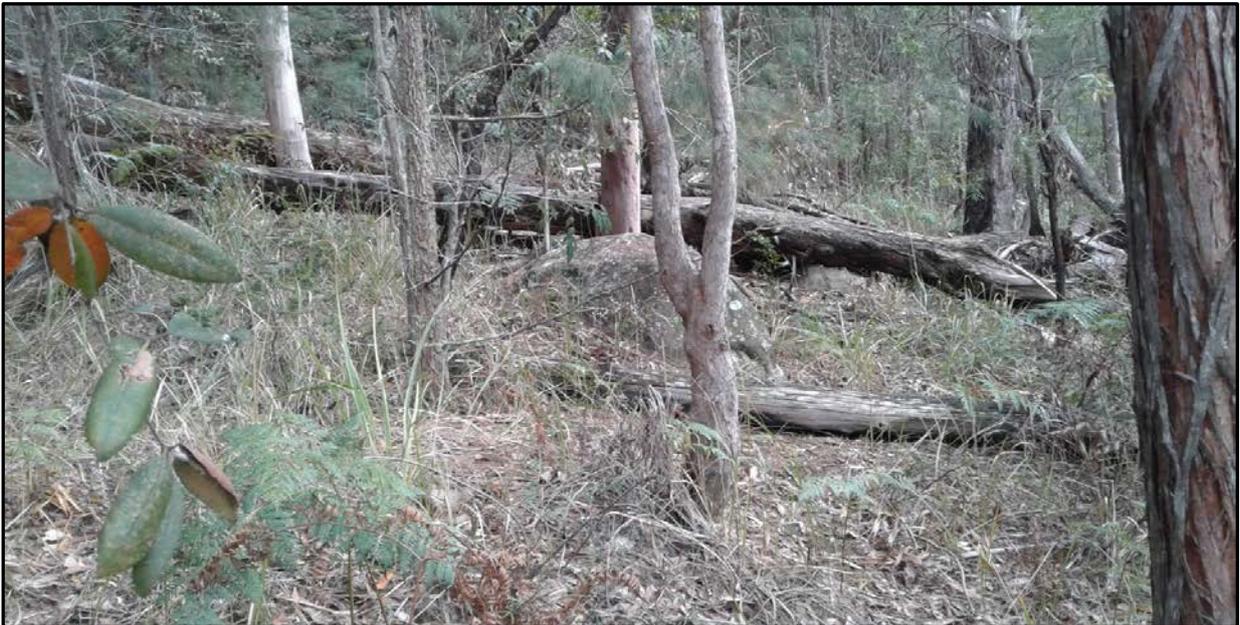
Although boulders are present upslope of the future development, the nearest boulder is some 50 m away and is relatively small (<2 m across). Furthermore, given the tabular shape of the boulders and the presence of bunds / catch drains upslope of the development area, further rolling / sliding of the boulders to the development area is considered unlikely. Similarly, any new boulders that may detach from the escarpment are likely to be caught up within the densely vegetated slopes or stop prior to reaching the area of the proposed industrial development, as indicated by observations made of previous detachments at the site.

Photo 8: Nearest boulder (small)

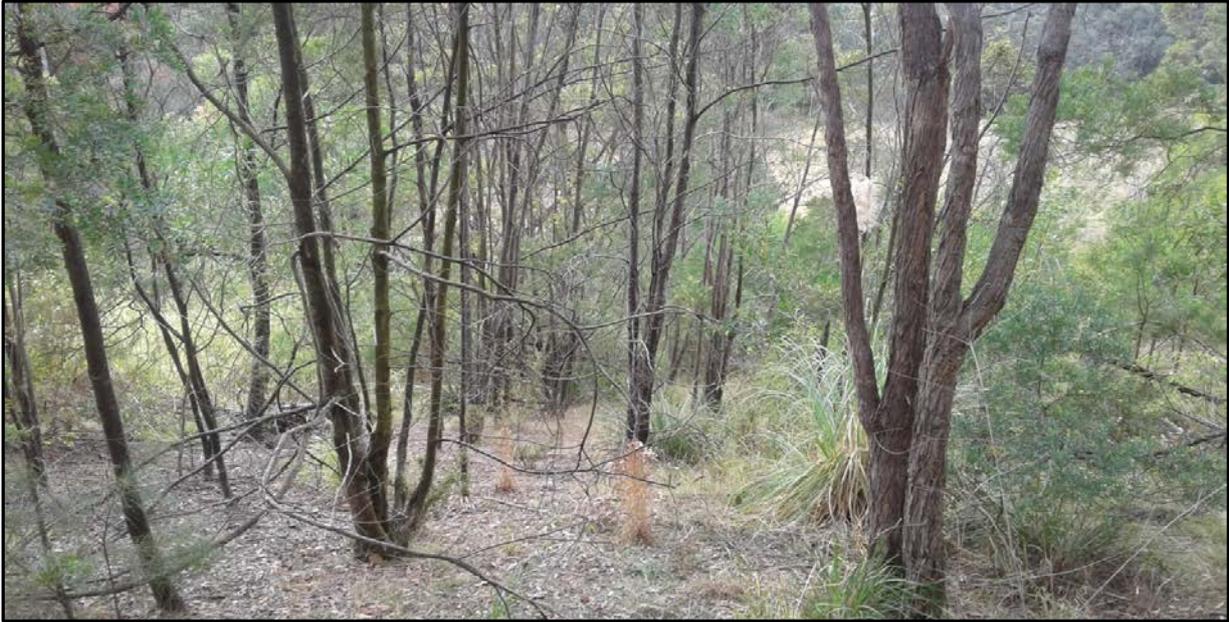
Photo 9: Path near toe of slope

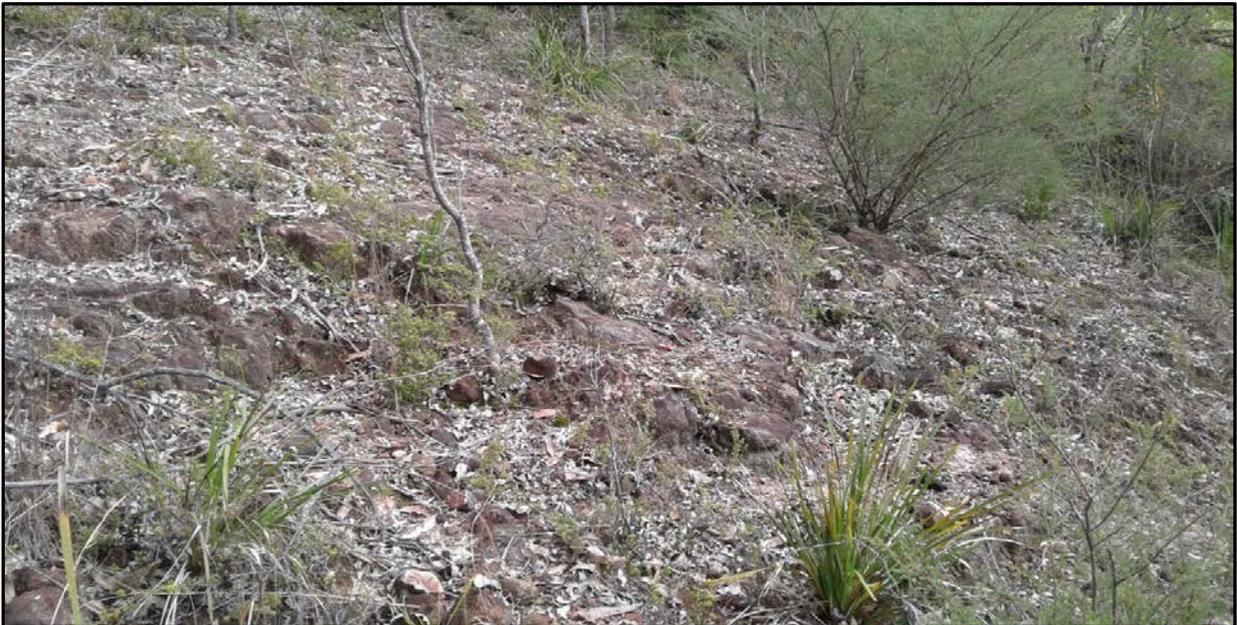
- No signs of gross instability were observed during the inspection;
- An area of exposed sandstone was observed near the toe of the slope and at the southern end of the proposed zone boundary;

Photo 10: Exposed sandstone batter near toe of slope

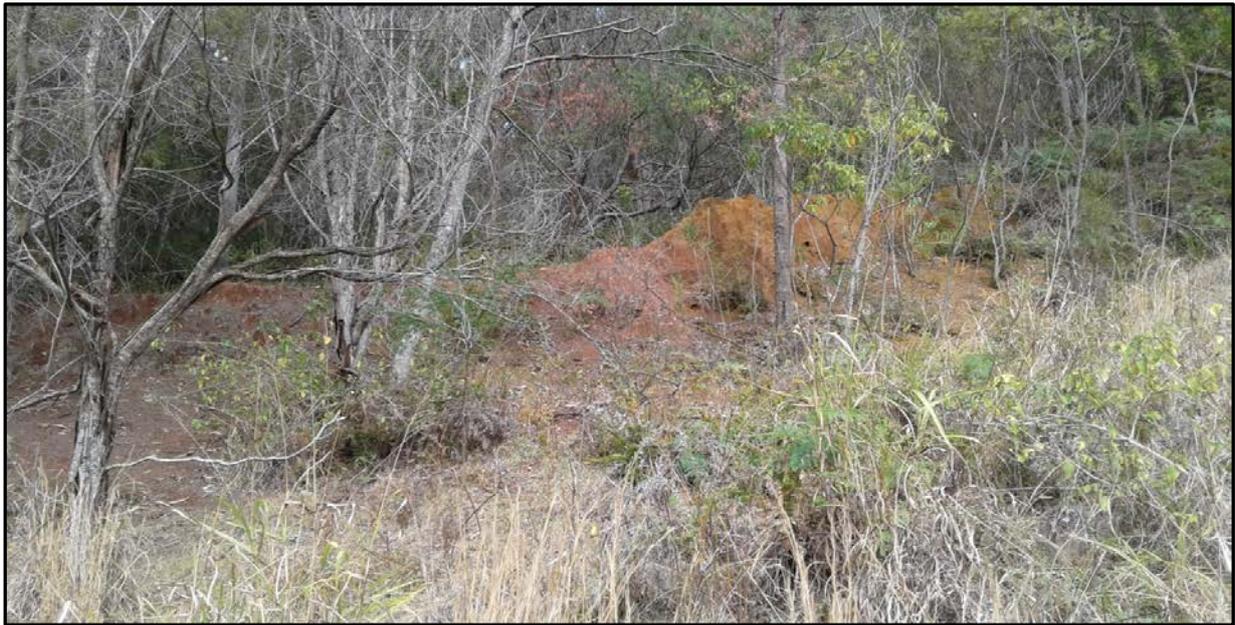
- Residual clay soils are exposed to the south of the cleared area, near the toe of the slope;
- A bund / catch drain has been constructed approximately 45 m upslope of proposed zone boundary, diverting upslope run-on to the intermittent drainage alignment to the north;

Photo 11: Residual soils exposed on site

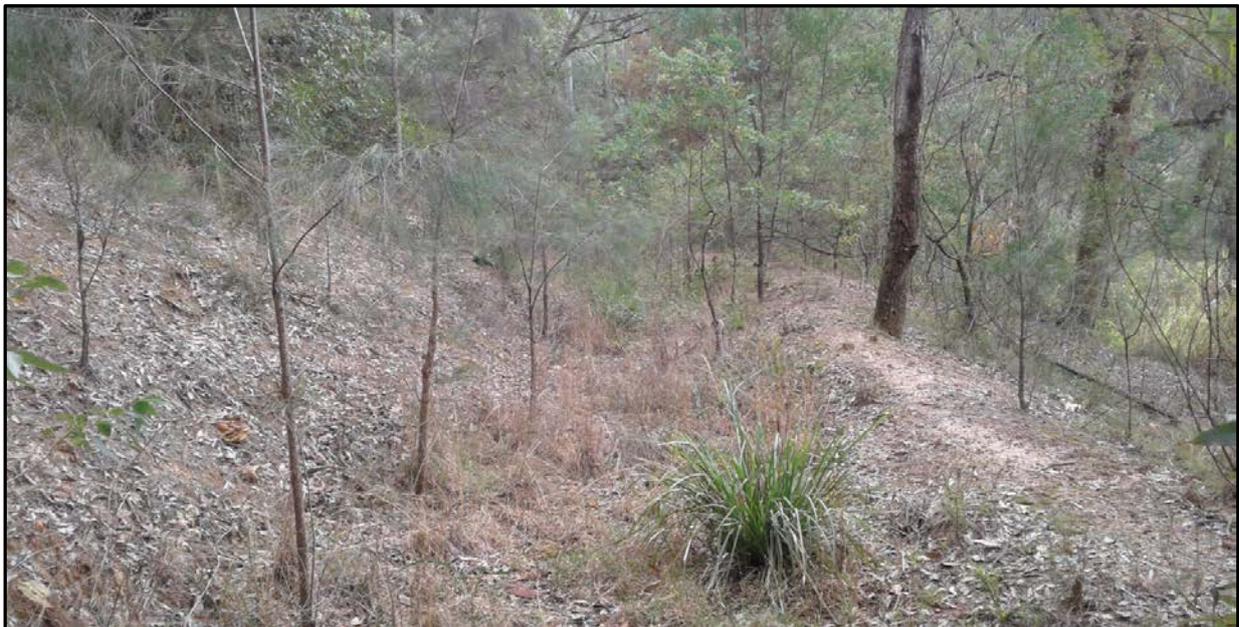
Photo 12: Catch drain / bund upslope of development area

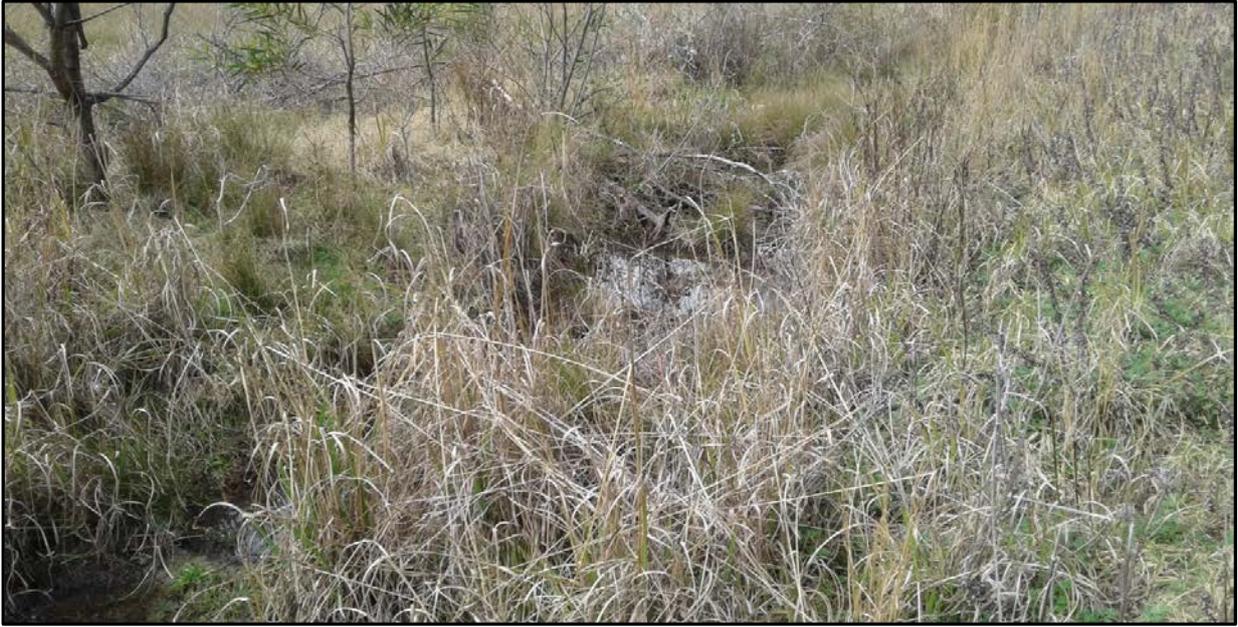
- Catch drains have also been constructed at the toe of slope, just west of the fill pad within the area to be rezoned 'IN1';
- Some fill (soil) mounds are present to the south-east area of the site, adjacent to and within the area to be rezoned 'IN1' or already zoned 'IN1'. These fill mounds were typically no higher than about 2 m and at some locations were covered with felled trees, branches and other vegetation;

Photo 13: Catch drain at toe of slope, adjacent to development area

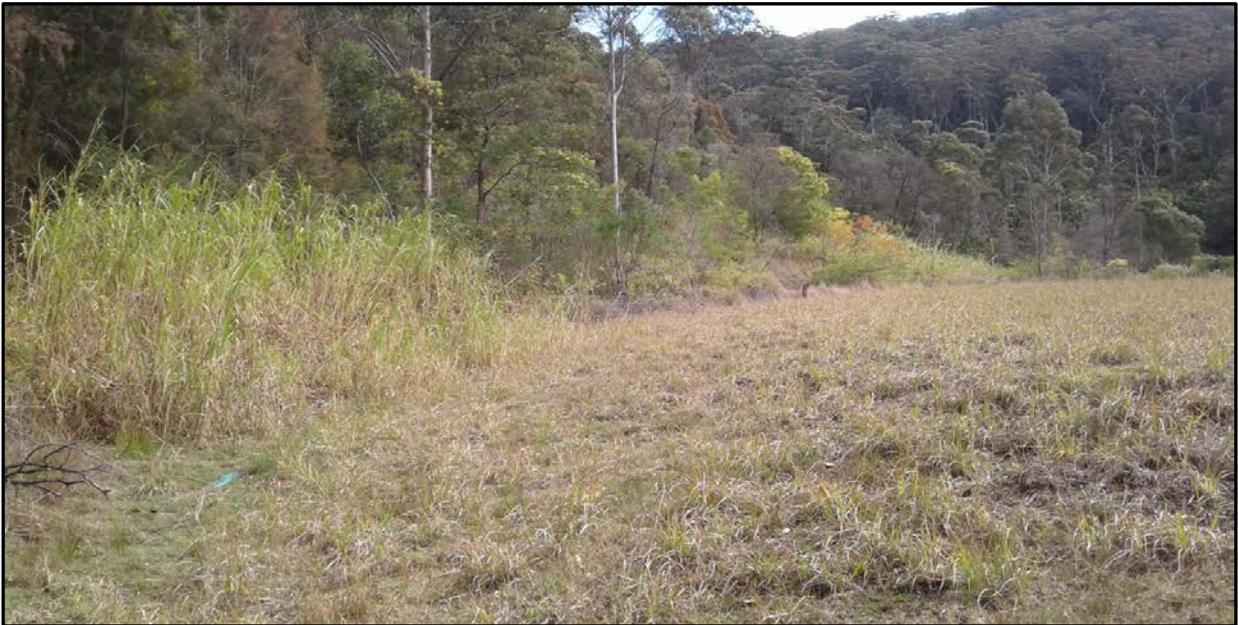
Photo 14: Toe of slope

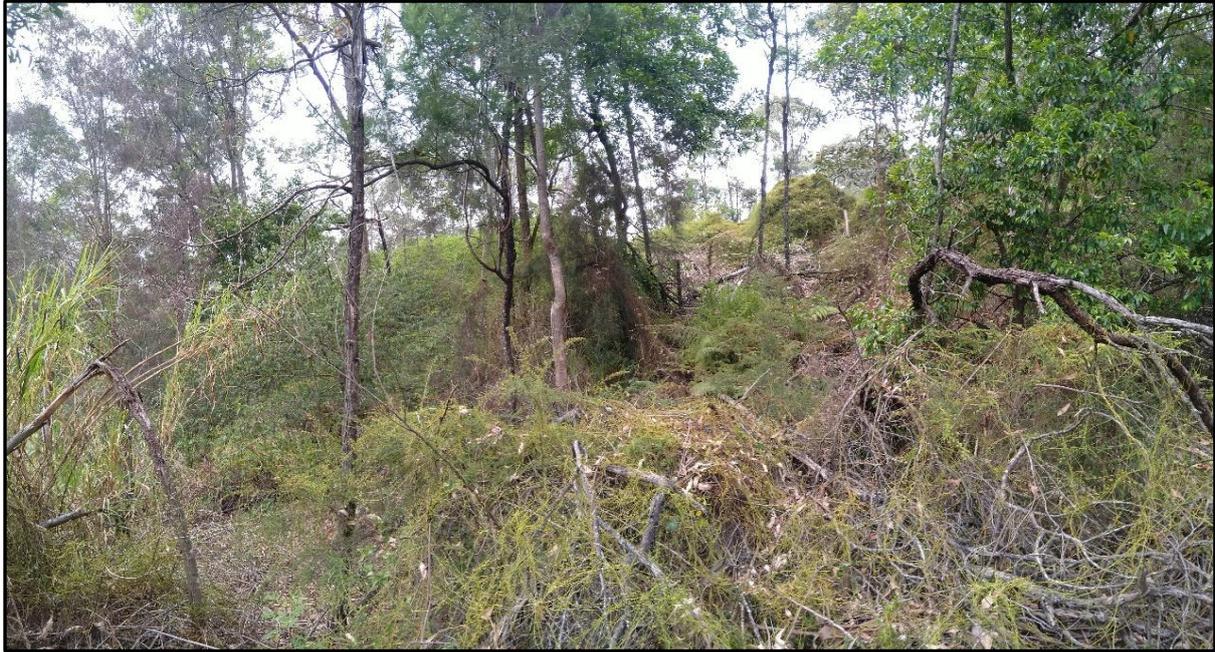
Photo 15: View of stockpiles of soil and vegetation, looking south

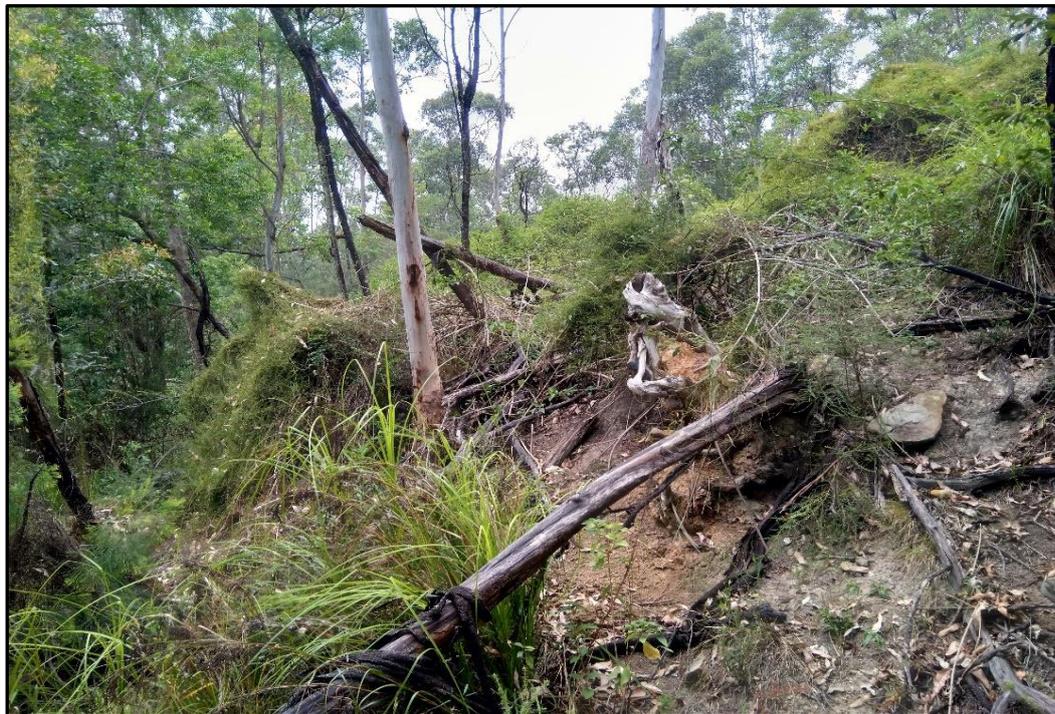
Photo 16: Exposed stockpile showing soils and vegetation

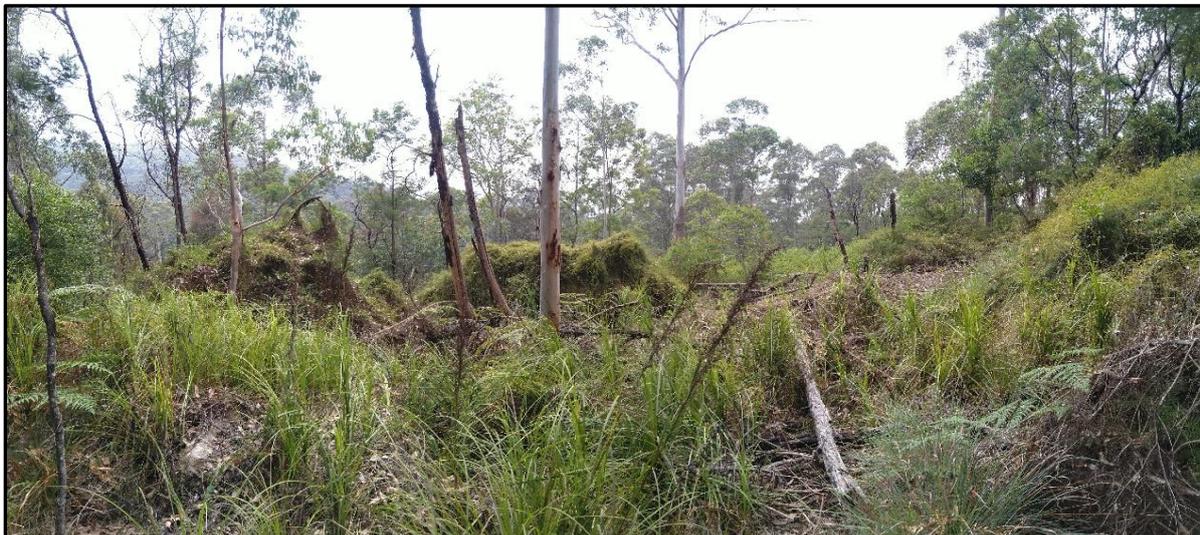
Photo 17: View of vegetation stockpiles west of cutting, looking south

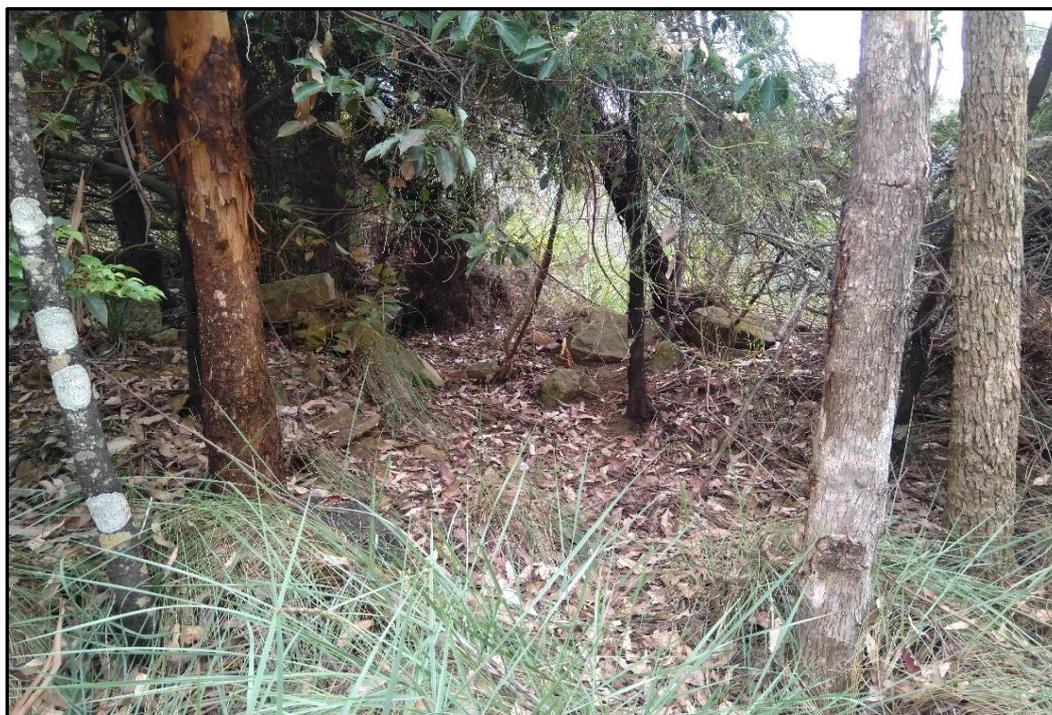
Photo 18: View of stockpiles sandstone boulders

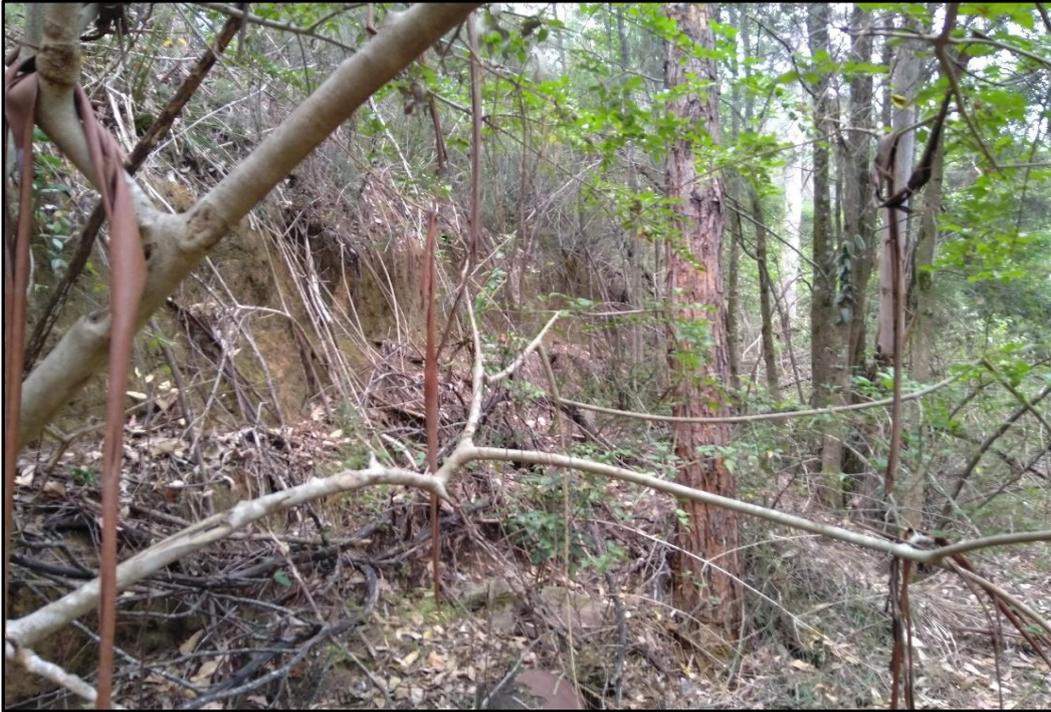
- A near vertical cutting, up to approximately 4 m to 5 m high, is present approximately 50 m to the south of the main area to be rezoned 'IN1'. The cutting appears to start within the area to be rezoned and crosses into the area already zoned 'IN1'. It is noted, however, that a site survey plan showing the cutting and rezone boundaries is currently not available;
- The cut face typically appears to comprise residual clay soils, however given the vegetation cover, full inspection of the cut face was not possible. Small (less than about 0.5 m³) wedges of residual clay soils were observed to be falling away from the cut face at some locations; and
- The south-east area of the site (area already zoned 'IN1') was currently being used to stockpile soils.

Photo 19: View of cutting looking west

Given that the near vertical cutting in the south-east area of the site is showing signs of instability, it is recommended that the portion of the cutting extending into the area to be rezoned 'E2', if any, be battered to a gradient of no steeper than 2 horizontal : 1 vertical. It is noted, however, that any development within the area zoned 'IN1' will likely include bulk earthworks to provide a level building platform, thus removing the cutting and the associated risk of instability.

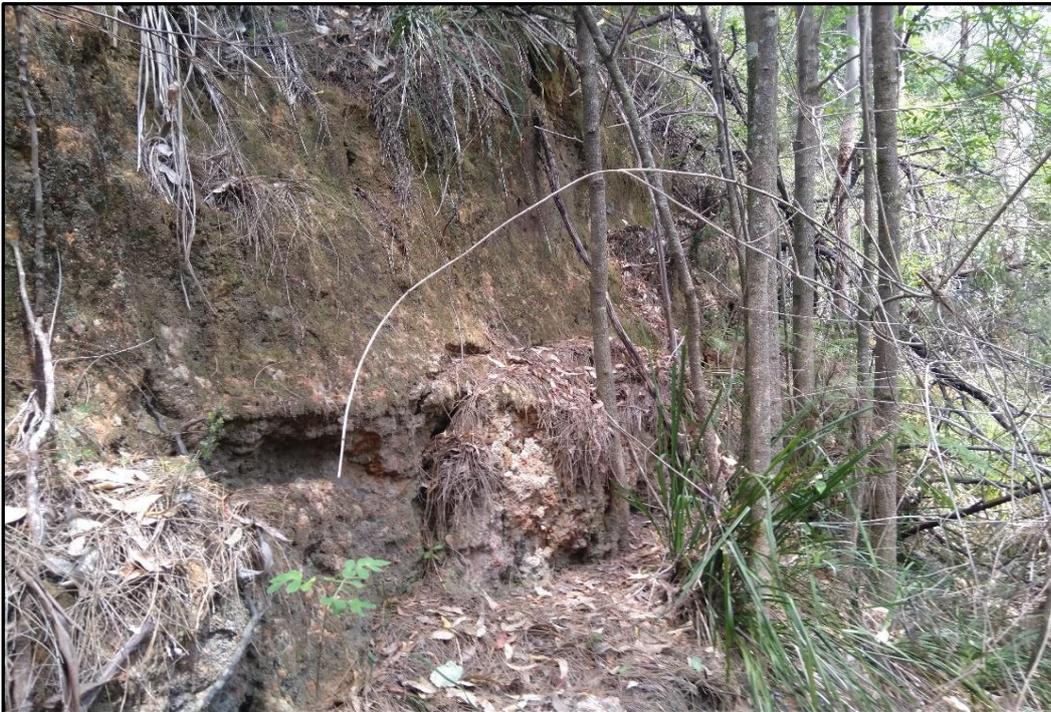
Photo 20: Example of loose soil wedge

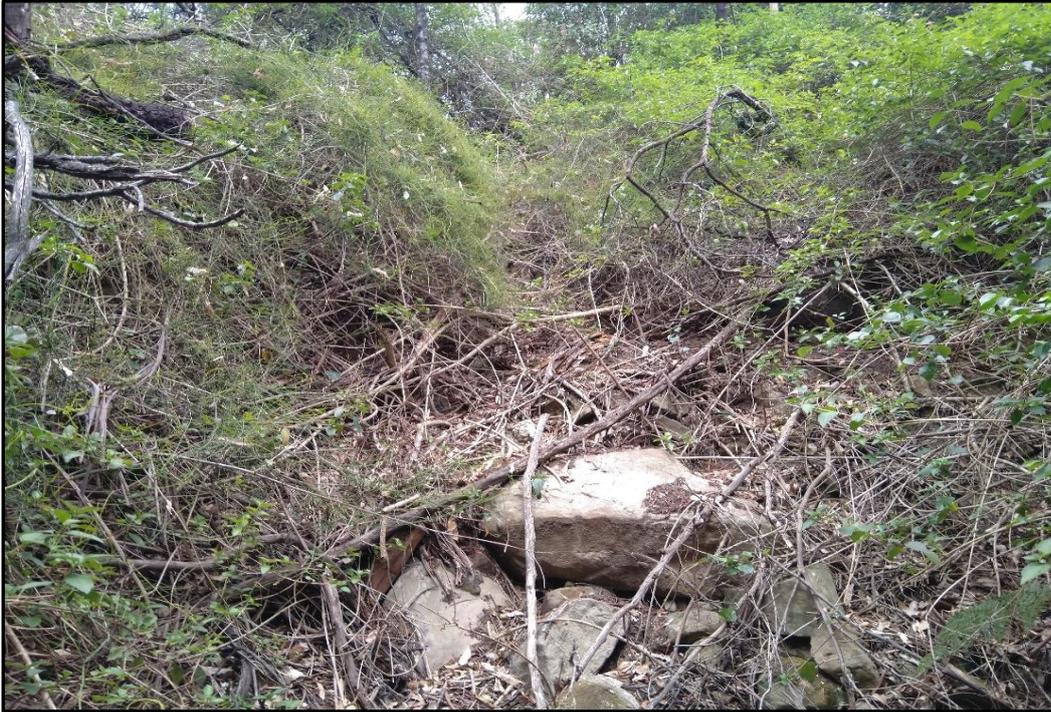
Photo 21: View of sandstone boulders at base of cutting, at western end

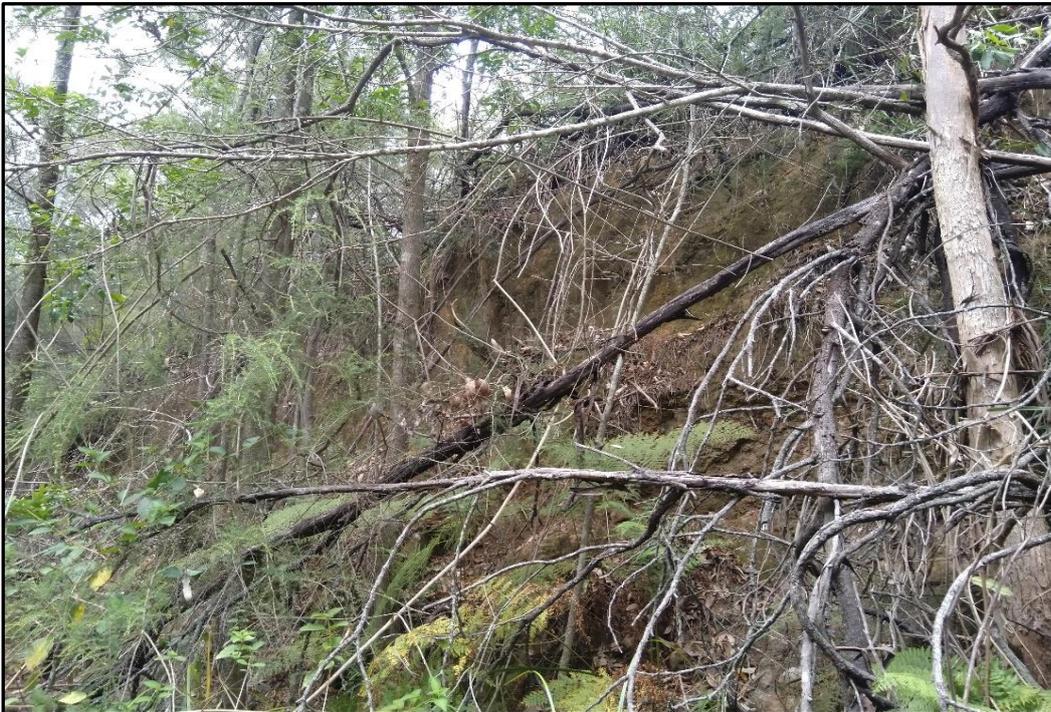
Photo 22: View of cutting looking east

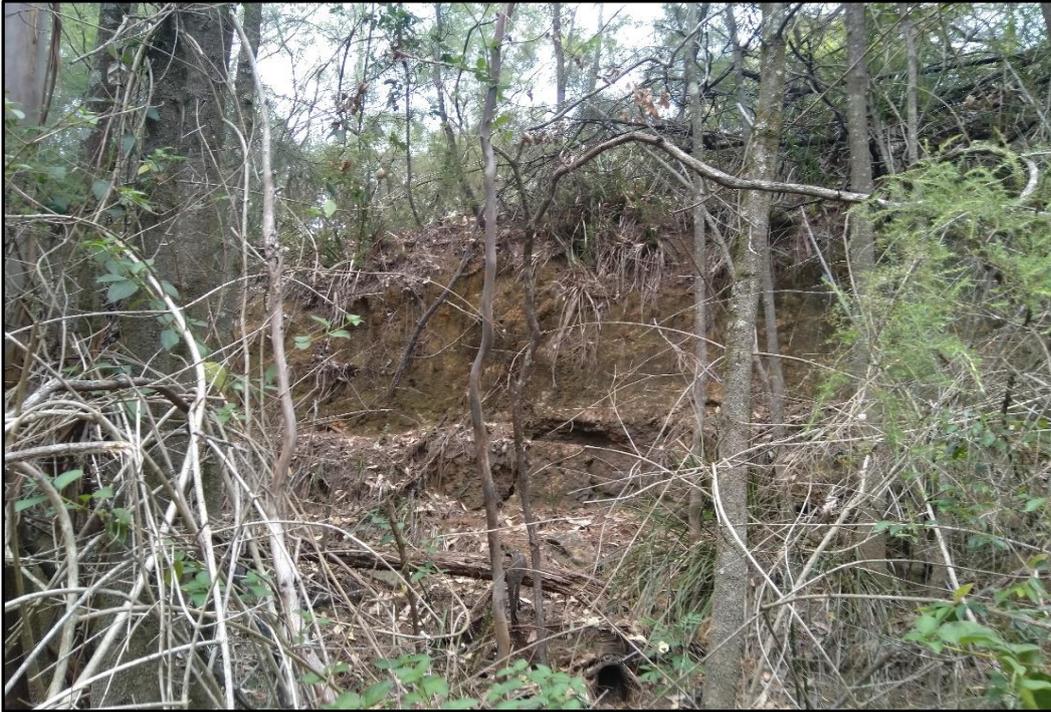
Photo 23: View of cutting showing loose soil wedges

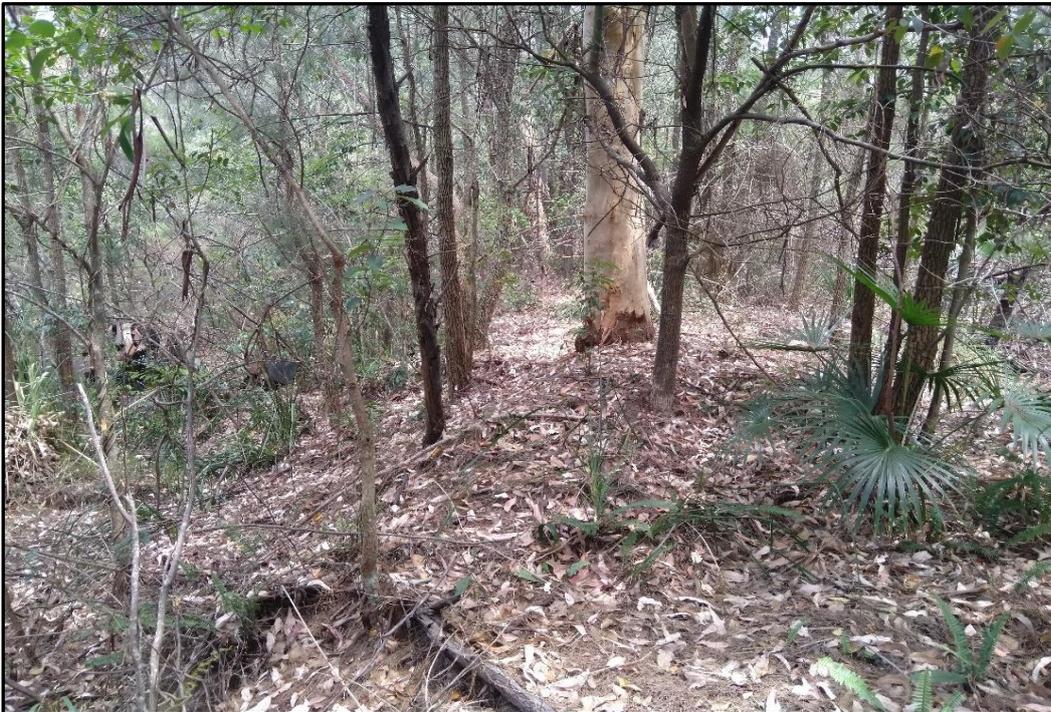
It is expected that the fill mounds, which were observed to be less than about 2 m high, are unlikely to become unstable and impact on future development. The fill mounds located within the development area are expected to be removed during construction. Further assessment of any remaining stockpiles within the rezoned area 'E2' should undertaken as part of a specific slope stability assessment at the time of development.

Photo 24: View of fill mound in south-east area of site

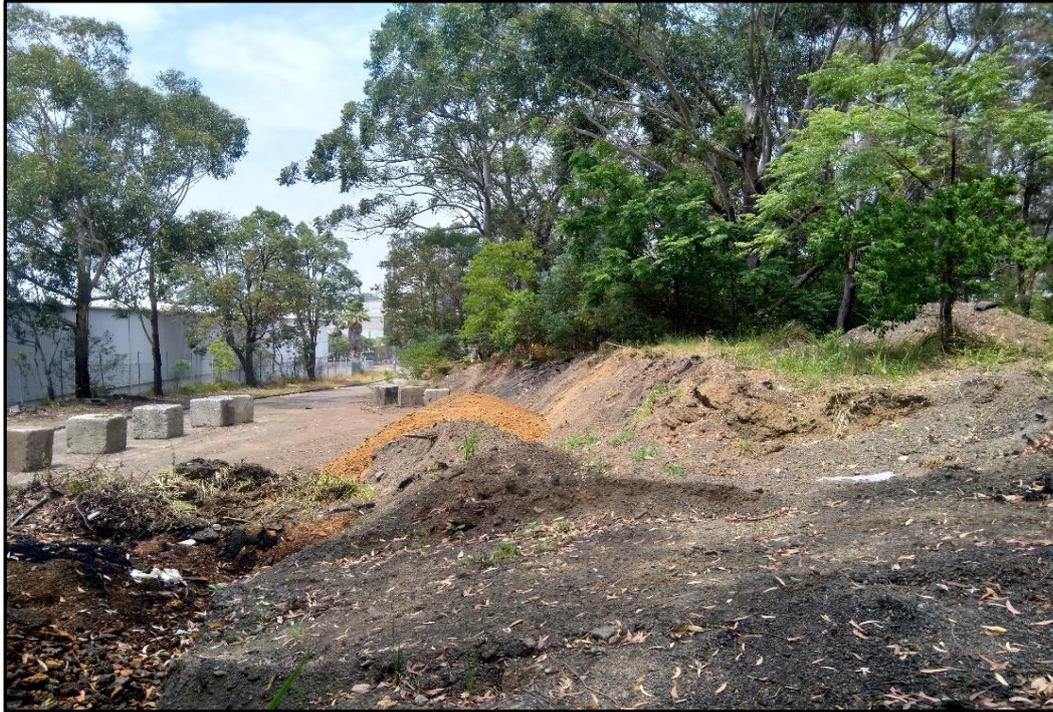
Photo 25: View of stockpiled soils in south-east area of site
