# Preliminary Site Investigation – Lake Munmorah

315, 325 & 335 Pacific Highway, Lake Munmorah, NSW 2259

20222732

Kleinfelder Document: NCA21R131473

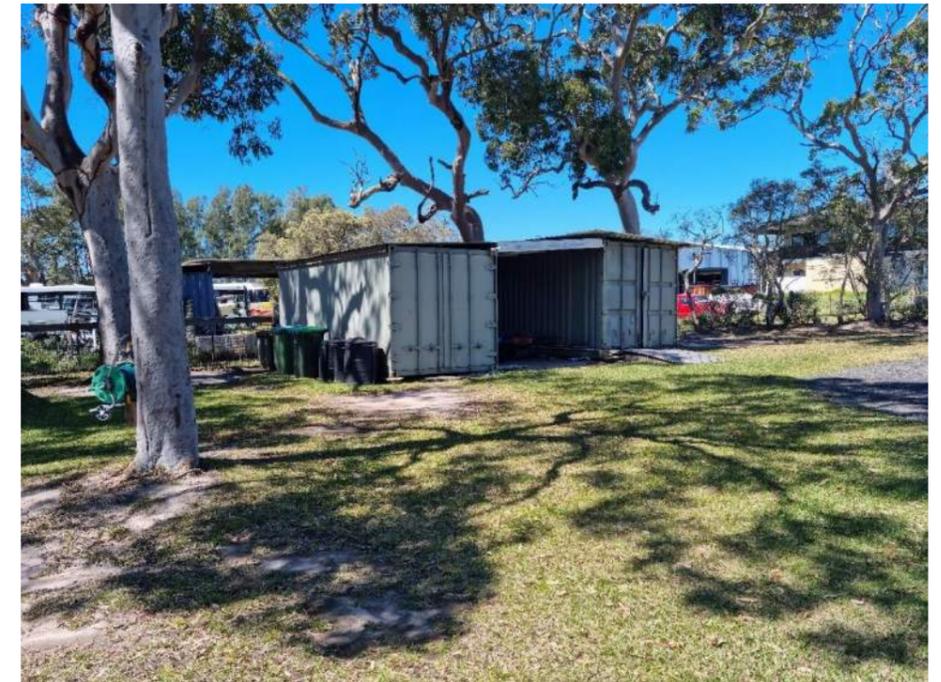
On the northern side of the house are a series of raised garden beds and a small fire pit. Approximately 15 m north-east of the house are three shipping containers (**Photo 6**) used for general outdoor storage, with a chicken shed adjacent to the storage shed housing several chickens (**Photo 7**). A septic tank (**Photo 8**) is located directly west of the residential dwelling and appears to have moist soils and exceptionally green grass appearing to trail from it further to the west (**Photo 9**). The apparent saturated nutrient-rich and moist soil indicates that the septic tank is leaking, though no odour was present. No other sources of potential contamination were evident.

**Photo 6:**  
Two of the three shipping containers located on the eastern side of Lot 27.

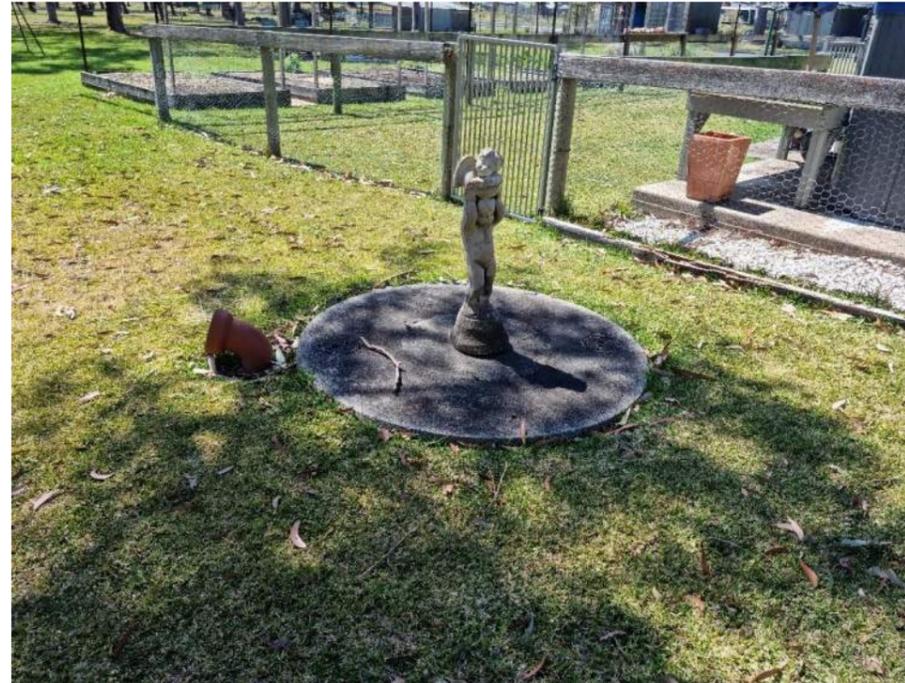
**Photo 8:**  
Septic tank located to the west of the above ground swimming pool on Lot 27.

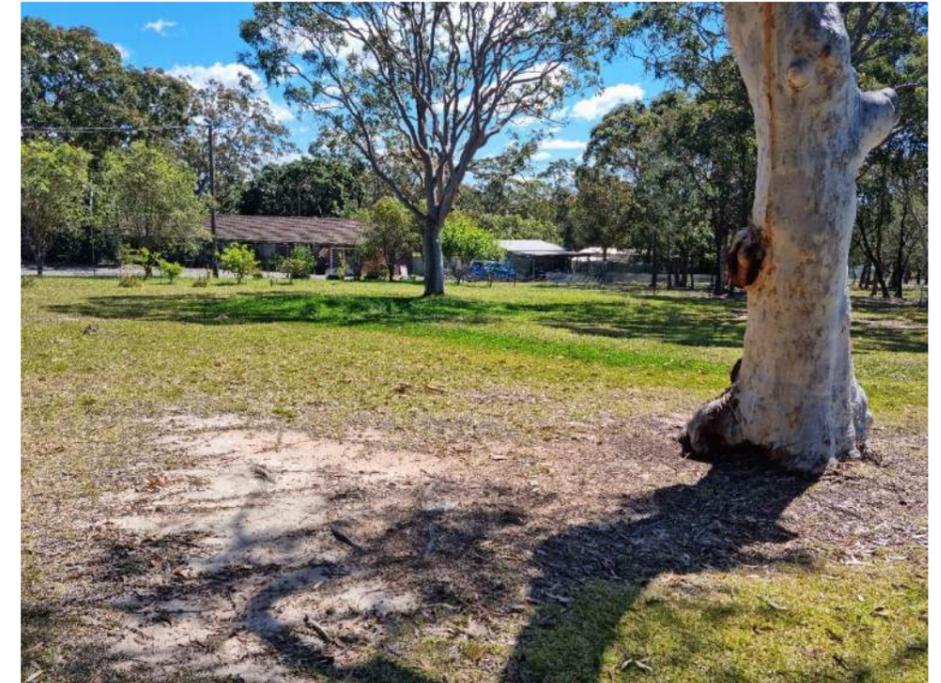
- A leak from the septic tank identified at Lot 27.
  - Isolated occurrences of empty fuel/oil drums located at Lot 12 and Lot 83.

**Photo 9:**  
Exceptionally green grass trailing west from the septic tank, indicating a potential leak.

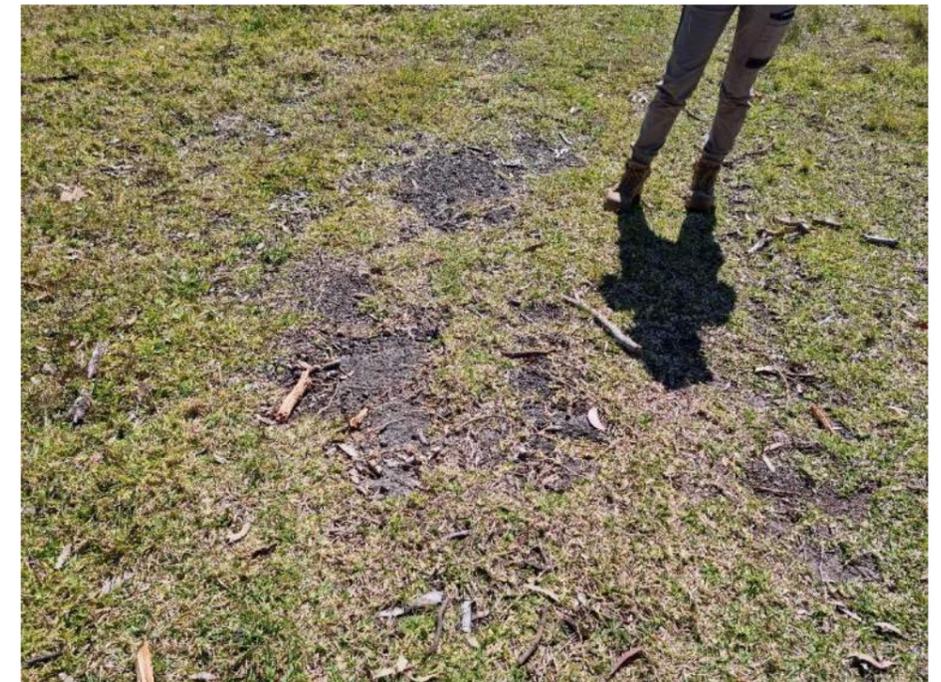
**Photo 12:**  
Asphalt patch (approximately 3m x 3m) located on the northern end of Lot 83, suggesting a previously built structure has since been removed.

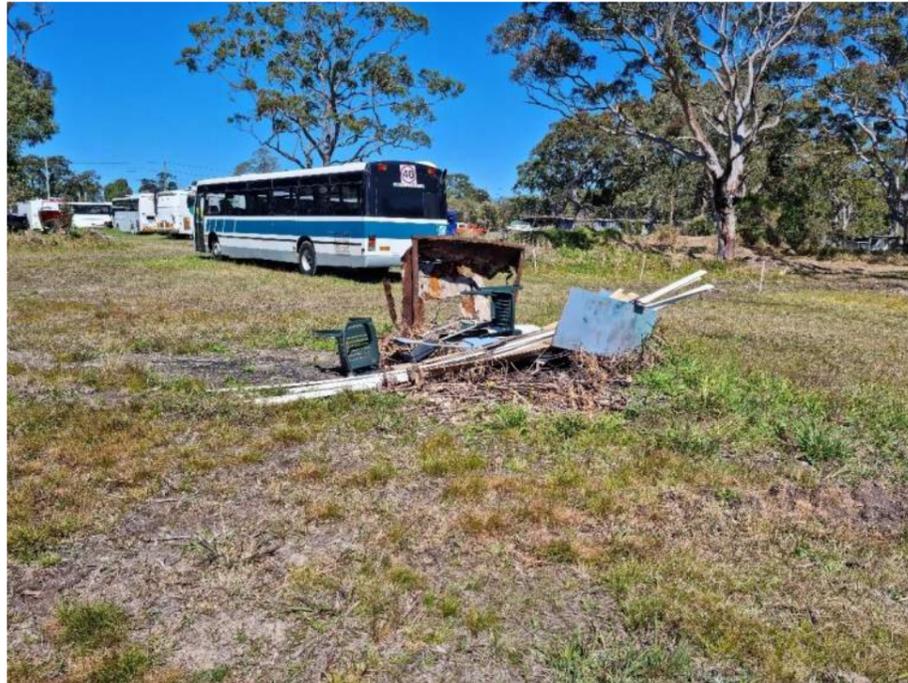
An isolated waste pile (**Photo 13**) was located within the central section of the lot north of the more active areas where the business and storage of vehicles takes place. The waste pile comprised mostly of wooden slats, metal, plastic and insulation material. Slightly west of this was a soil stockpile (**Photo 14**) approximately 1.5 m at its highest point. Fill material was evident throughout the stockpile including fibro sheeting, concrete, plastic, glass and potential asbestos fragments (**Photo 15**) were found amongst the stockpile. An additional waste pile (**Photo 16**) was located approximately 80 m north-east of the main commercial building in a small, treed area adjacent to the Possum Street entry. Materials observed included tin, plastic, concrete, brick and rock. Potential asbestos fragments (**Photo 17**) were also found amongst the waste. A pile of bricks and pavers (**Photo 18**) were discovered adjacent to the back gate, where a small patch of oil/ grease (**Photo 19**) was located (source unconfirmed).

**Photo 13:**  
Waste pile located behind the area of parked buses on Lot 83 containing wooden slats, metal, plastic and insulation material.

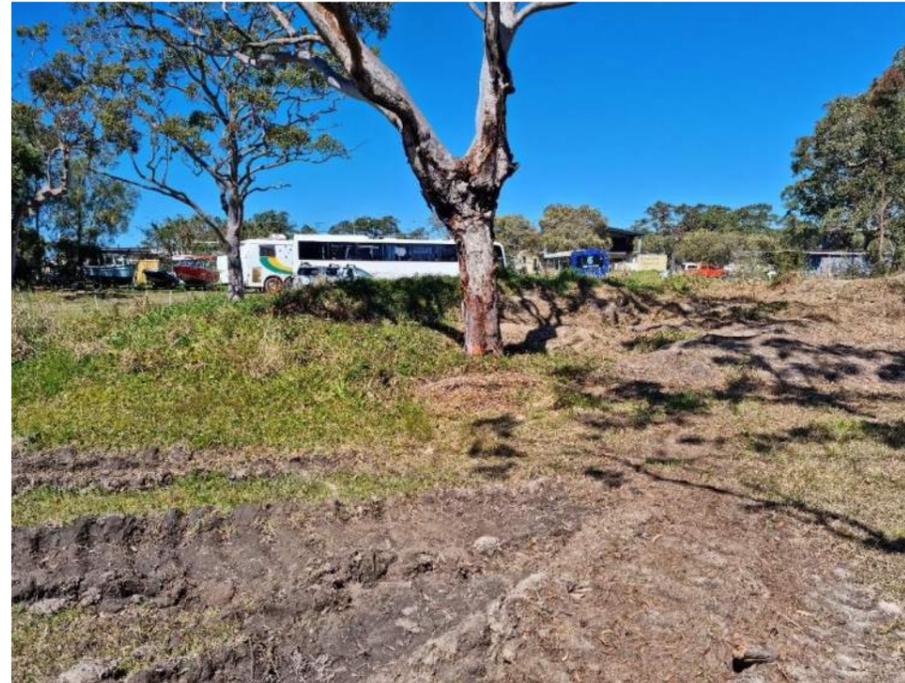
**Photo 14:**  
Soil stockpile on containing some fill material that has the potential to have been relocated from a contaminated site.

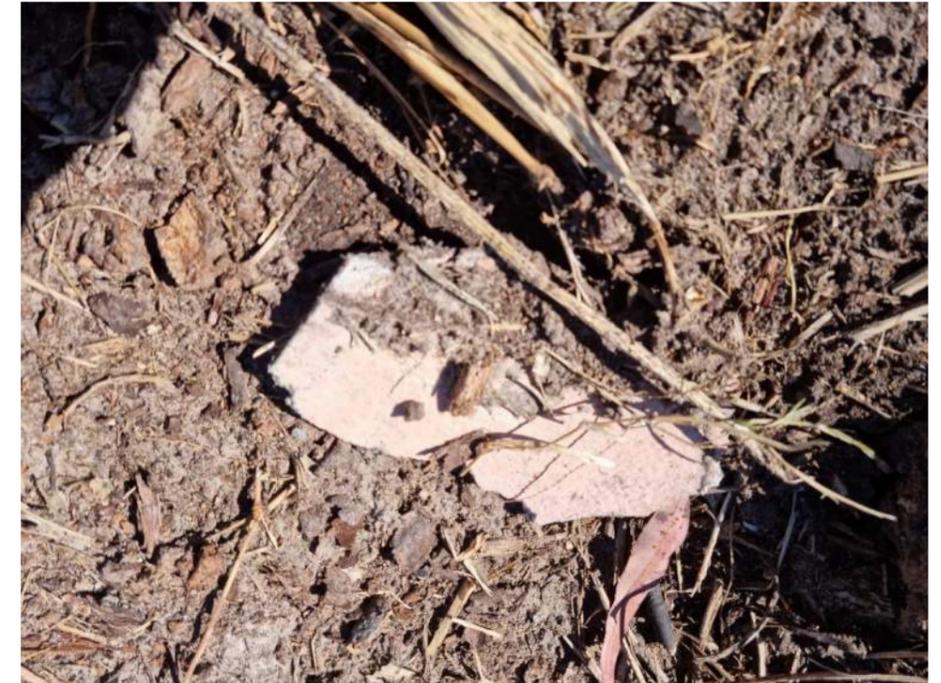
**Photo 15:**  
Potential ACM found amongst the fill material in the soil stockpile from Photo 14.

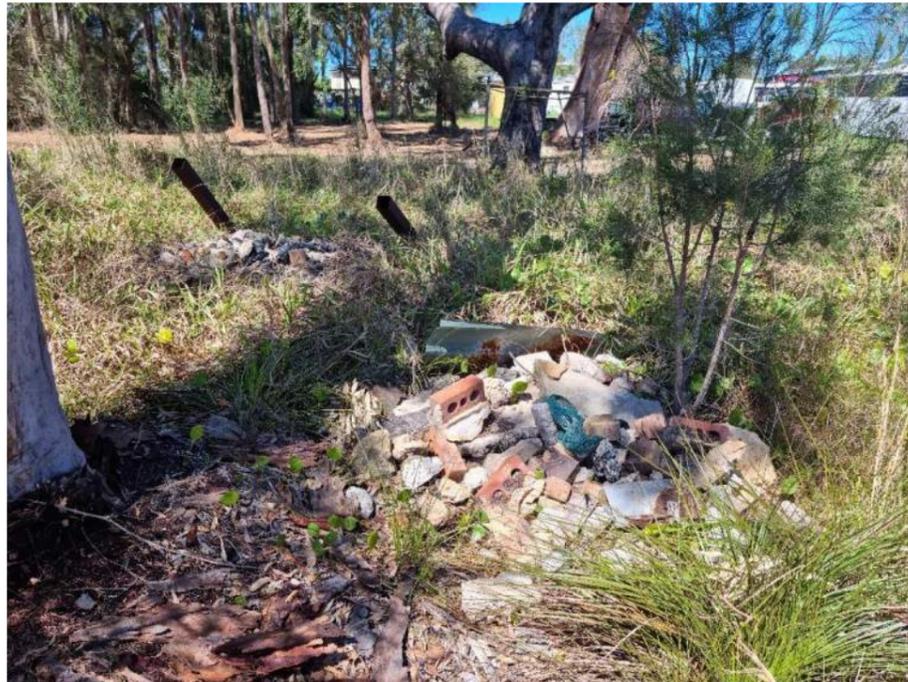
**Photo 16:**  
Waste pile located approximately 80 m north-east of the main commercial building (Lot 83) in a dense area of trees. Materials include tin, plastic, concrete and brick.

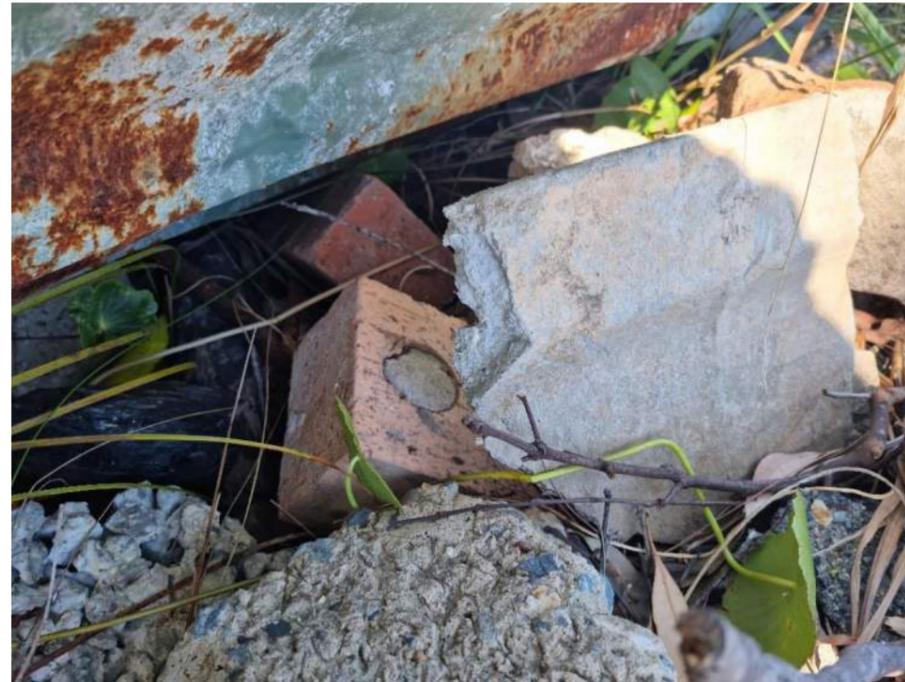
**Photo 17:**  
Potential ACM found amongst the waste pile in Photo 16.

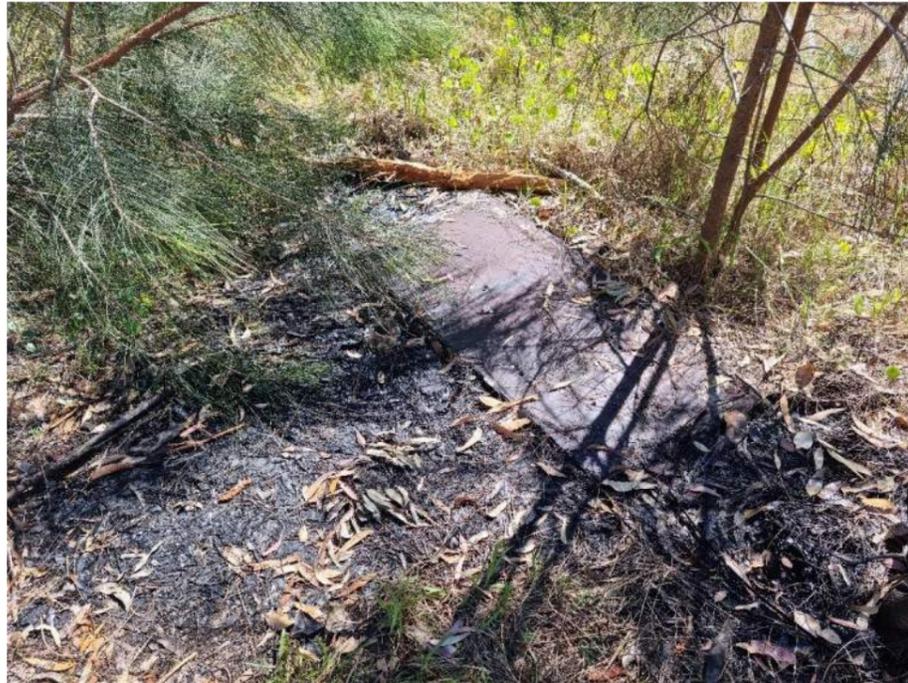
**Photo 19:**  
Patch of oil/grease located adjacent to the pile of bricks and pavements from Photo 18 (source unconfirmed).

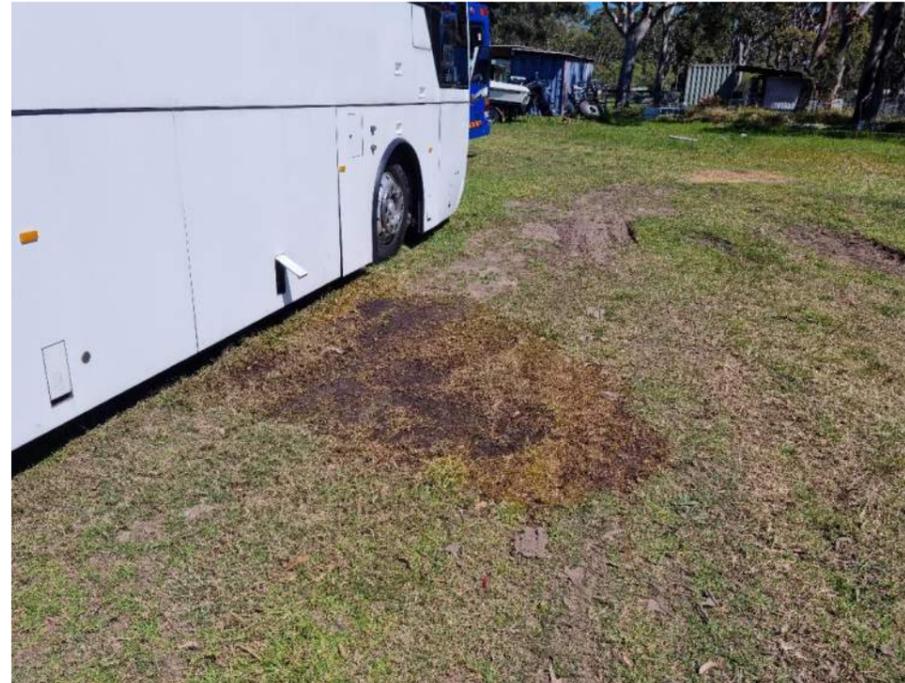
**Photo 20:**  
Discharge of oil from a bus parked behind the main buildings on Lot 83.

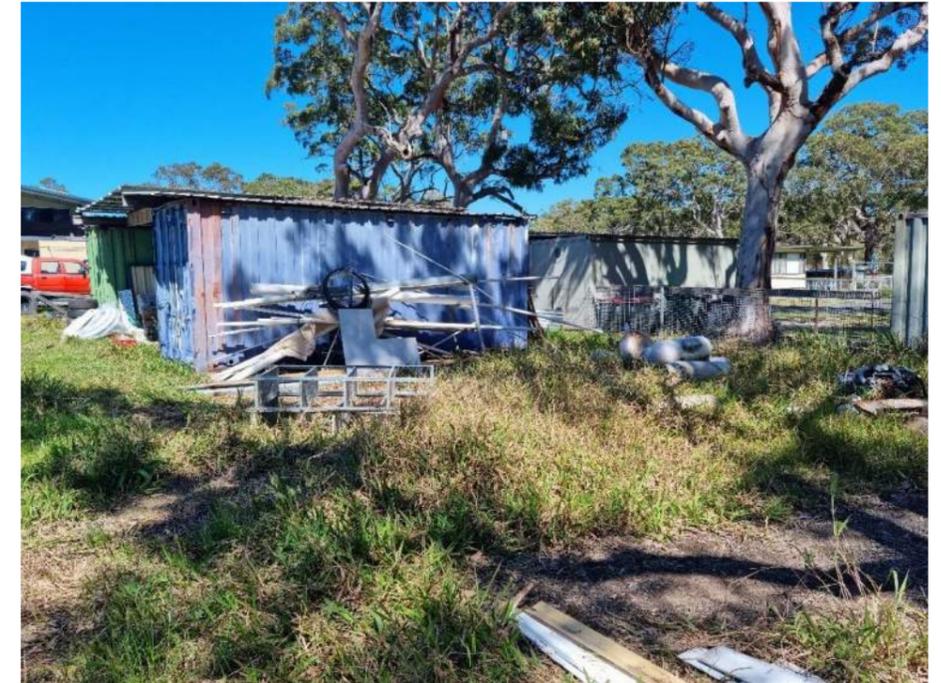
**Photo 21:**  
A shed with two shipping containers either side used for storage of various items. Numerous piles of waste are also located here.

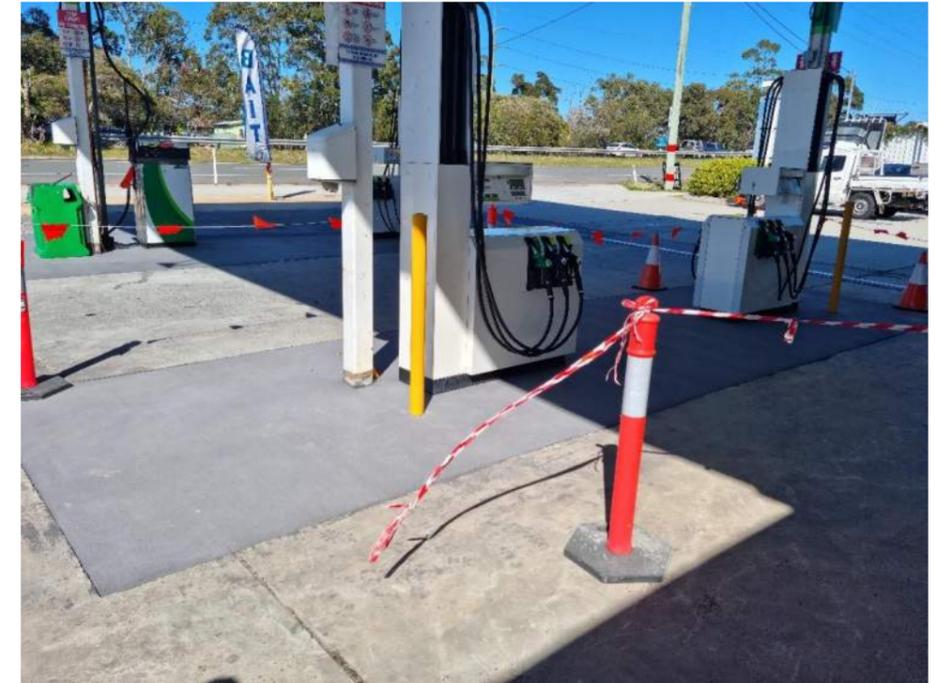
**Photo 27:**  
Two bowsers currently not in operation, with newly laid concrete at their bases.

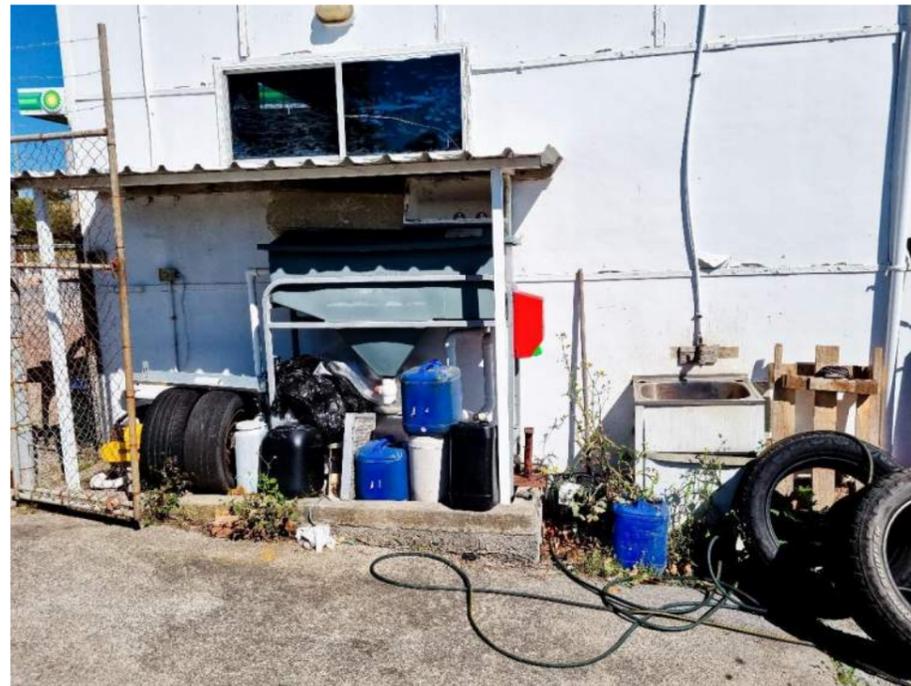
**Photo 332:**  
Old jerry cans, tyres and other various waste materials stored against the eastern wall of the garage service centre building.

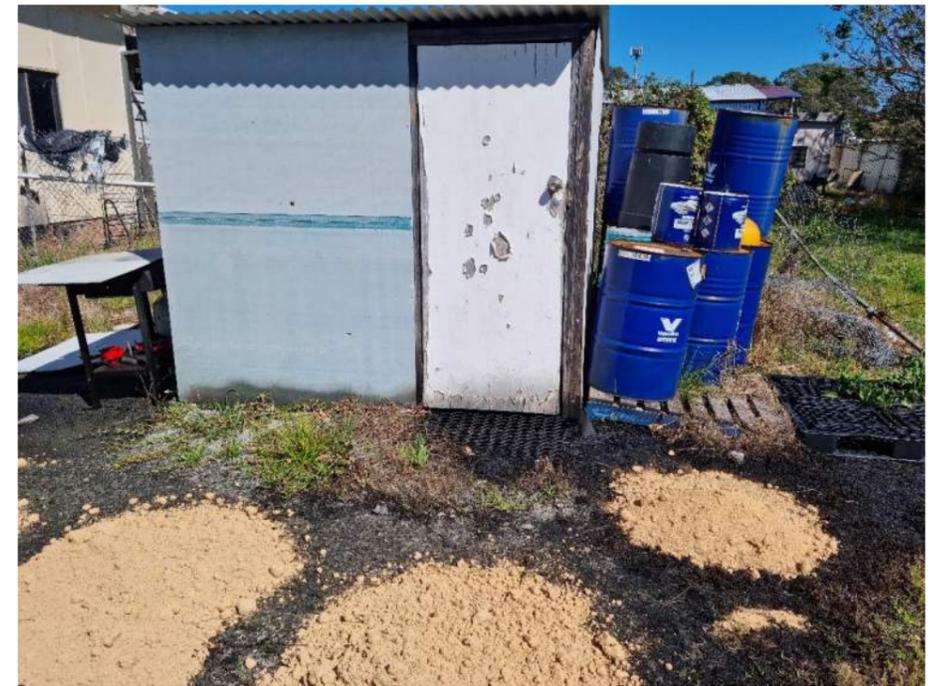
The remaining area of land behind (north) the buildings is grassed and mostly cleared of vegetation. A small shed is located behind the main garage service centre building to the east, with stacked oil drums (**Photo 33**) and a small pile of potential asbestos fragments (**Photo 34**) on either side. Surrounding this is a large patch of an oily grease substance that has caused some localised die-back and staining of the grassed surface (**Photo 35**). Sand has been stockpiled to absorb the substance ,but not spread at the time of the walkover. A shipping container (**Photo 36**) is also present in the north-east corner with two old bowsers stored beside it. A half-fence separates the back grassed area of the two buildings, to the west of which is fill material / rubble (tile, concrete and small fragments of asbestos). Another shed (**Photo 37**) is present in the centre of the back area behind the main building, holding various equipment and machinery. It appears in a degraded state. A third shed (**Photo 38**) is located on the western side of the lot where additional fill material and oil drums are stored. This shed appears to hold general inventory/stock for the service station and retail store. Directly behind the service station building the area appears to be used for additional storage for the service station and retail shop (**Photo 39**). In addition to these structures, two boats, two cars and a shipping container are stored on the lot.

**Photo 333:**  
Small storage shed behind the garage service centre building, with stacked oil drums adjacent.

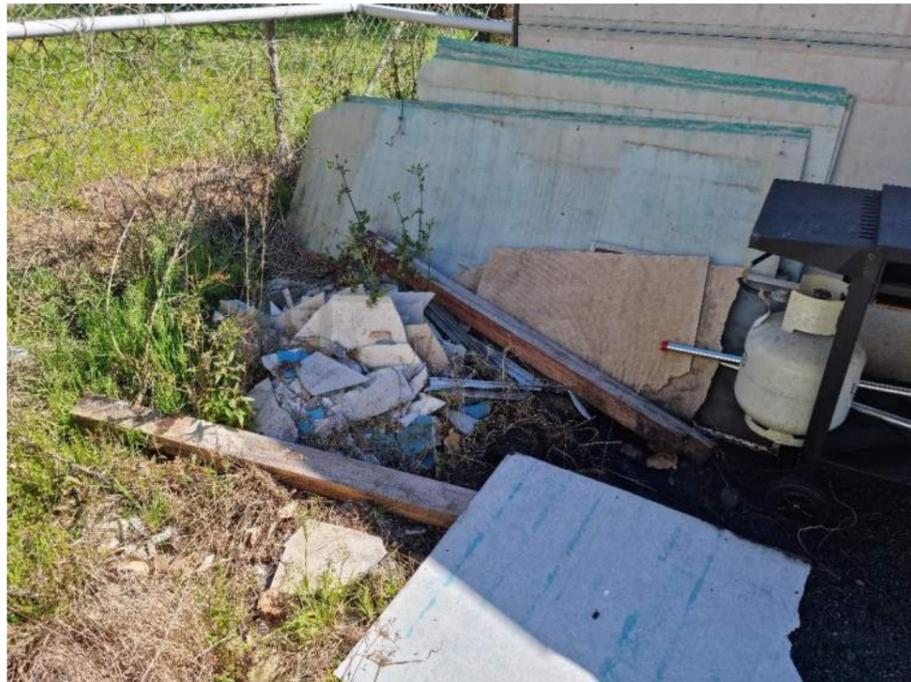
**Photo 334:**  
Pile of asbestos fragments located adjacent to the small shed in Photo 33.

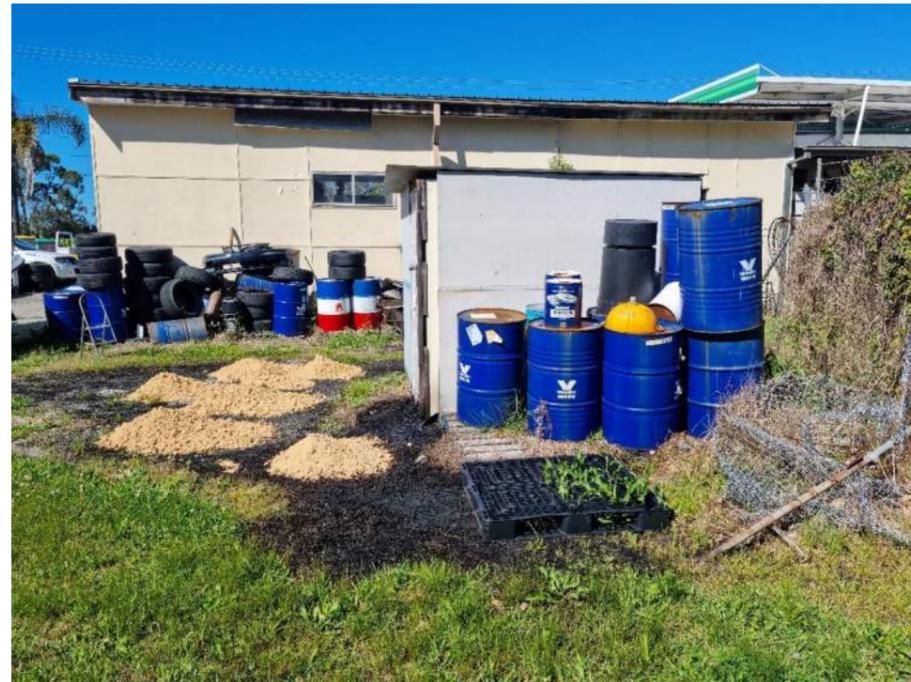
**Photo 335:**  
Large patch of an oily grease substance that has stained the grassed area. It appears to have originated from the small shed.

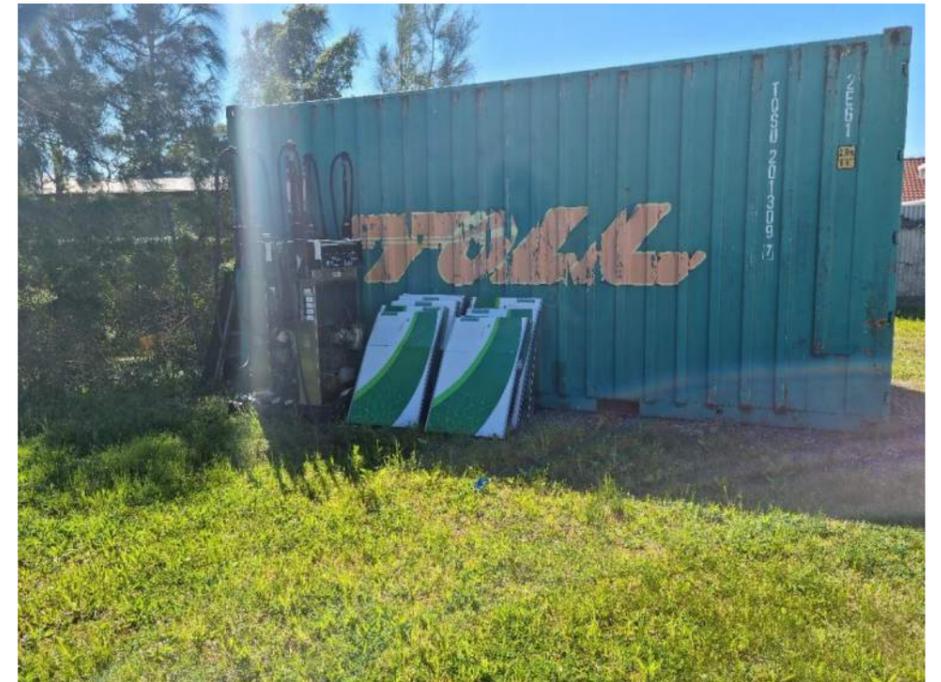
**Photo 336:**  
Shipping container located in the north-eastern corner of Lot 12 with two old bowsers beside it.

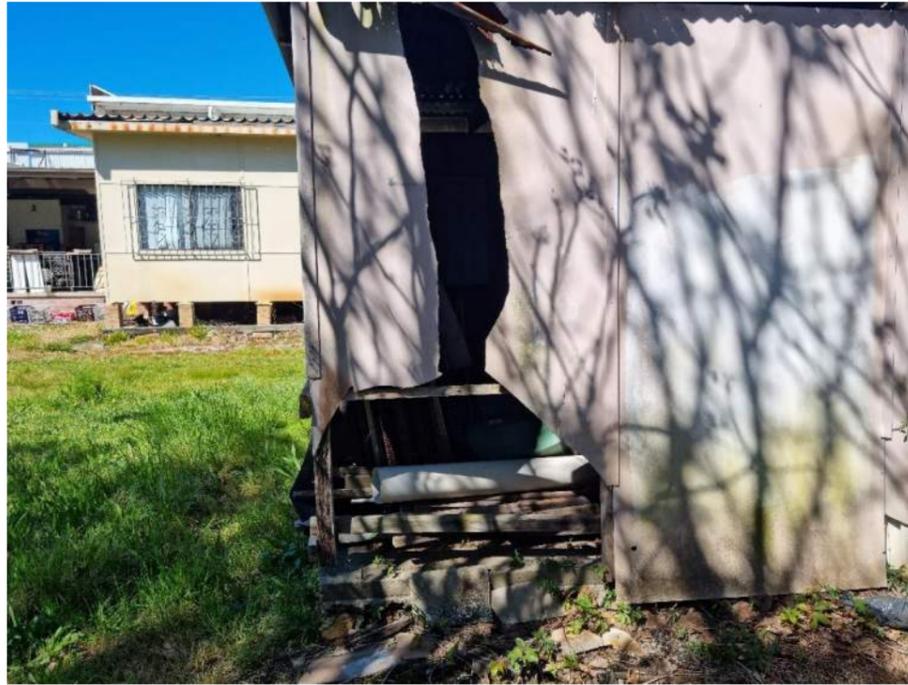
**Photo 37:**  
A second shed at the back of the main site buildings that appears to be in poor condition with broken walls exposing the contents.
