WAMBERAL TERMINAL COASTAL PROTECTION ASSESSMENT

DRAFT FINAL Stage 2 – Coastal Protection Amenity Assessment

Prepared for:
Central Coast Council

Report Numbers: MHL2779, WRL TR 2021/05

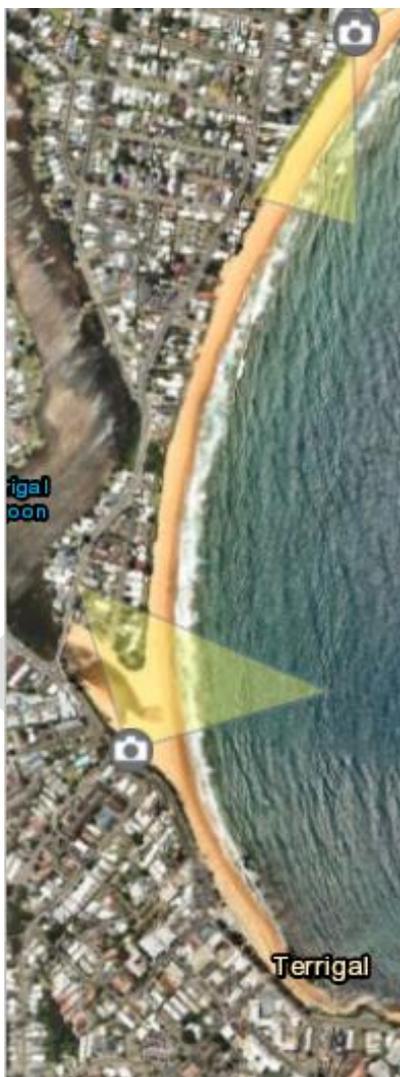
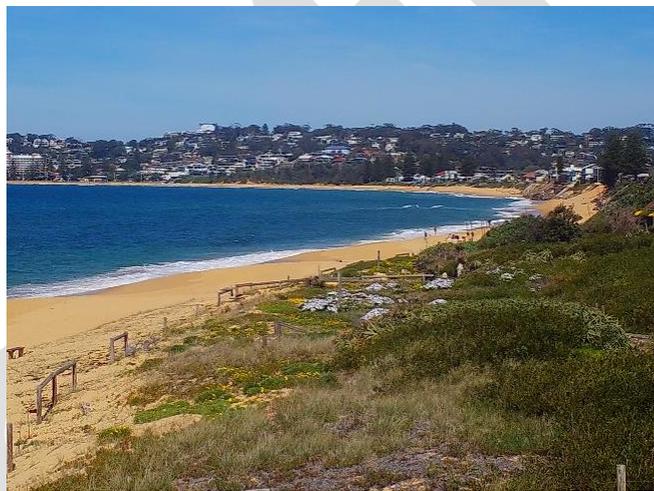
Camera 1: Wamberal SLSC looking south

Camera 2: Terrigal Lagoon looking north

Figure 3.4: Monitoring cameras installed at Wamberal SLSC and Terrigal Lagoon in 2020

Camera based monitoring systems were established by WRL in early 2020 to monitor beach width change at Wamberal. These systems are still operational and were installed above Terrigal Lagoon facing north in April 2019 and onto the Wamberal Beach lifeguard tower looking south in July 2020 immediately after the storm event (Figure 3.4). These customised systems transmit images every 15 minutes during daylight hours and are used to monitor shoreline change using a custom-built coastal imaging software package using the methodology described in Harley et al. (2019). The impact of the July 2020 storm on beach width is shown in Figure 3.5, while recovery of the beach following the storm is shown in Figure 3.6 and Figure 3.7

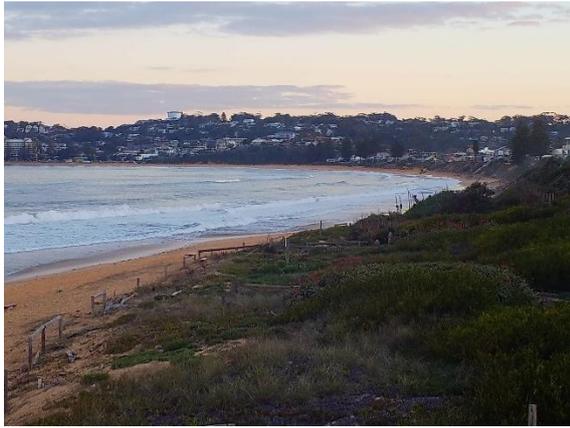
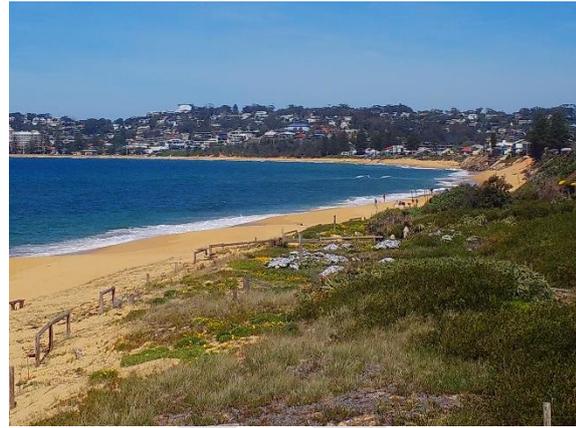
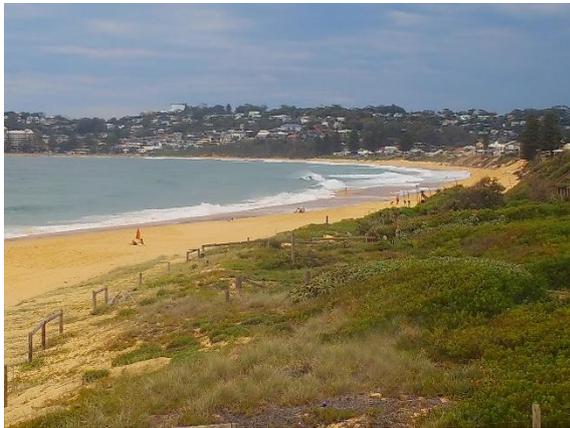
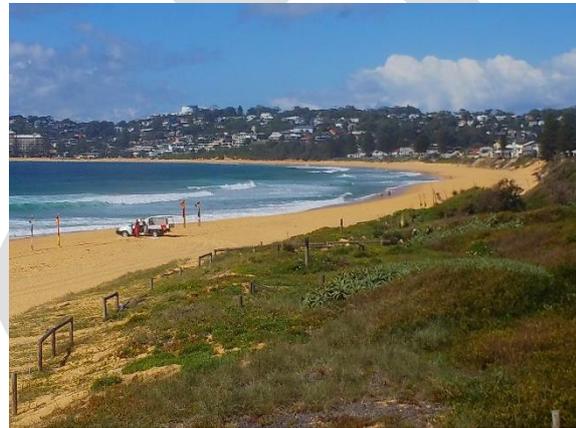
Post Storm- July 2020

2 months post storm- Sept 2020

6 months post storm- Dec 2020

8 months post storm- Mar 2021

Images taken at approximately mid to high tide.

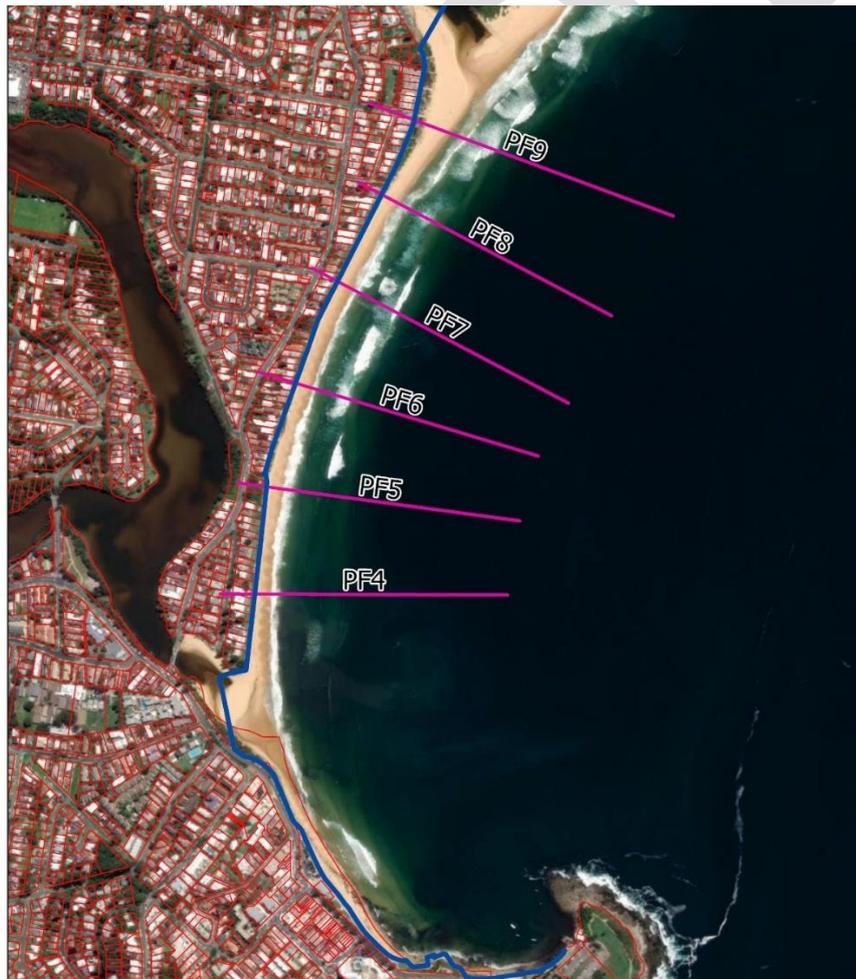
Figure 4.3: Profiles used in beach width model

Beach width is defined as the dry area of beach extending from the top of the wave runup to a baseline feature at the back of the beach (Figure 4.1). The baseline is typically considered to be either a fixed object that bounds the beach such as a seawall, fence or cliff, or is a pre-defined stable position on a beach profile such as vegetation line or erosion scarp. The limiting feature at Wamberal Beach is either existing ad-hoc rock protection, a seawall (to be constructed) or a dune scarp generally associated with the most eroded state of the beach. Wave runup reaching the baseline feature defines the case with zero beach width. i.e. when the seawall, scarp or other feature is directly exposed to wave runup. A beach width model has been developed for Wamberal in this study to create hourly dry beach width for a period of 10 years. The beach width model incorporates measured offshore wave height, modelled nearshore wave height, measured tide, measured and modelled wave runup, and measured beach profile measurements (see Section 3), to create a continuous beach width timeseries. The beach width model was applied at six profiles located between Terrigal and Wamberal Lagoon entrances as shown in Figure 4.3.

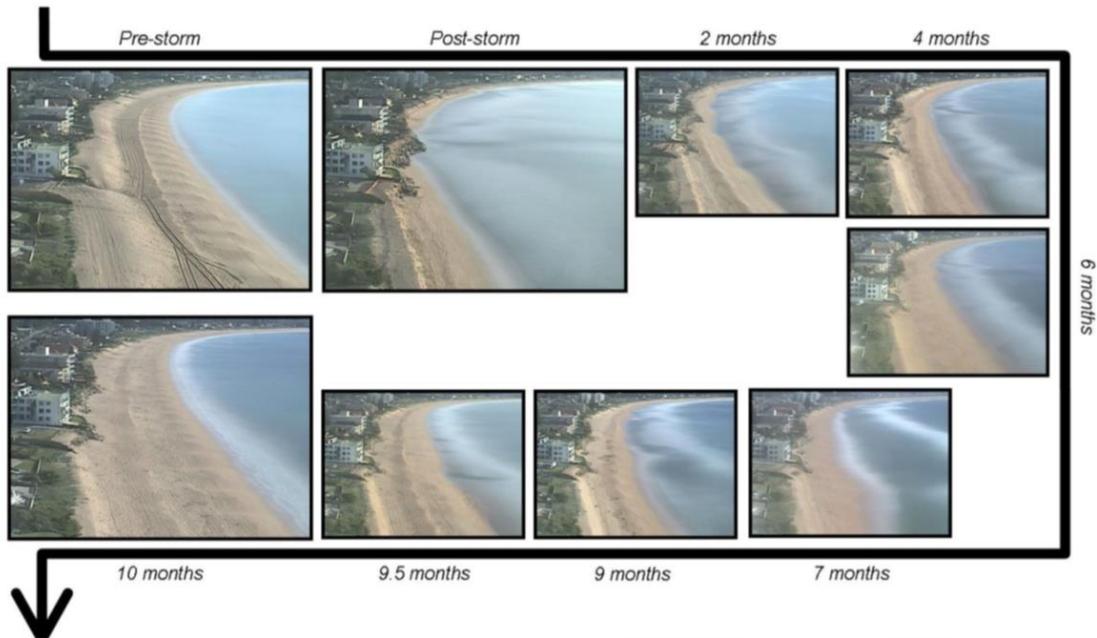
Note: Beach recovery and the return of shoreline and berm morphology to pre-storm conditions following storm erosion at Collaroy-Narrabeen Beach in June 2007. Images taken at approximately mid to low tide. From Phillips (2018).

Figure 5.7: Beach recovery at Collaroy-Narrabeen Beach in June 2007

Once sediment returns to the shoreline, swash processes rework this sediment up onto the subaerial beach to rebuild the berm as shown in Figure 5.7. A high-frequency scanning LiDAR at Collaroy Beach at Flight Deck Apartment Building was used to capture this process investigating tide-by-tide recovery following a storm in April 2015 (Phillips et al. 2018; 2019). Principal modes of berm recovery were classified based on ocean water level and nearshore wave conditions as the beach built back to its pre-storm state over the months following the storm.

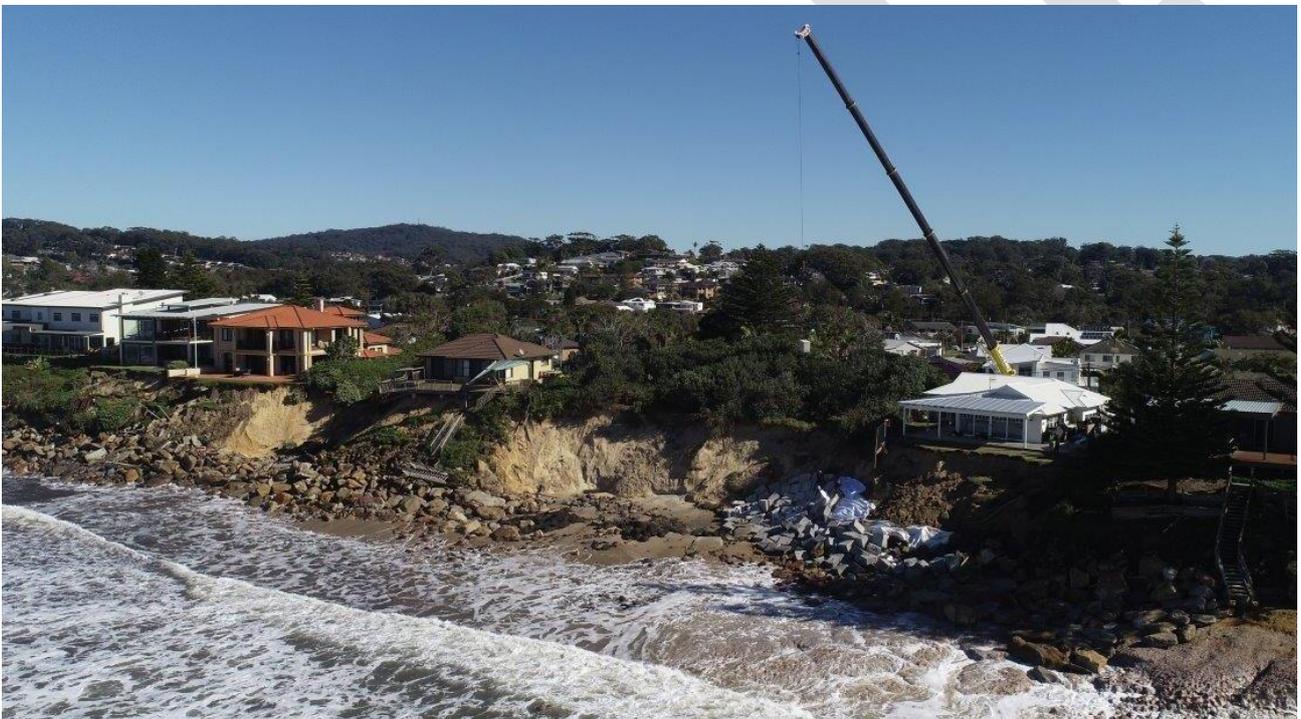
Figure 5.8: Wamberal Beach after storm erosion on 20th July 2020. MHL drone survey.

These materials are exposed and mobilised with storm erosion events, causing public safety concerns and inhibiting alongshore beach access such that sections of the beach have required to be closed to the public for periods of time after storms. Often these materials are left strewn on the beach by waves creating hazards for beach users as shown in Figure 5.8.

During construction, it is strongly recommended that any existing ad-hoc material and emergency rock toe protection works seaward of the proposed new seawall be removed to enhance beach amenity, or where suitable used as fill where required landward of the seawall. Any existing rock protection removed with construction should be replaced by sand nourishment wherever possible to extend the level of the natural beach berm or foredune seaward of the seawall. All sand excavated during the construction of the proposed seawall should be screened (to remove any oversized materials) and placed seaward of the works with any necessary fill landward of the seawall comprised of the separated materials (if suitable) and/or suitable clean fill that would be imported to the site. This will maximise the amount of sand added to the beach area as a result of the works and largely improve existing beach amenity.
