Report on  
Preliminary Site Investigation (Contamination)

Proposed Mixed-Use Development  
43-46 The Esplanade, Ettalong Beach

Project 83795.00  
April 2020

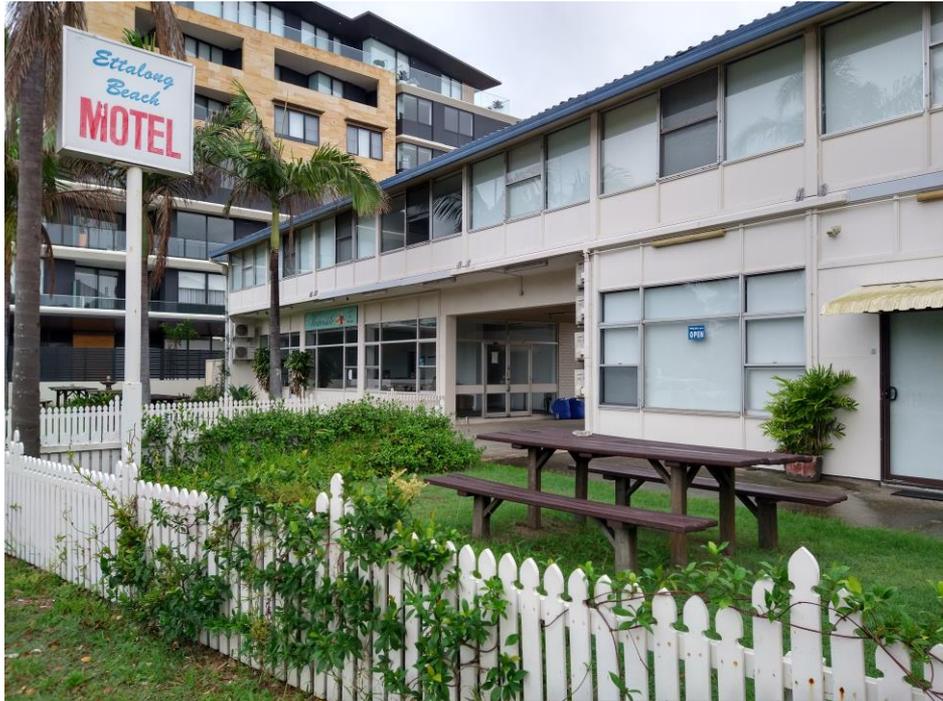
At the time of the walkover, Lots 117 to 119 was occupied by Ettalong Beach Motel, a two-storey building (Photograph 1). The southern portion of the property fronting The Esplanade was predominately grass-covered with a concrete driveway. The rear of the property consisted of an asphaltic concrete car park with limited landscaped areas and a small office / reception building (Photograph 2). The western side of the motel was observed to have minor areas of exposed fill with some building rubble (Photograph 3).

Photo 1 – Lots 117 to119: Ettalong Beach Motel

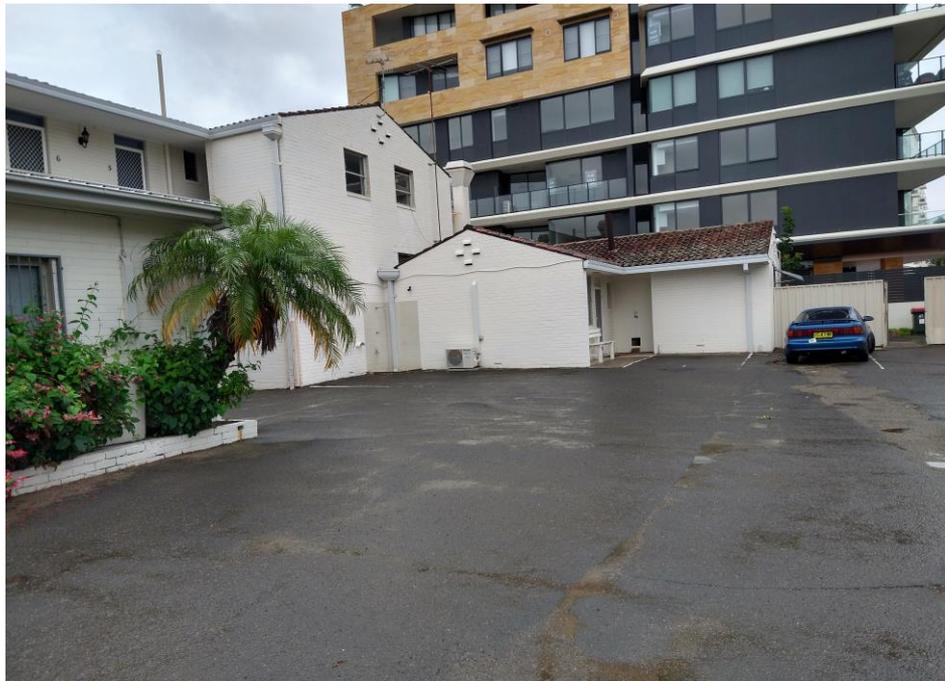
Photo 2 – Rear car park area

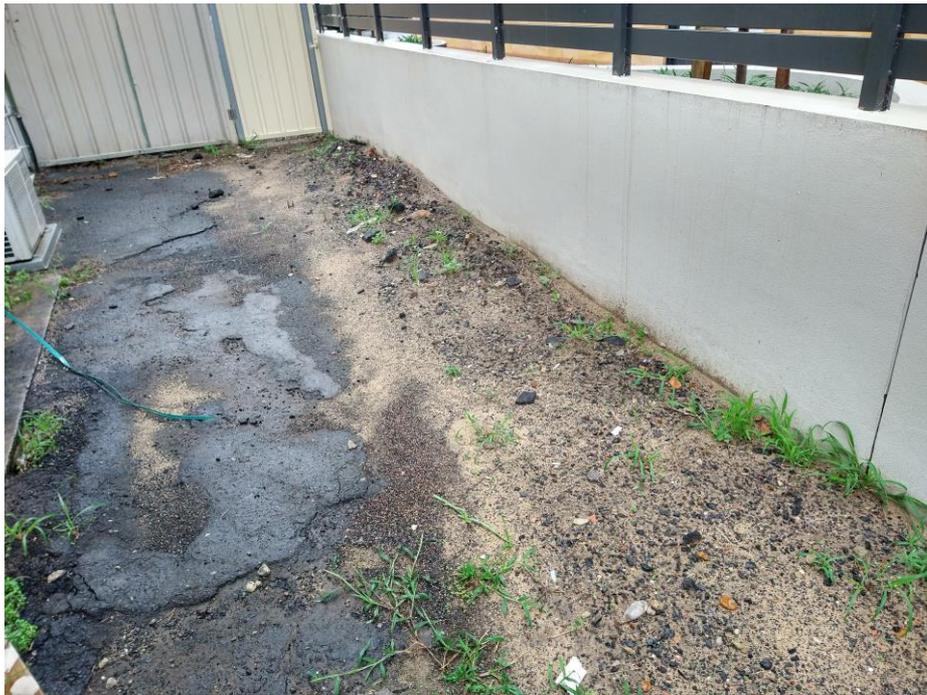
Photo 3 – Western side of Ettalong Beach Motel

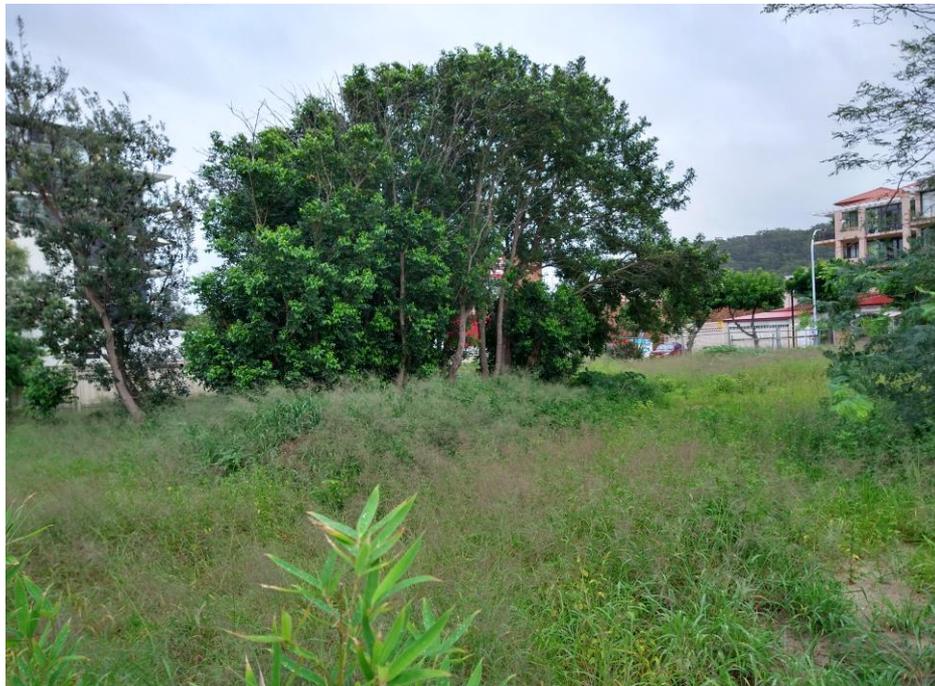
At the time of the walkover, Lots 120 to 121 was vacant, with the majority of the area covered in tall grass and a few mature trees (Photograph 4). Building rubble including tile, brick and potential asbestos containing material (PACM) was observed on the ground surface (Photographs 5 and 6). There was a mounded area within the central southern portion of Lots 120 and 121 with fragments of PACM and building rubble observed on the surface (Photograph 7).

Photo 4 – Lots 120 to 121: vacant area covered in tall grass

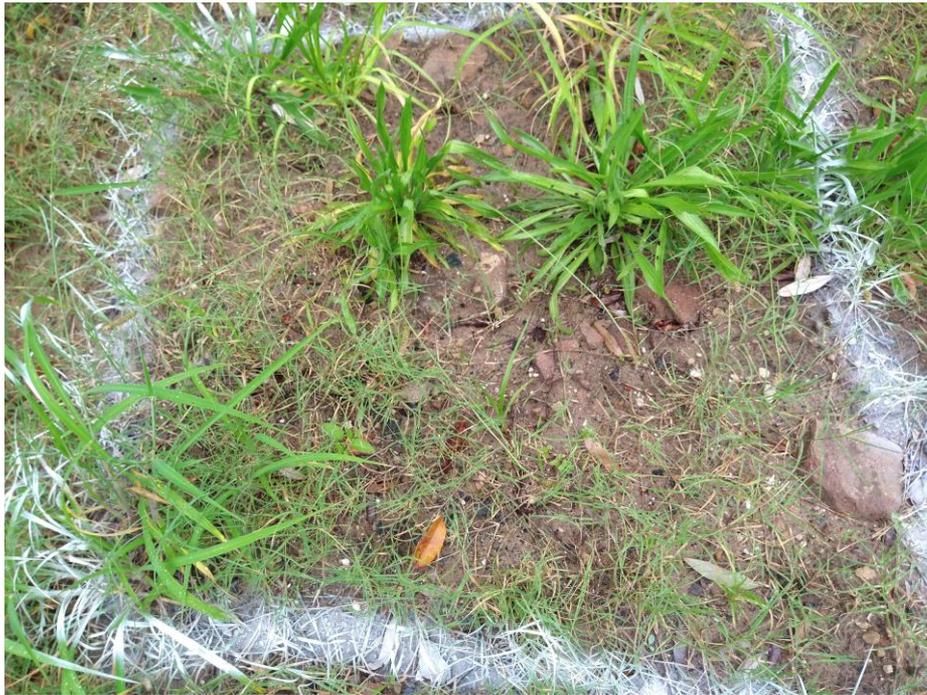
Photo 5 – Building rubble on ground surface

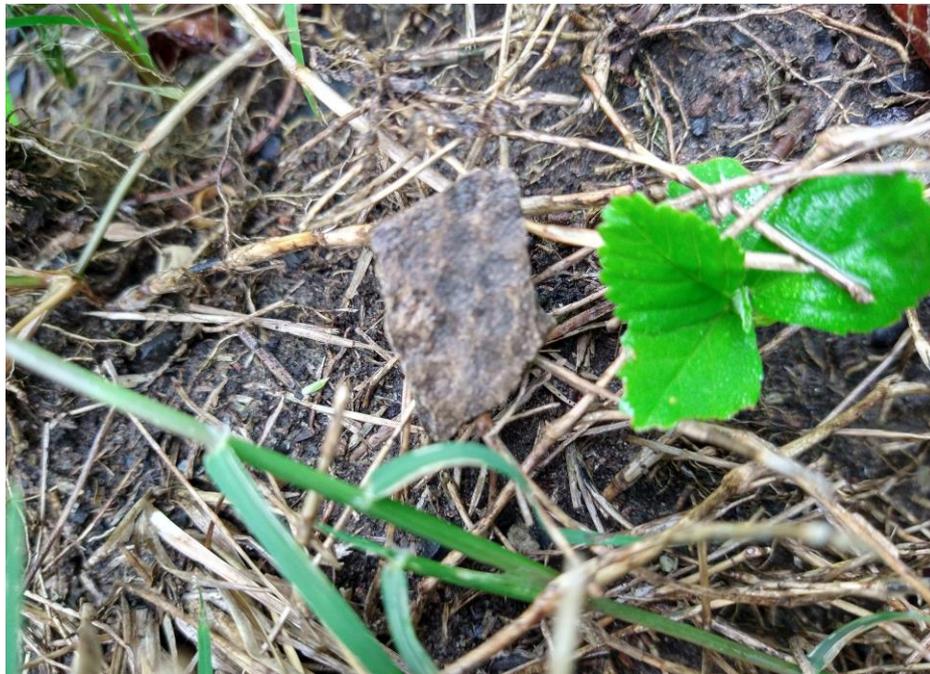
Photo 6 – Fragment of potential asbestos containing material on ground surface

- **Existing Structures:** A pre-demolition hazardous building material survey in accordance with SafeWork NSW requirements is recommended to be conducted by an appropriately qualified occupation hygienist prior to the demolition of the existing structures. All demolition work should be undertaken by a licenced demolition contractor and a clearance certificate provided by an occupational hygienist for the ground surface post demolition;

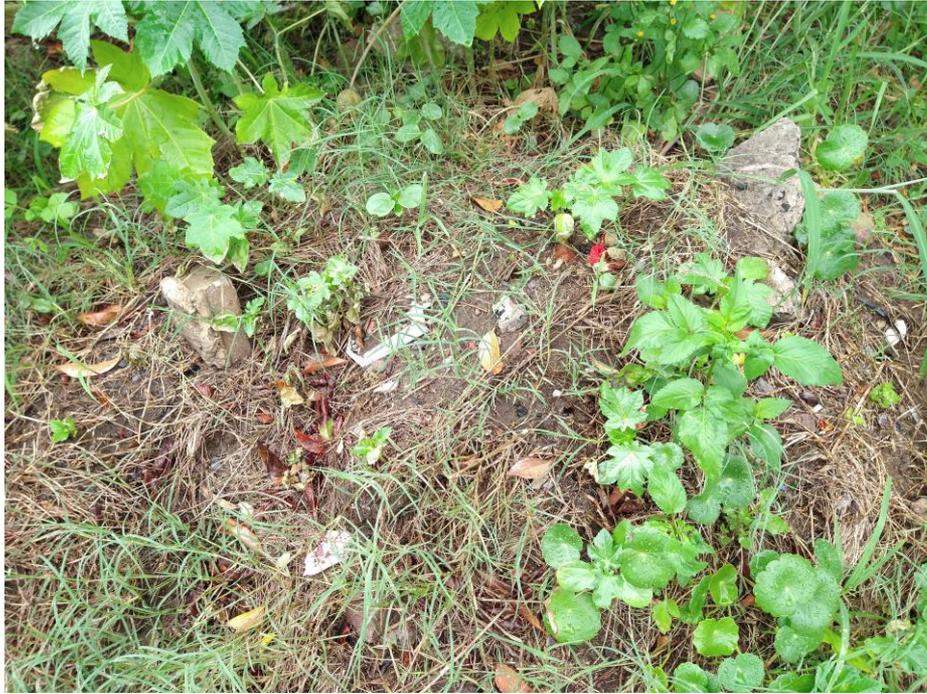
Photo 7 – Mounded area with building rubble on the surface

- **Soil** – An intrusive soil investigation with associated contamination sampling should be conducted to assess the potential for soil contamination. It would be considered appropriate to undertake the further intrusive works following the demolition of the existing structures. It should be noted, in the current investigation, PACM was observed on the ground surface and during drilling (within Lots 120 and 121), which would require remediation prior to site development. The remediation is likely to involve removal of impacted soils followed by off-site disposal; a cap and contain strategy, or an emu-pick, which would be outlined in a remediation action plan (RAP); and

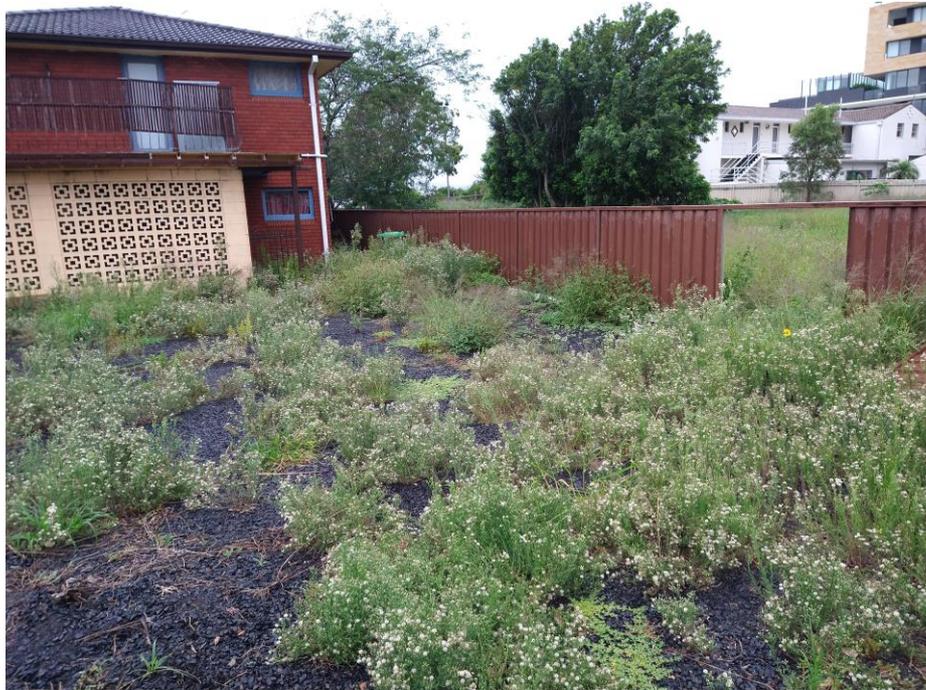
Photo 8 – Rear of residential property (No. 43)

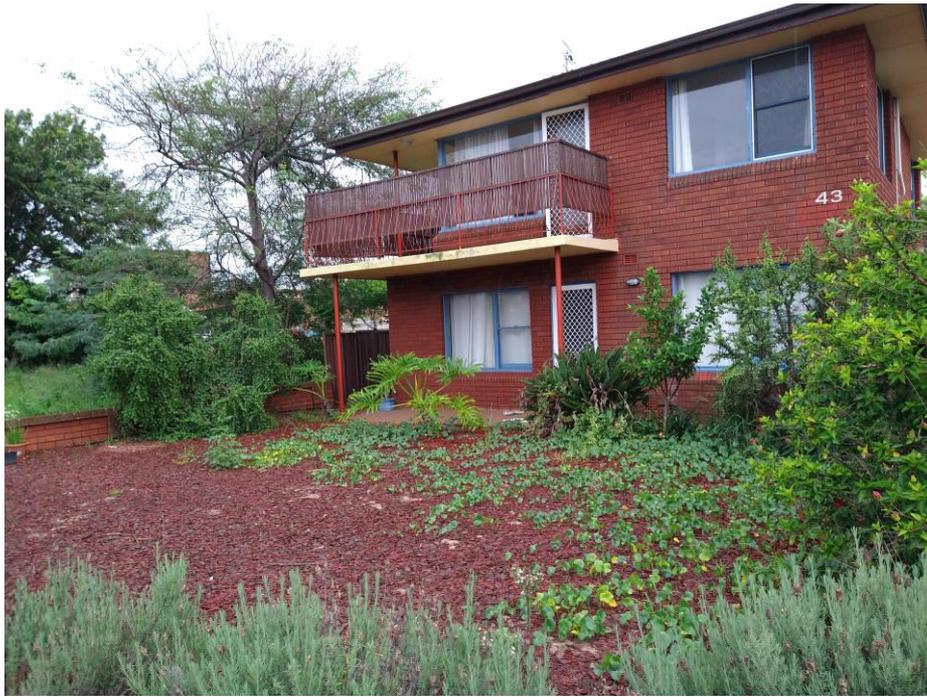
Photo 9 – Front yard of No. 43

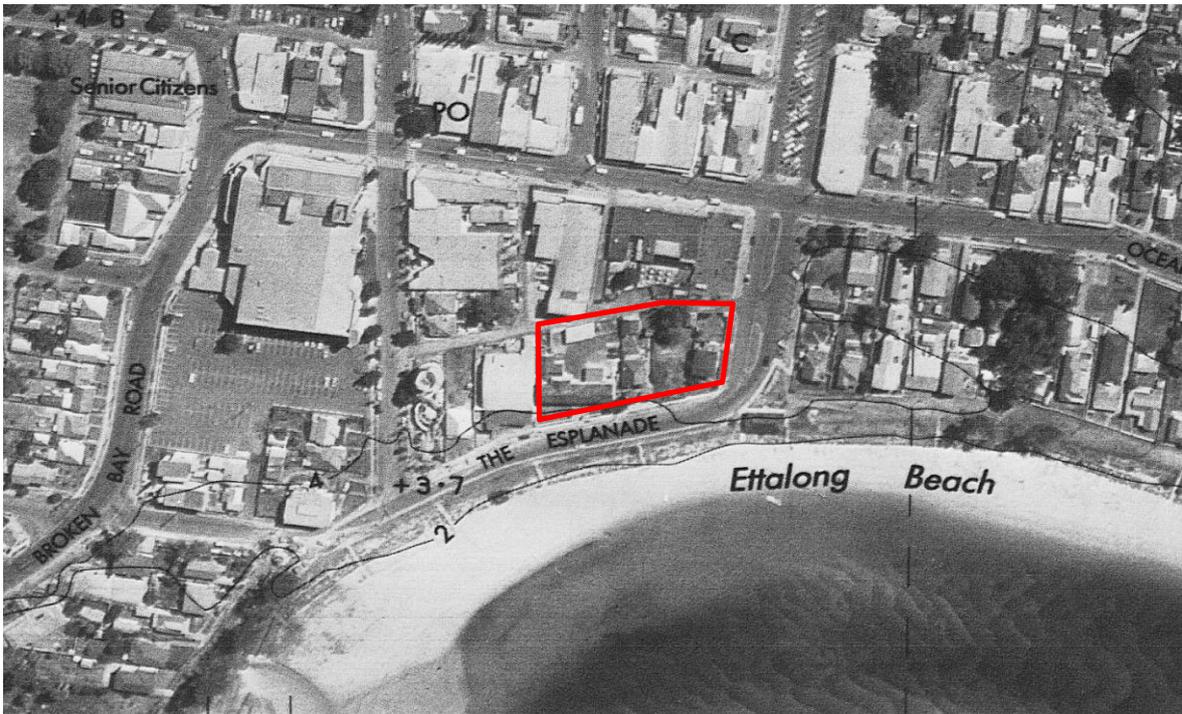
Photo 2 - 1985

**1985** – The aerial photograph is of higher resolution. The site layout of lots 117 to 119 appears much the same as present. The structures within Lots 120 to 122 are more clearly identified as residential houses. The land use immediately north and west appears to be predominately commercial, with some residential land use to the east of the site, and west of Broken Bay Road.

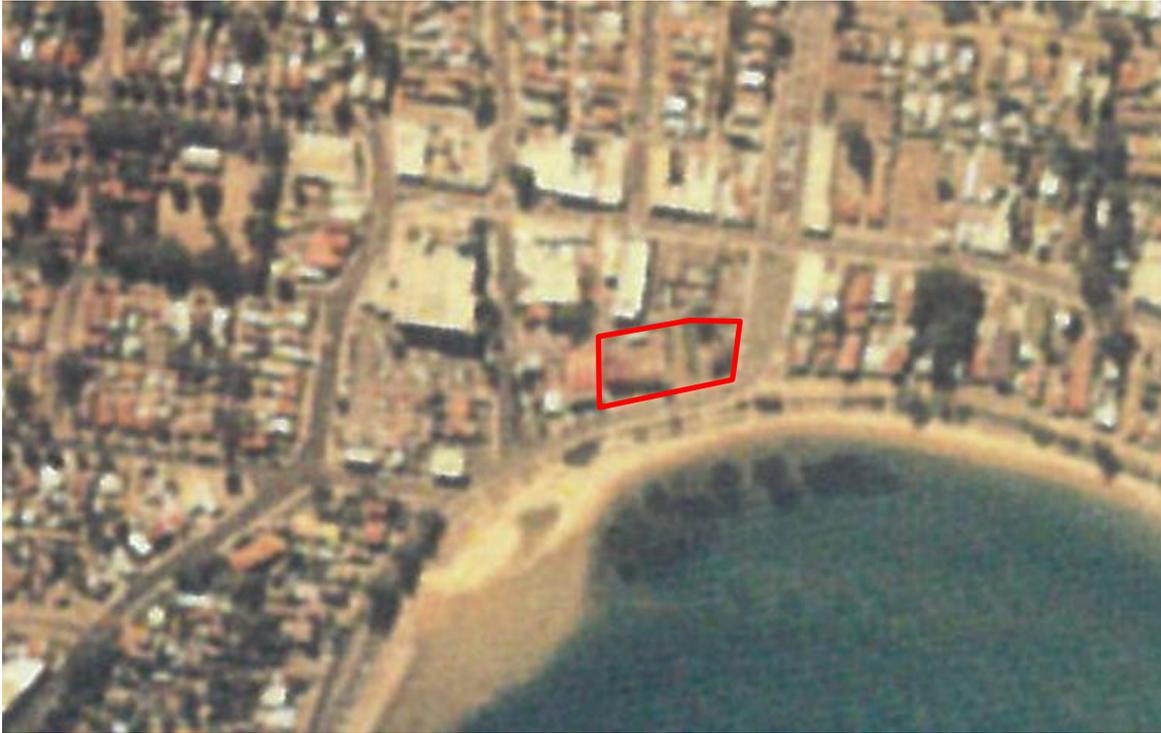
Photo 3 - 1991

**1991** – The historical aerial photograph is of poor resolution. It appears that the residential structures within Lots 120 and 121 observed in the 1985 aerial may have been demolished, although it is difficult to ascertain the detail due to the small scale and resolution. The surrounding land use appears much the same as in 1985.

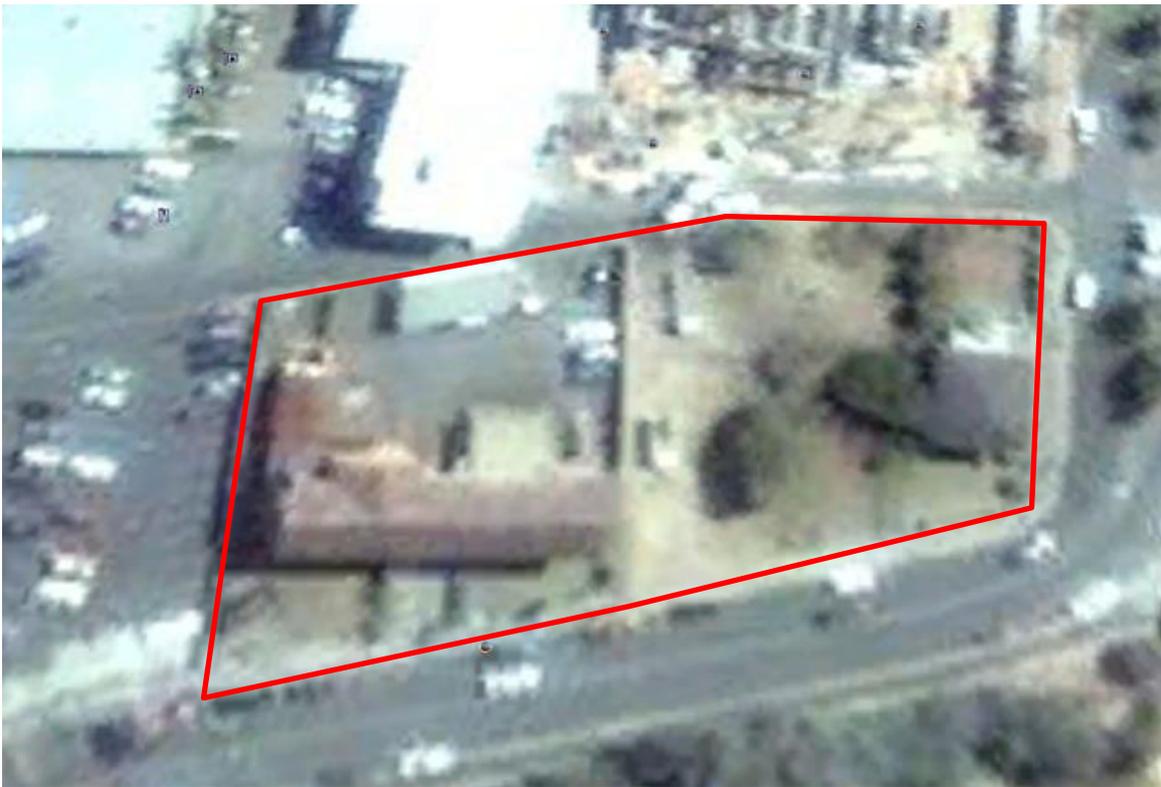
Photo 4 - 2003

**2003** – Lots 120 and 121 comprises grass covered, vacant land with some trees/shrubs. Lots 117 to 119 and Lot 122 appear much the same as in 1985. The building immediately west of the site, observed since 1978 has been demolished, and has been replaced with a car park. It appears that some earth works / possible demolition activity is being undertaken immediately north of the site.

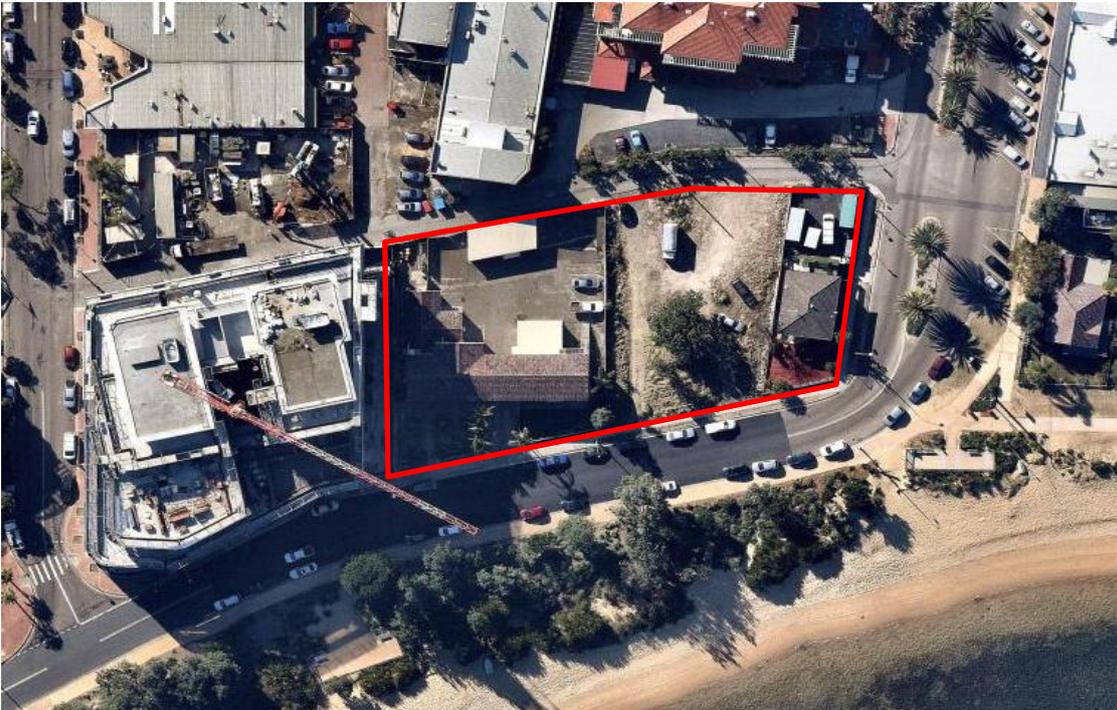
Photo 8 - August 2018

**Aug 2018** – The site appears much the same as in August 2017. It is noted that landscaping bark (or similar) has been placed within the front yard of Lot 122. Construction of the building west of the site has progressed.
