# Preliminary Site Investigation – Lake Munmorah

315, 325 & 335 Pacific Highway, Lake Munmorah, NSW 2259

20222732

Kleinfelder Document: NCA21R131473

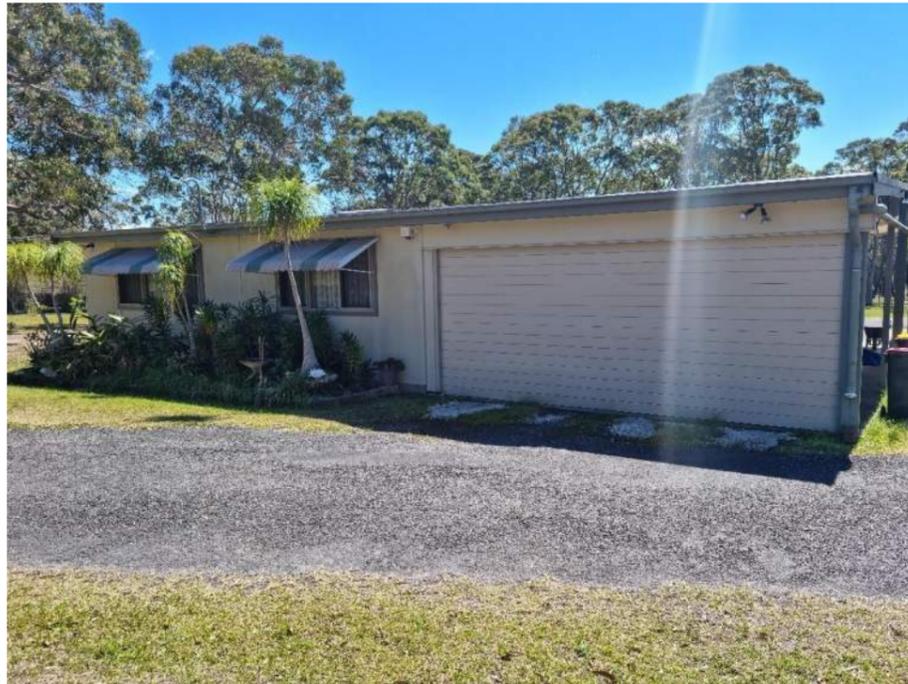
Lot 27 is a 2.12 ha semi-rural property with one dwelling (**Photo 1**) and a detached demountable building (**Photo 2**) adjacent to the garage. The lot is generally grassed with a moderate density of native trees and goats grazing along the northern section of the property (**Photo 3**). A chainwire fence supported by wooden beams runs along the perimeter, with an additional fence line running east to west to control the movements of the goats on the northern half of the property. A rough asphalt surface begins at the gate on the south-west end of the Lot and leads to the fibro house located approximately 75 m north-east (**Photo 4**). A rainwater tank is located behind the demountable building to the east of the dwelling, while an above ground pool is situated on the west side (**Photo 5**).

**Photo 1:**  
Residential dwelling located on Lot 27 (semi-rural property).

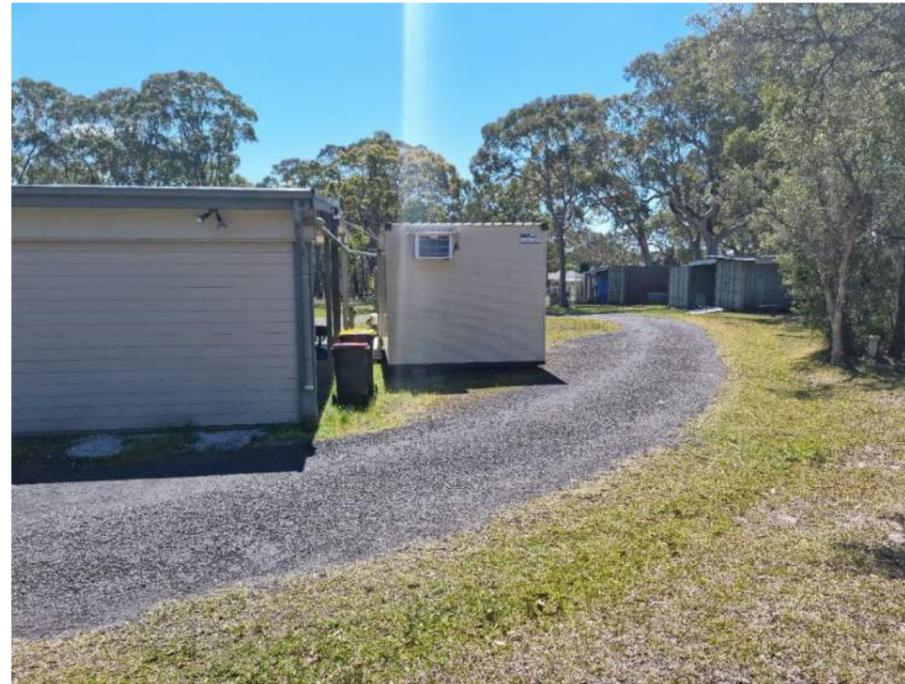
**Photo 2:**  
Detached demountable building adjacent to the garage on Lot 27.

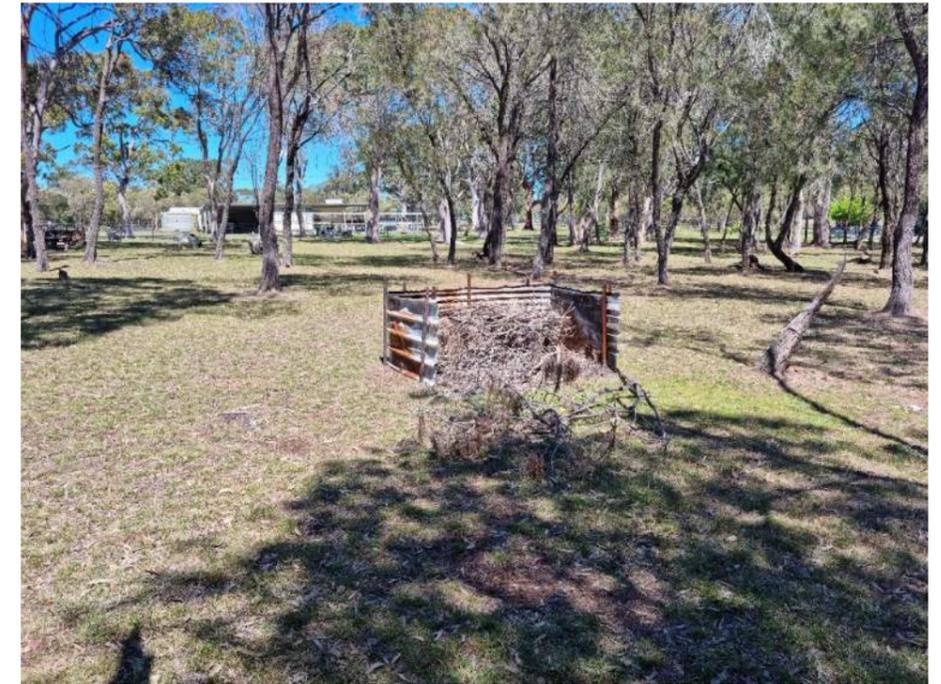
**Photo 3:**  
Grassed area comprising the majority of Lot 27 with moderate sporadicity of native trees and several goats grazing the land.

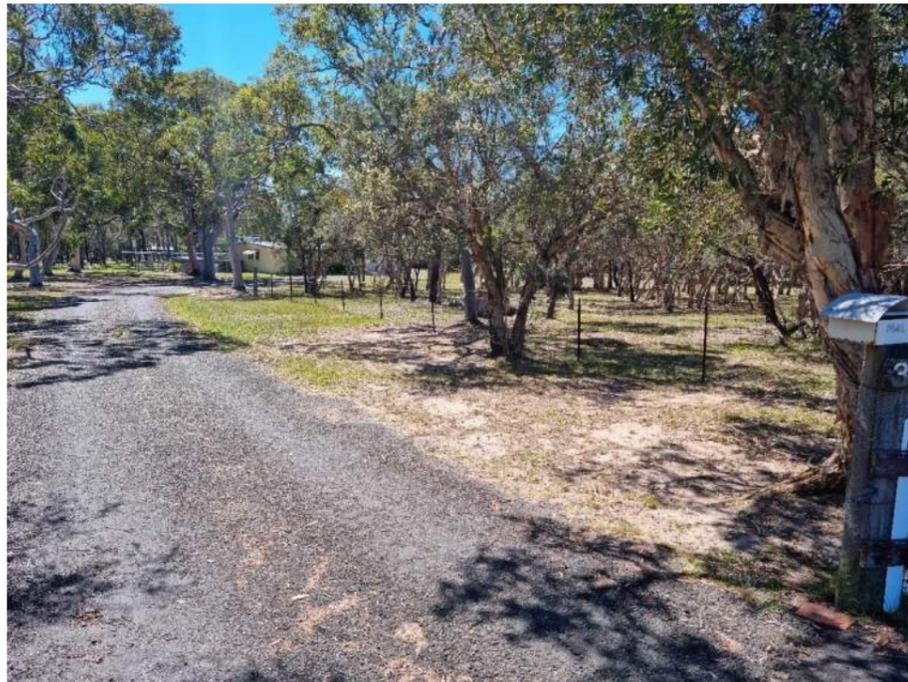
**Photo 4:**  
Rough asphalt driveway leading to the residential house located onsite.

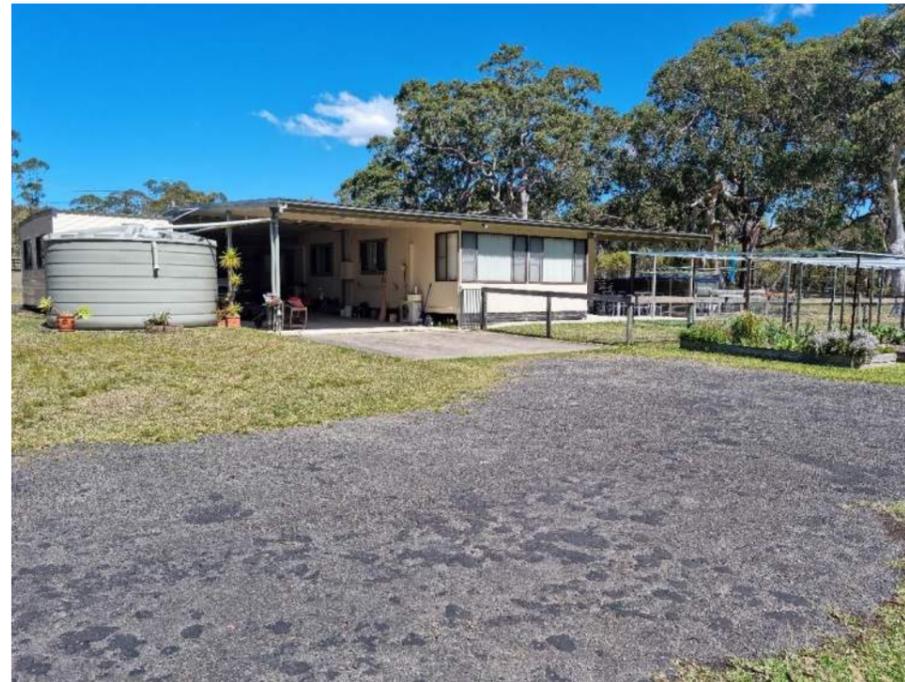
**Photo 5:**  
View of the back of the dwelling, showing a rainwater tank located behind the demountable building, and an above ground swimming pool on the opposing side of the house.

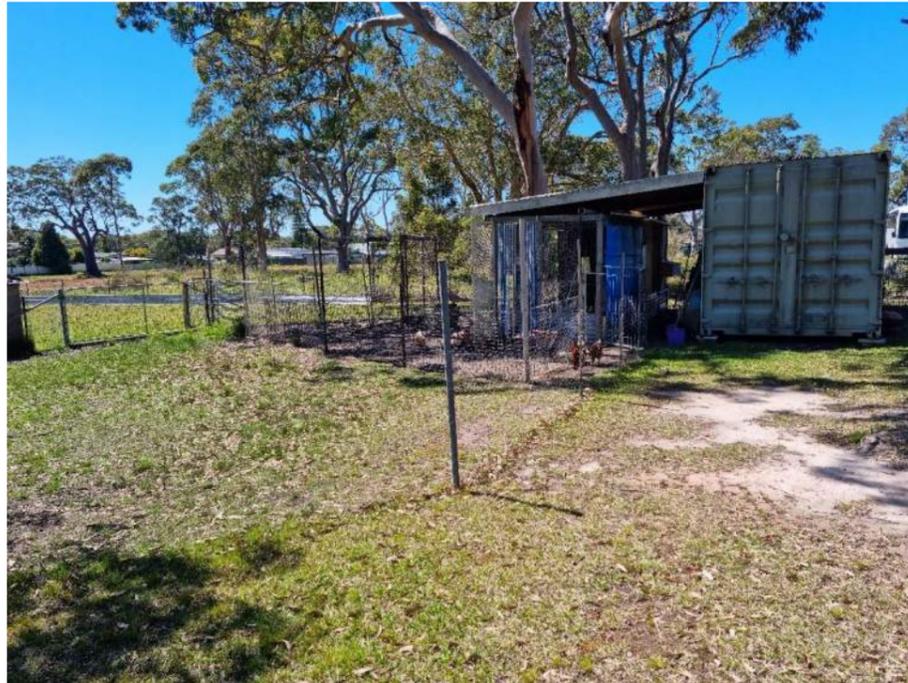
**Photo 7:**  
The third shipping container onsite with a chicken shed adjacent.

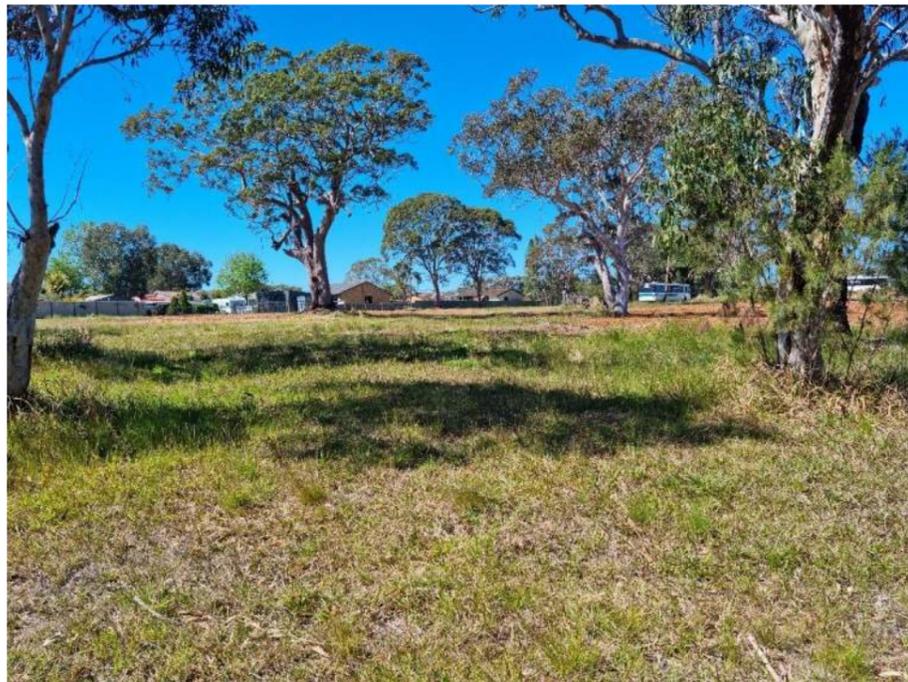
**Photo 10:**  
View of the back of Lot 83, showing the predominantly grassed area with sparse Eucalypt tree growth.

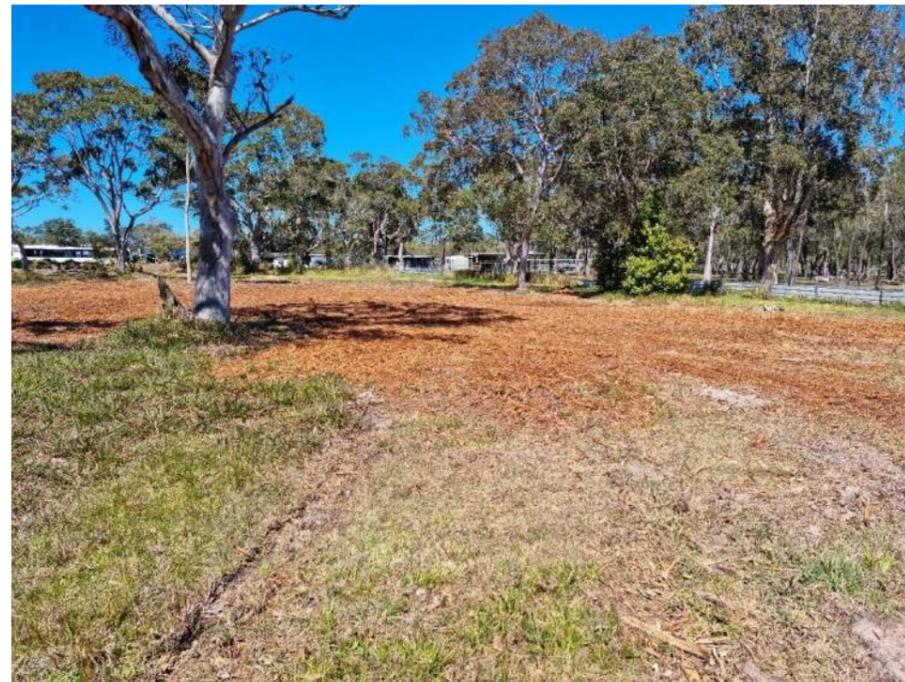
**Photo 11:**  
Recently mulched area on Lot 83.

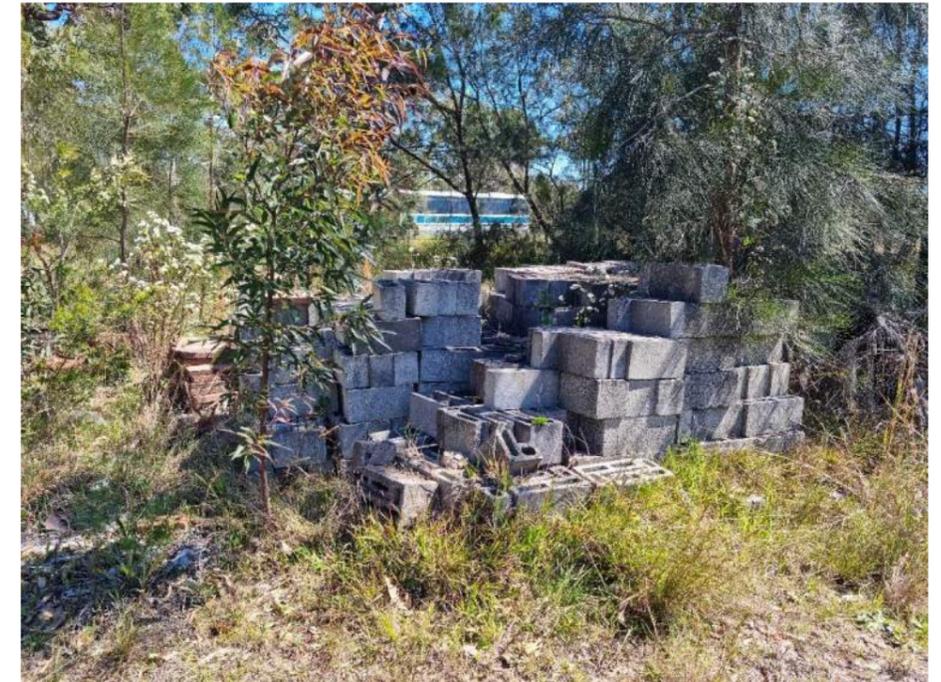
**Photo 18:**  
Pile of bricks and pavements located adjacent to the back gate of Lot 83.

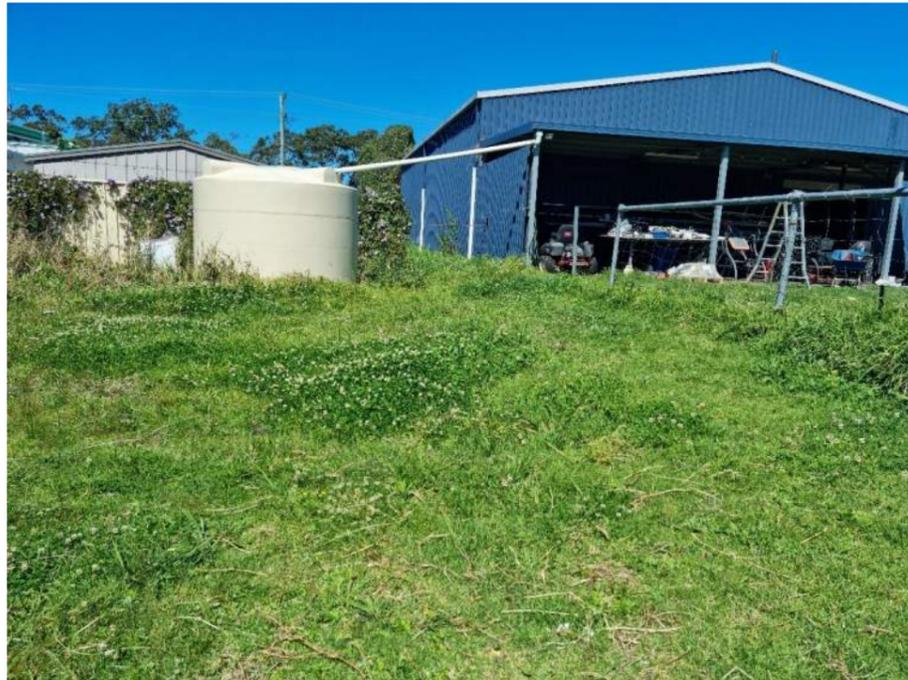
Several buses, cars and boats were present on the southern half of the lot, north of the residential and commercial buildings. Small-scale discharge of oil or fuel from one of the buses was evident on a grassed area adjacent to the bus (**Photo 20**). Other similar patches of fuel / oil were identified within this area. A shed with two shipping containers either side (**Photo 21**) were located along the western perimeter of the lot behind the residential building (approximately 30 m away), where several small piles of assorted waste/building materials are situated. They are currently being used for storage of various items, including a refrigerator and old drums. A large shed storing building materials and a mower backs onto the workshop, with a rainwater tank adjacent (**Photo 22**).

**Photo 22:**  
Large shed backing the main commercial building on Lot 83, with a rainwater tank adjacent.

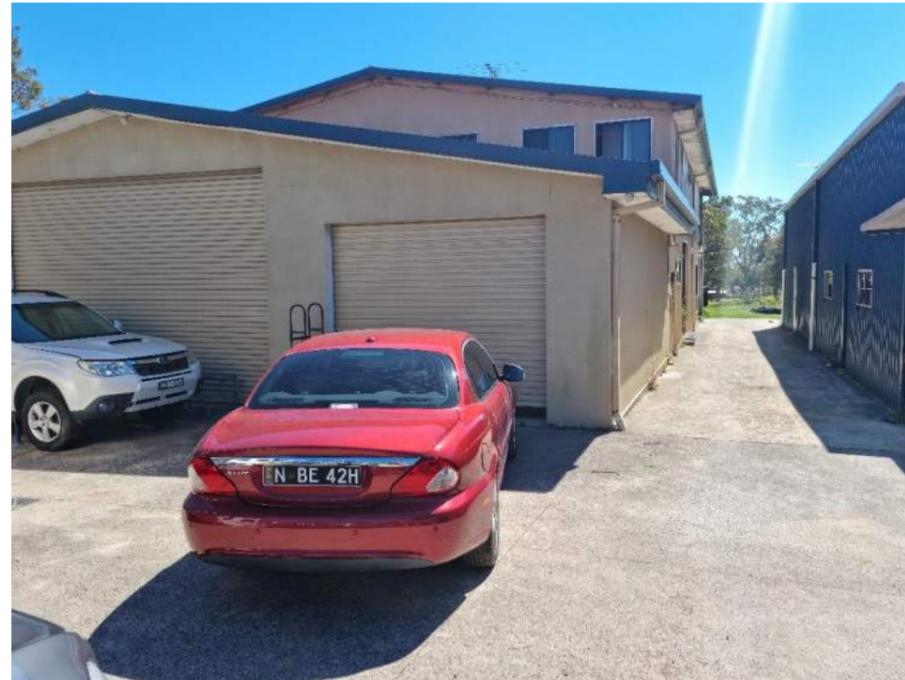
**Photo 23:**  
Concreted area on the southern end of Lot 83 in front of the commercial and residential buildings located onsite.

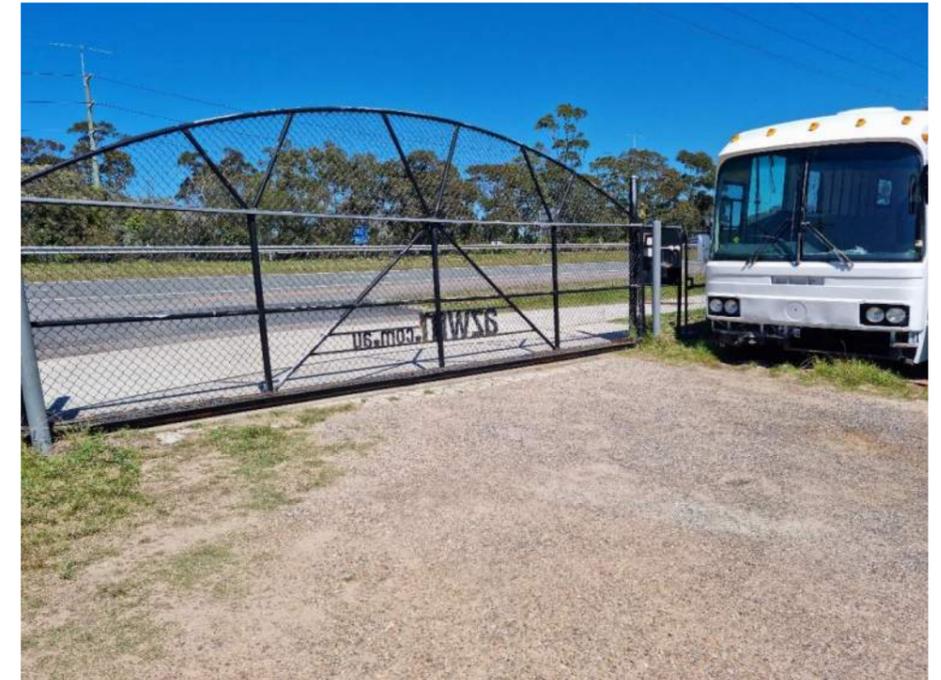
**Photo 24:**  
Crushed concrete/gravel area at the main entrance to the front of the lot where the site buildings are located.

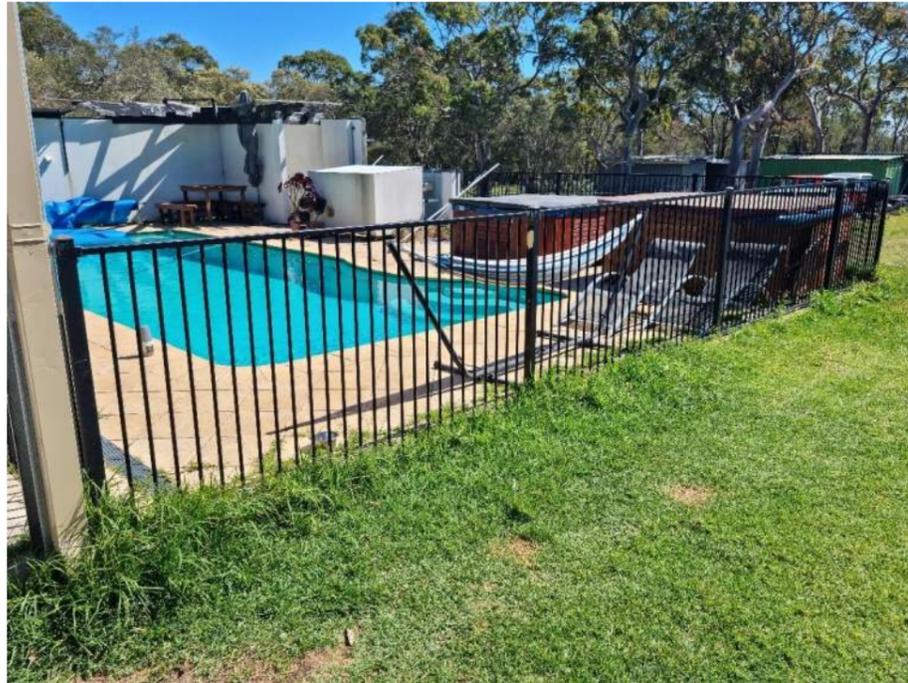
**Photo 25:**  
Swimming pool and two spas located at the back of the residential property on Lot 83 (adjacent to the commercial business building).

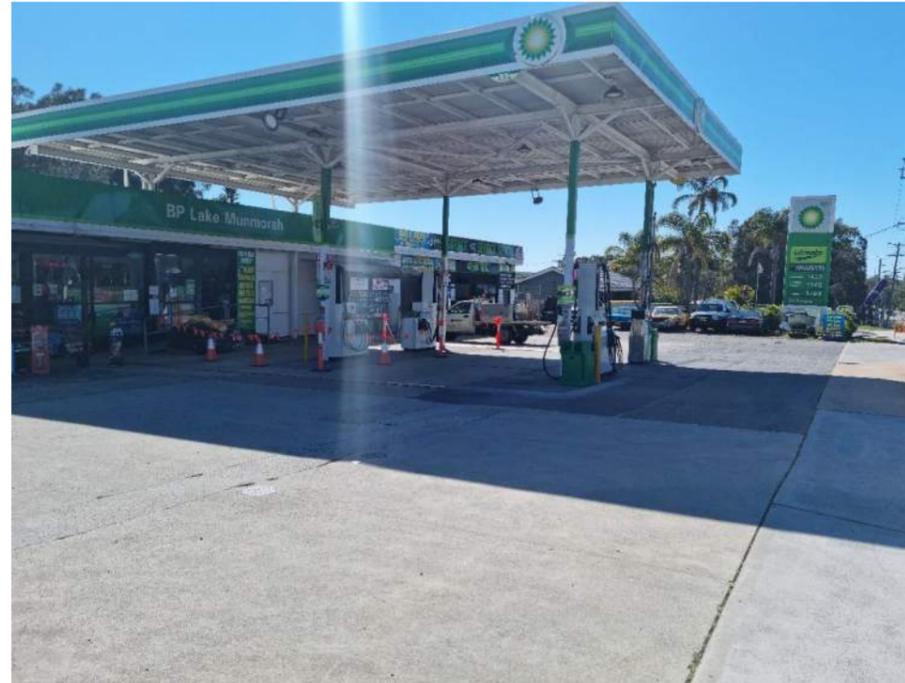
Lot 12 is an operating BP branded service station consisting of one primary commercial building including a mechanical workshop, retail shop and a canopy and three smaller structures on the northern side of the property. Four fuel bowsers are located within the forecourt area (**Photo 26**). The bowsers appear to be recently upgraded, with new concrete surrounding the bowser sumps. Two of the four bowsers were not in use at the time of the walkover, likely due to recently applied concrete (**Photo 27**). Two underground storage tanks (USTs) were present; one 55 kL fibreglass split tank holding unleaded and premium unleaded, the other a 45 kL steel tank containing diesel. The bowsers were bunded beneath the canopy and no offsite contamination (fuel in exposed drains) was evident. Four drainage pits were identified within the forecourt, two of which are in close proximity to the adjacent residential property to the east. Two monitoring wells were also identified, one the eastern side of the forecourt (**Photo 28**) and another on the western side.

**Photo 26:**  
View of Lot 12 (BP service station) from the footpath adjacent to the Pacific Highway, showing the main BP shop building, adjacent garage service centre and the four bowsers of the service station.

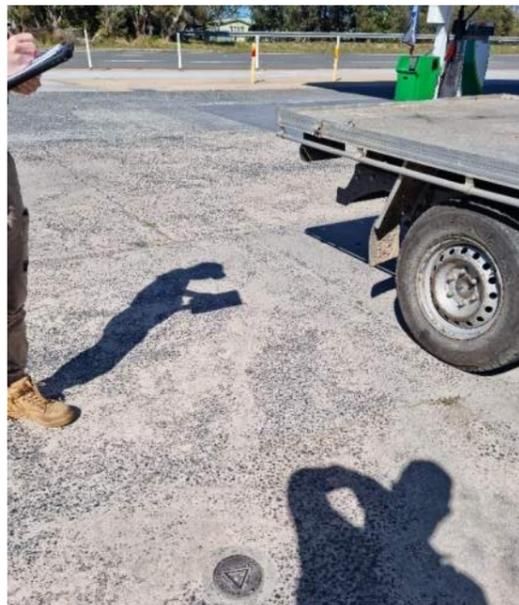
**Photo 28:**  
Monitoring well located on the eastern side of the service station.

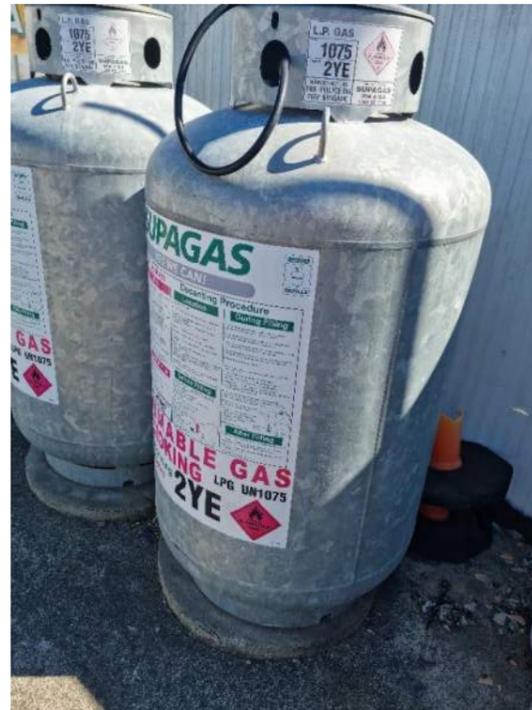
Two 210 kg LPG gasoline tanks (**Photo 29**) were present in the north-west corner of the BP service station, as well as approximately 20 smaller 8.5kg exchangeable LPG gas bottles contained in a storage cage. Chlorine containers (**Photo 30**) are also stored outside the shop window on the west side of the main building. Due to their age, the buildings likely contain asbestos material, though they appeared to be in good condition with no obvious signs of significant deterioration (**Photo 31**). Along the wall on the western side of the garage service centre, old jerry cans / fuel containers were stored (**Photo 32**), though appear empty. Other waste was also located here, such as tyres, scrap metal and old piping.

**Photo 29:**  
Two large LPG gas tanks located in the north-west corner of Lot 12

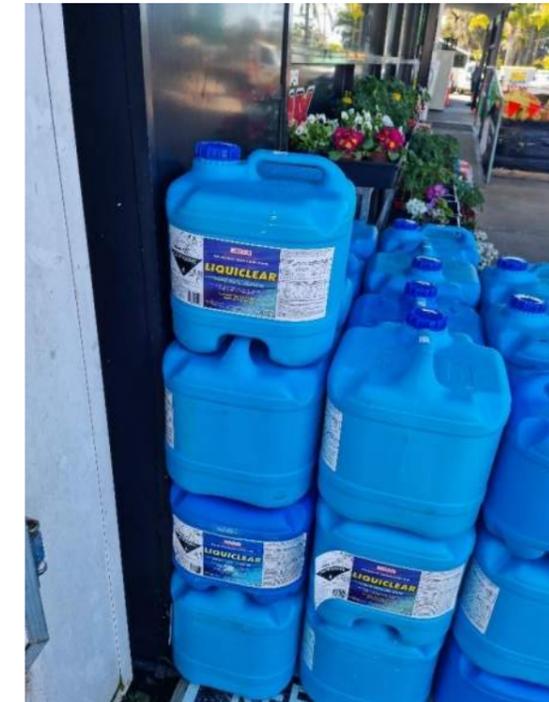
**Photo 30:**  
Chlorine containers stacks outside the BP shop window to the west.

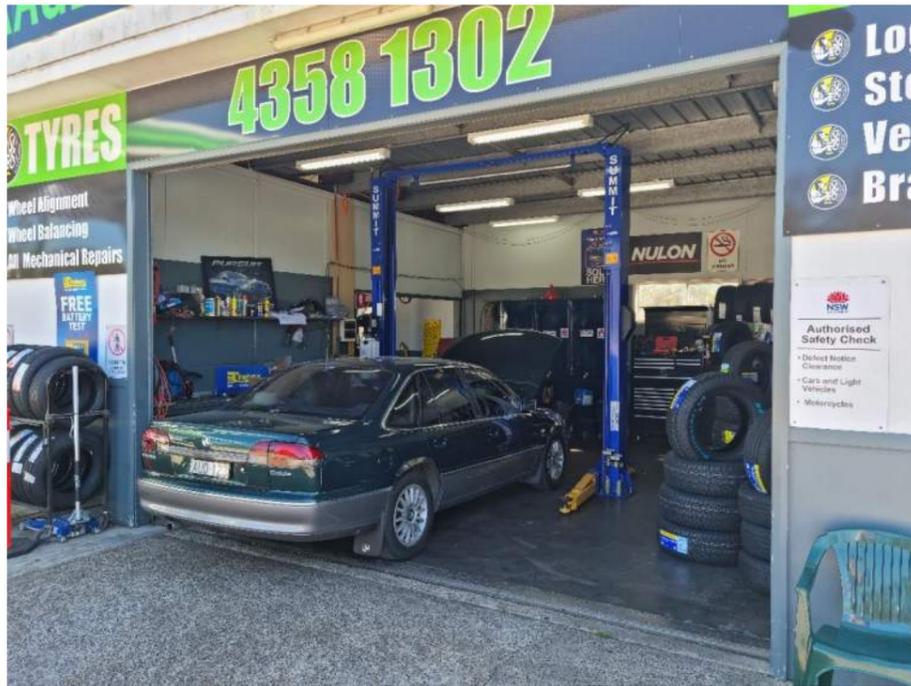
**Photo 331:**  
Garage service centre adjacent to the BP shop. Appears to be in good condition and recently painted.

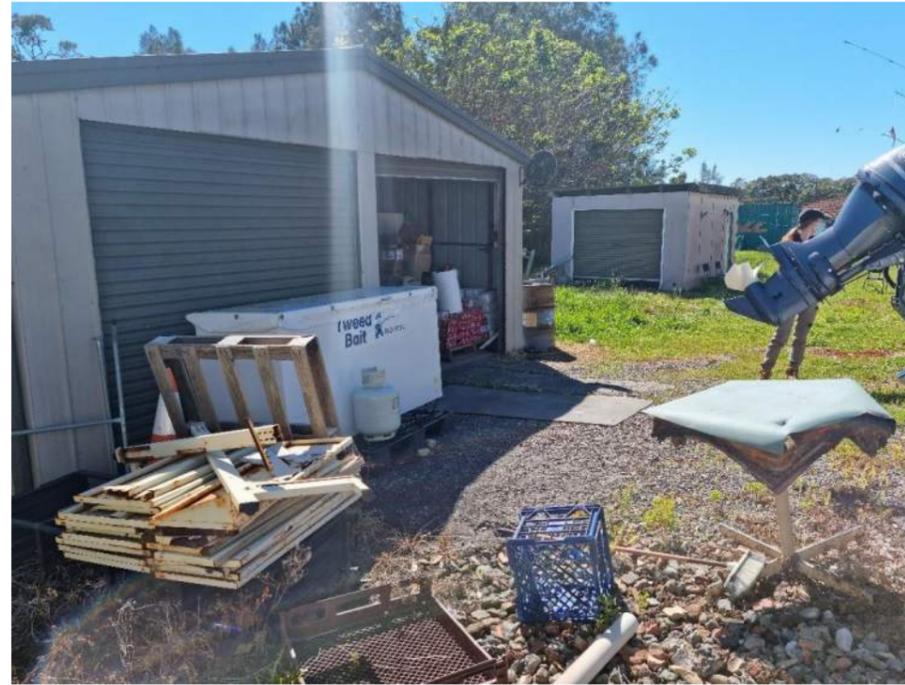
**Photo 38:**  
Third shed onsite holding general inventory/stock for the BP shop. This shed is in relatively good condition.

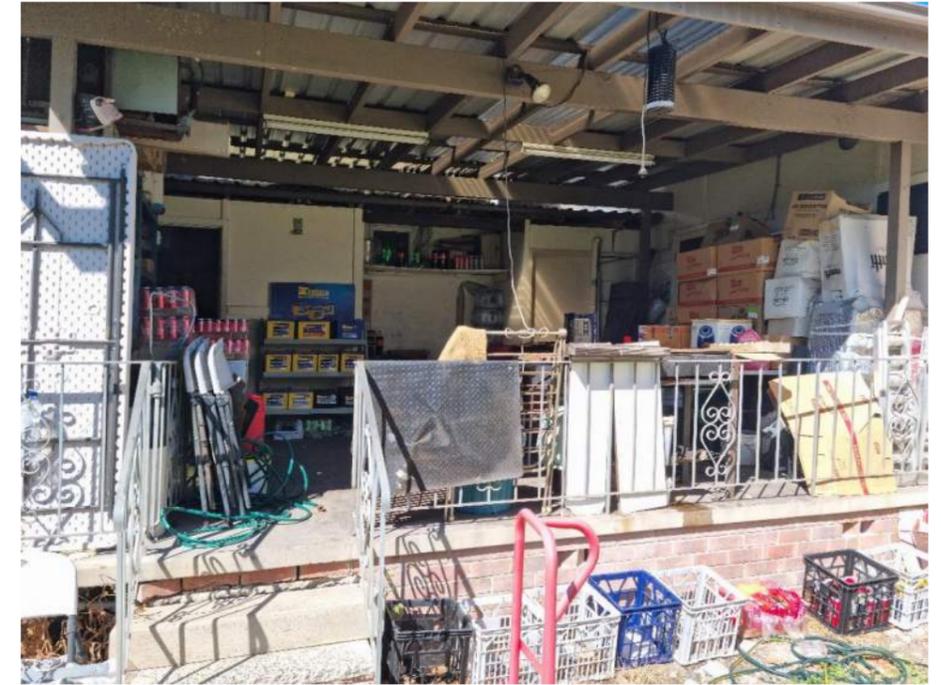
**Photo 39:**  
Workshop backing onto the service station building.
